ILIFF & ASSOCIATES INC. "A Roof Asset Management Corporation"

VISUAL ONLY - ROOF INSPECTION  
CITY OF FARMERS BRANCH

DATE OF SURVEY: April 2, 2025  
BUILDING NAME: Fire Station #3/Bob Phelps Fire Administration Building  
ADDRESS: 13333 Hutton Dr.  
Farmers Branch, TX  
INSPECTOR: William Allen  
ROOF CONSTRUCTION: White mineral surfaced modified bitumen (mop applied)  
Ridgid insulation over metal deck  
Architectural standing seam metal panels  
Ridgid insulation over metal deck  
ROOF AREA: Metal section: 16,087 sq. ft. BUR section: 4,903 sq. ft.  
BLDG. HT: Varies: 24' - 38'  
ACCESS METHOD: Roof hatch - northwest section

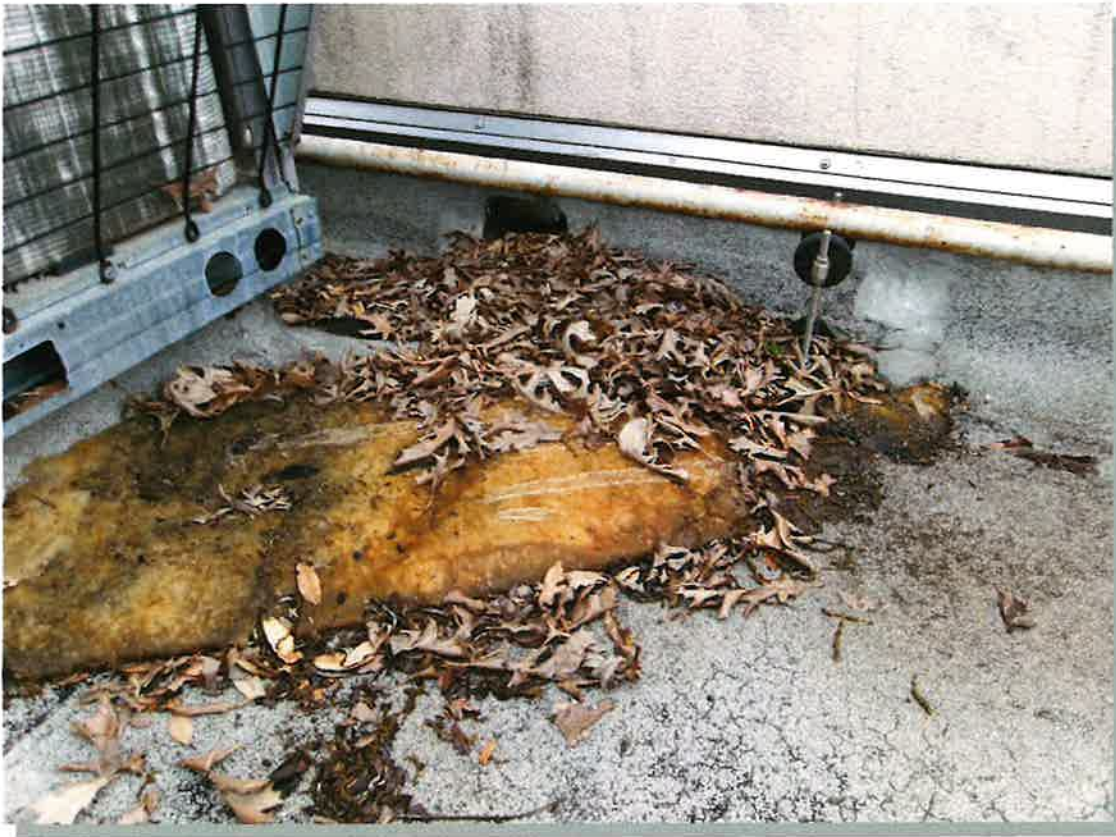
☒ RESTRICTIVE DEBRIS - Seasonal leaf debris.

Restrictive debris.

Recommend removal of seasonal leaf debris from roof and ALL conductor leads.

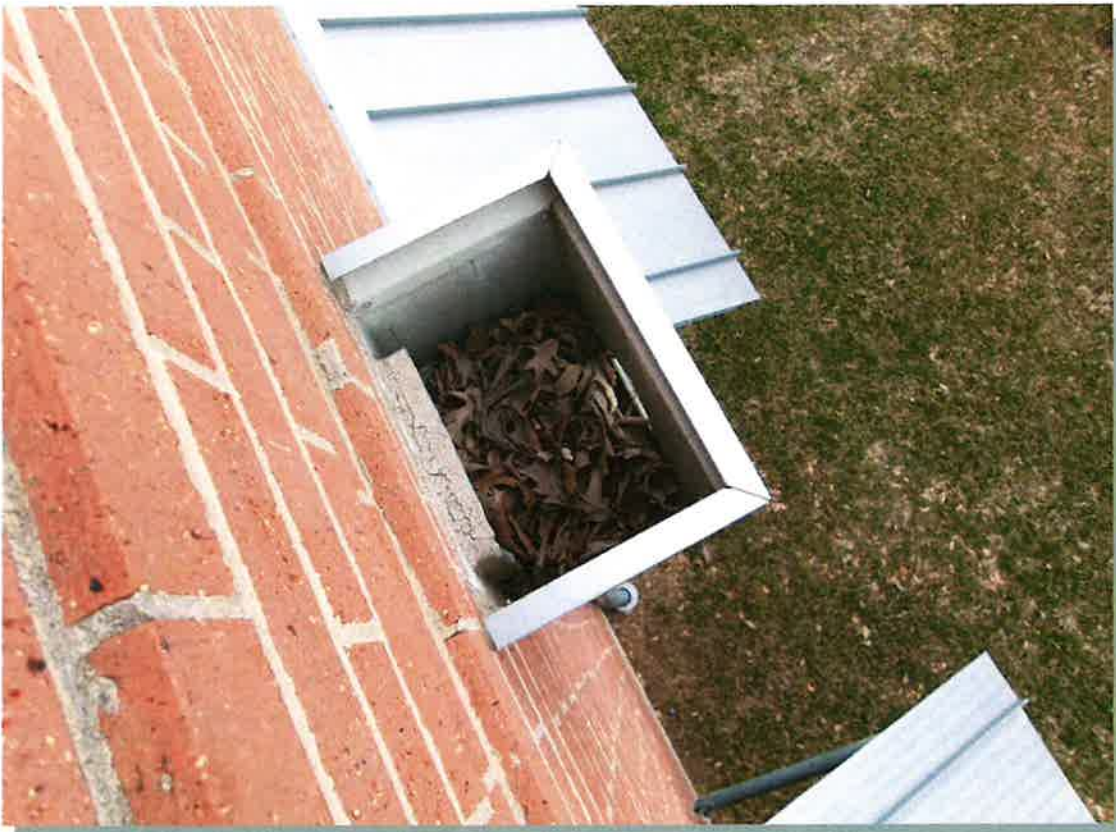
Debris filled conductor head.

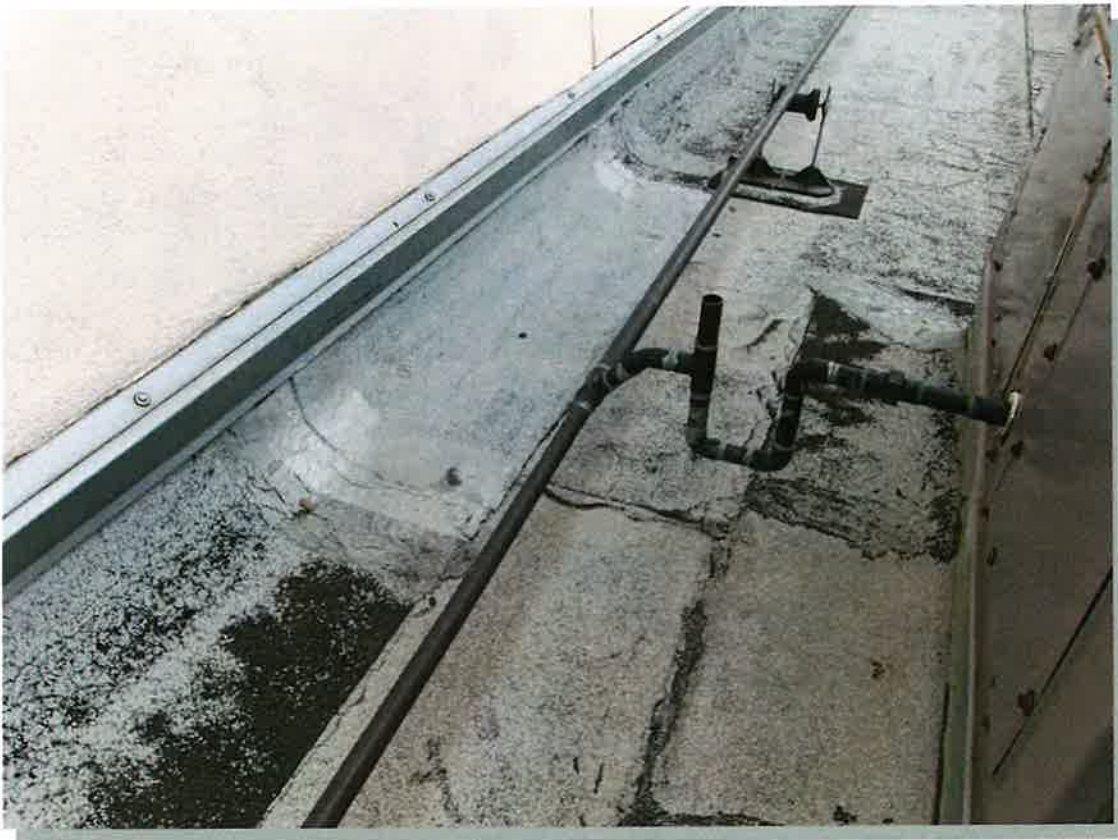
Previous repair.

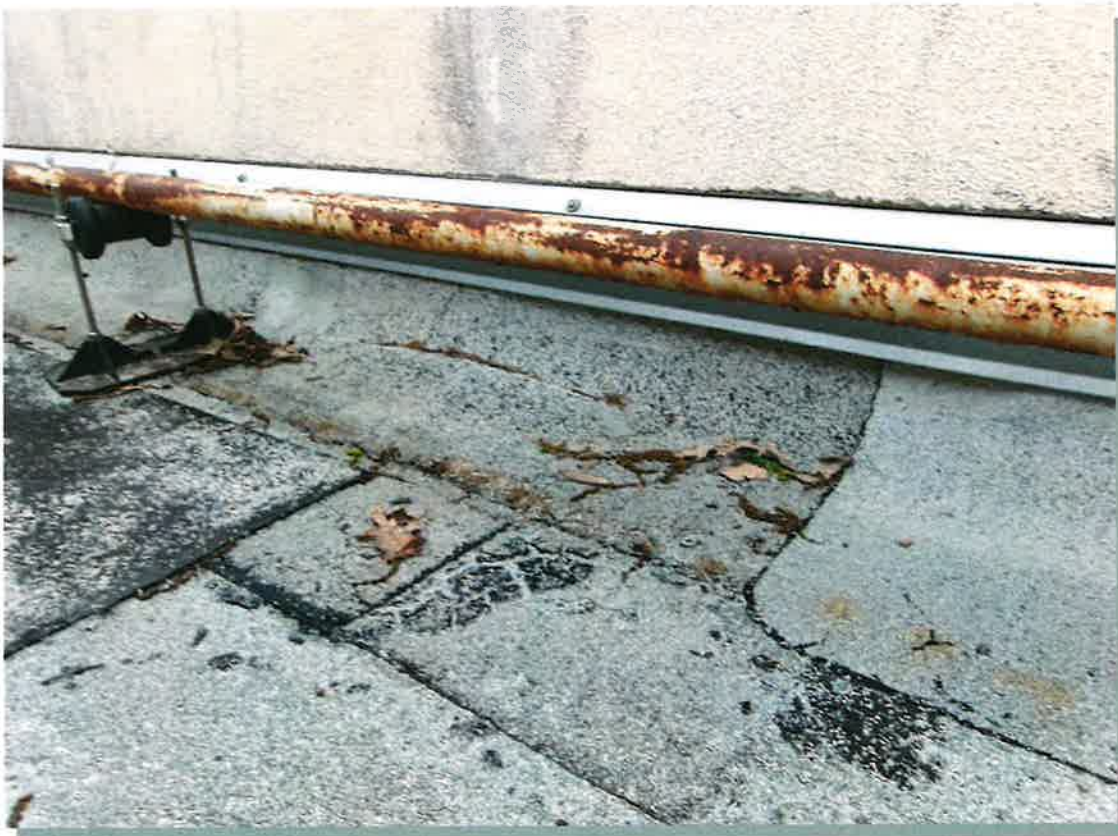
- Blister development observed.

Blister development along perimeter wall flashing.

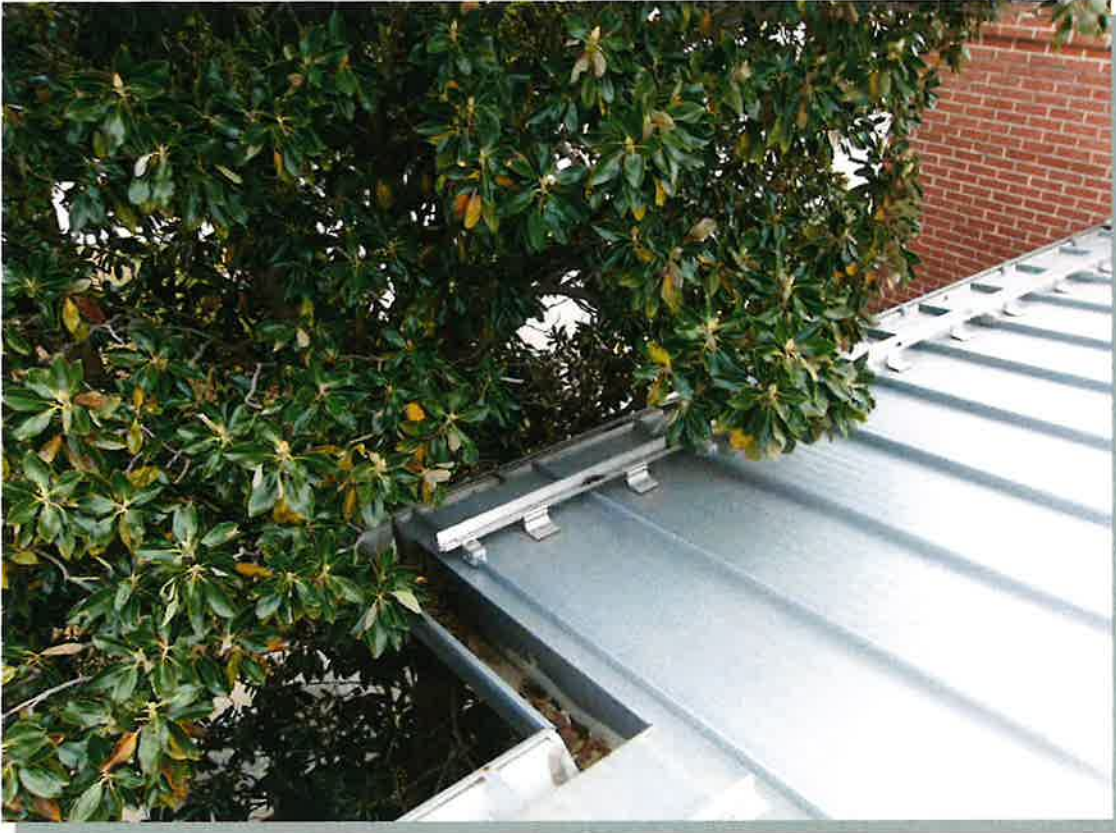
OTHER: Overhanging tree limbs.

Overhanging tree limbs.

Recommend landscaping contractor trim back over hanging tree limbs that are scrubbing the roof surface.

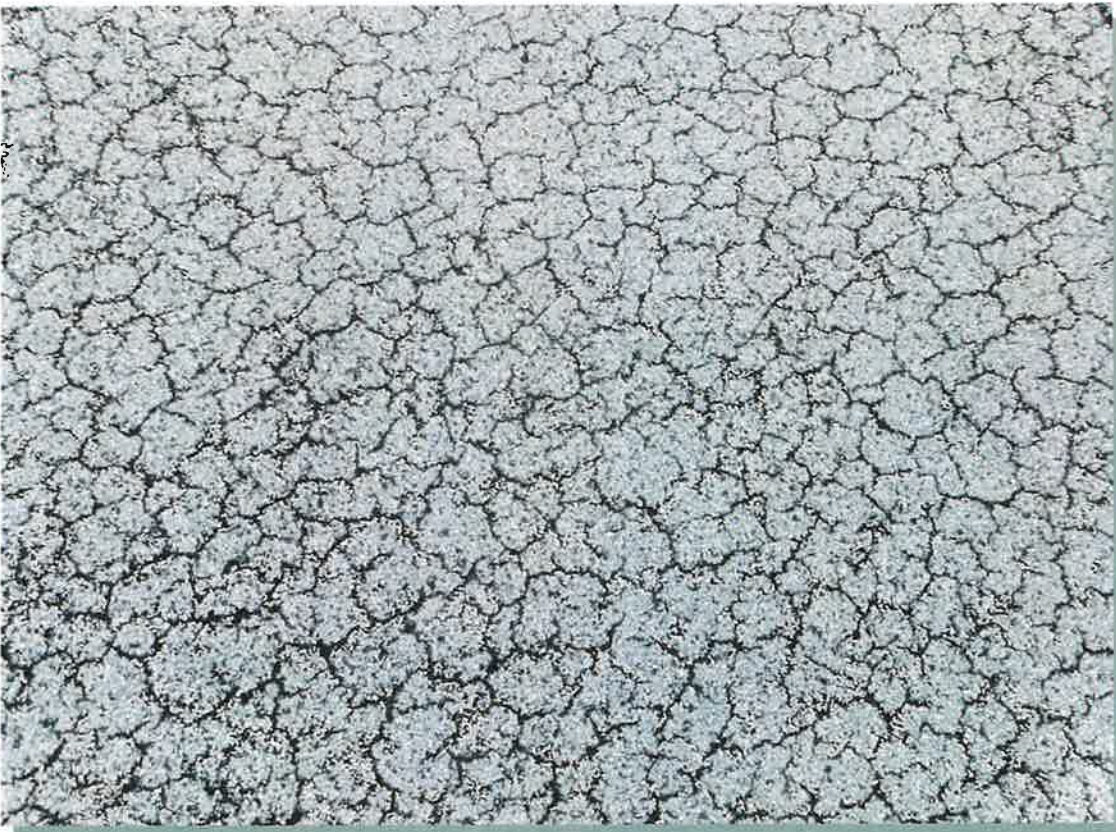
Membrane cracking in field of roof.

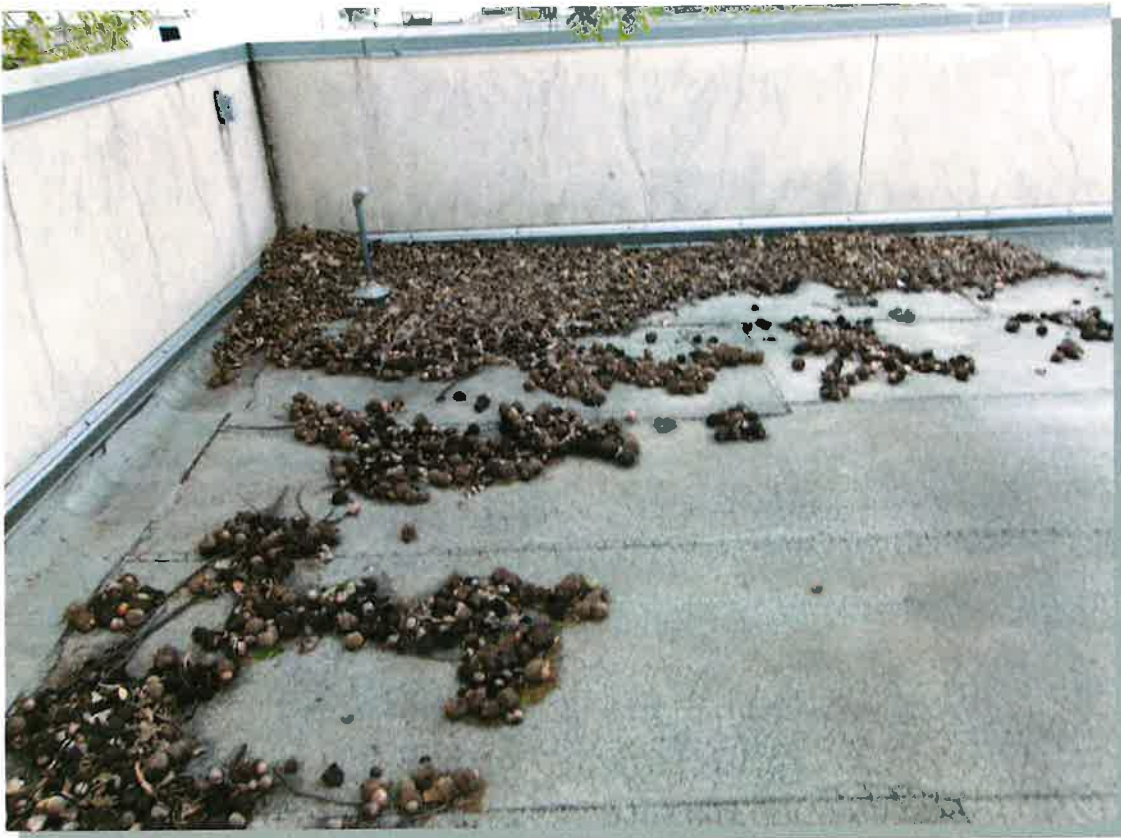
DEBRIS: ☐ HEAVY ☐ MODERATE ☒ LIGHT - Seasonal leaf debris ☐ NONE

Seasonal leaf debris.
