Rawhide Creek Infrastructure Assessment

Final Technical Memorandum

December 18, 2020

TO: Marc Bentley, PE
FROM: David Rivera, PhD, PE, CFM
SUBJECT: Rawhide Creek Infrastructure Assessment
DATE: 12/18/2020
PROJECT: FBR20638 – Rawhide Infrastructure Assessment

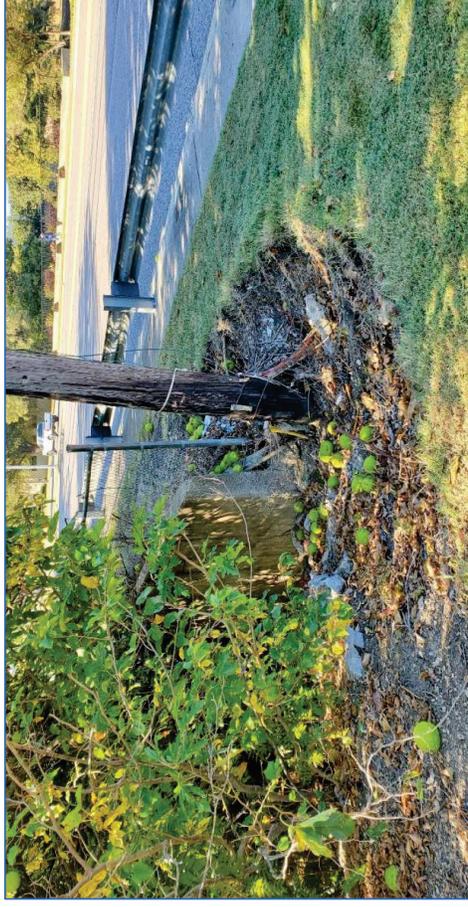
Image 2. Erosion along sidewalk-adjacent utility pole.

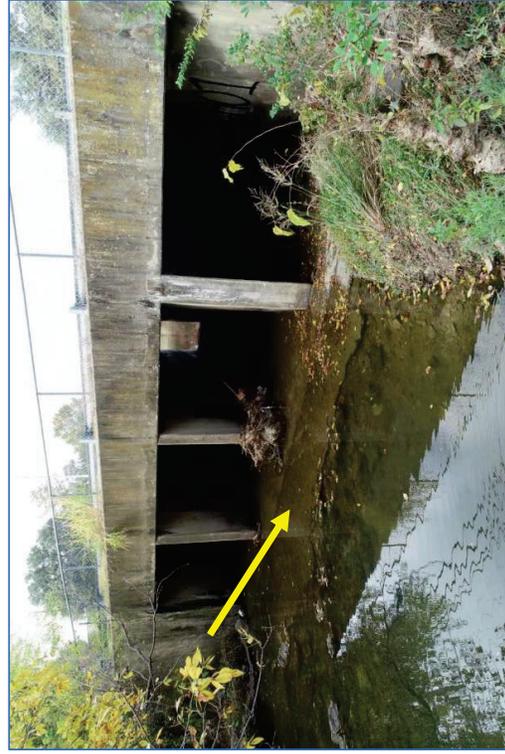
Image 1. Damaged concrete apron upstream

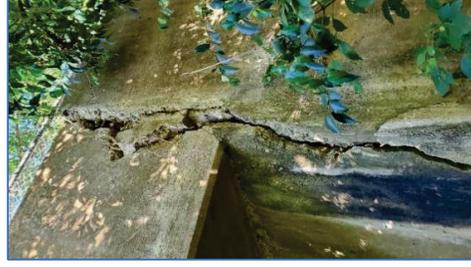
Image 3. Elongated crack within concrete culvert.

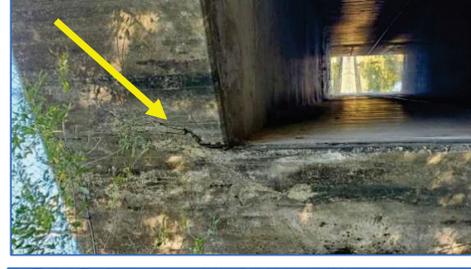
Image 4. Continued damage/cracks along culvert.

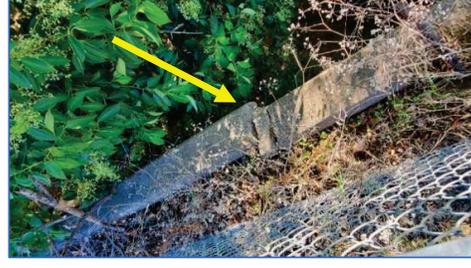
Image 5. Ground-level view of cracks within culvert.

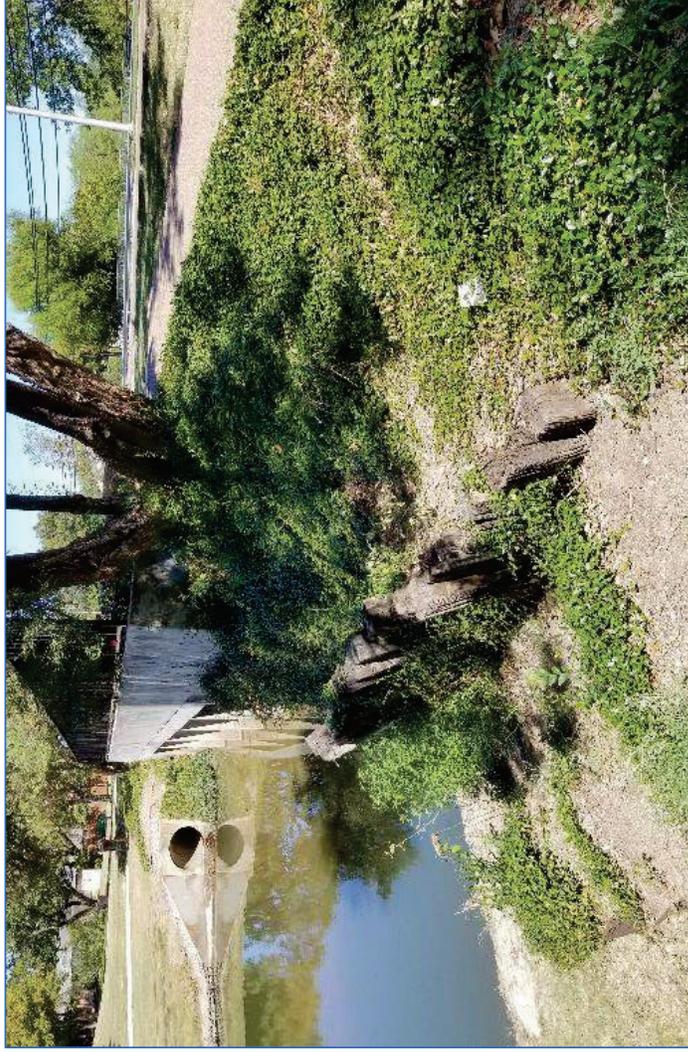
Image 6. Timber retaining wall at southwest corner.

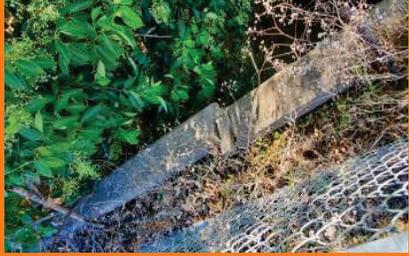
Problem: Northeast wingwall cracked at connection with culvert.
Solution: Replace wingwall.

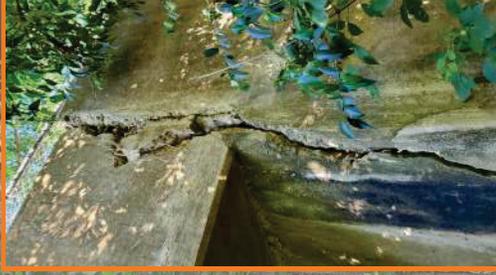
Problem: Crack developing on southeast wingwall at culvert.
Solution: Replace wingwall.

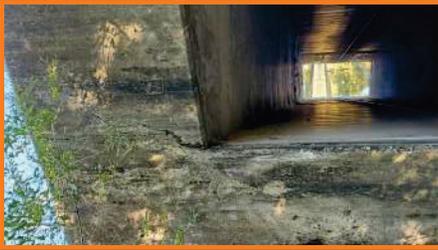
Problem: Additional cracks developing within southeast wingwall.
Solution: Repair spalled, cracked, and delaminated patches of concrete.

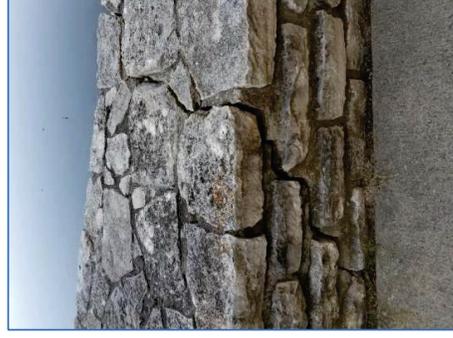
Image 10. Cracks within stone and grout of the retaining wall.

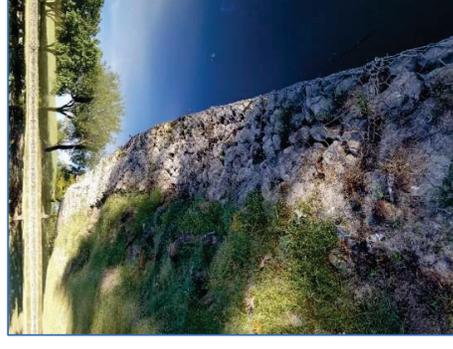
Image 11. Gabion bank erosion.

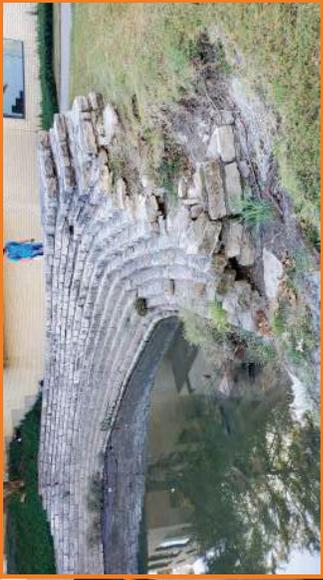
Problem: Damaged stone retaining wall and erosion of bank at end of wall.

Solution: Remove and replace 400 SF of stone retaining wall.

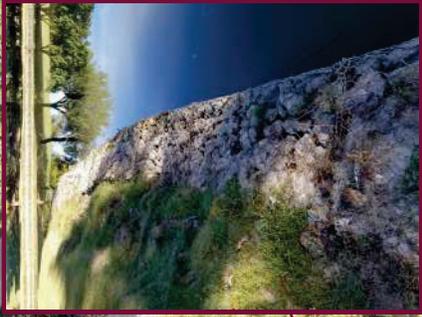
Problem: Minor erosion at the top of the gabion baskets.

Solution: Perform grading to establish uniform slope along channel lining.

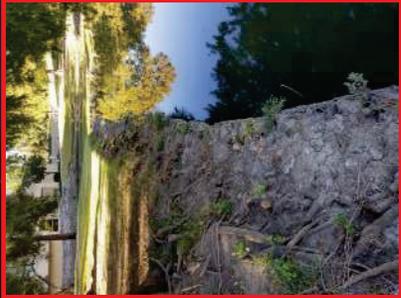
Problem: Damaged gabion baskets.

Solution: Remove and replace 190 LF of damaged gabion wall.

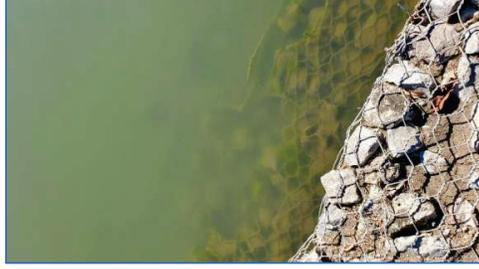
Image 14. Broken-up gabion wall within the channel lining.

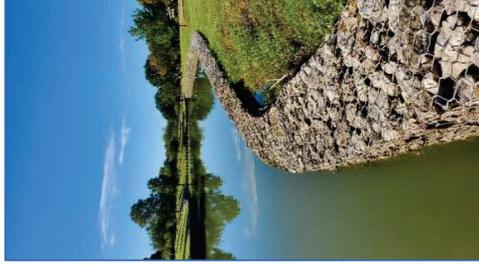
Image 13. Leaning gabion wall (downstream view).

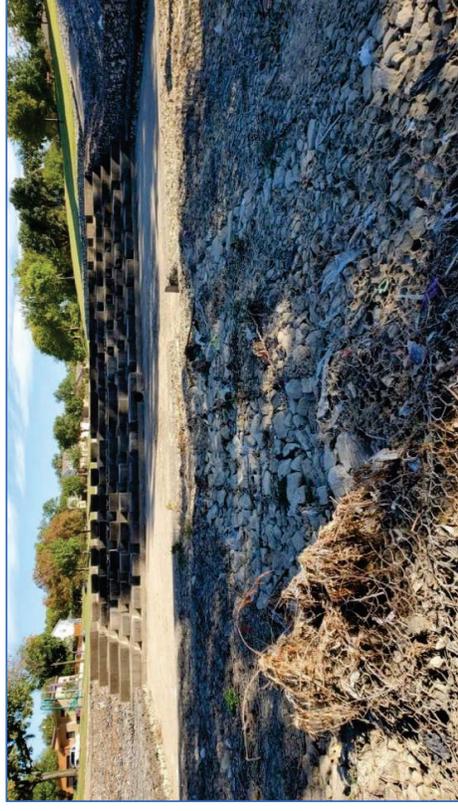
Image 16. Close-up of wire damage within gabion mattress.

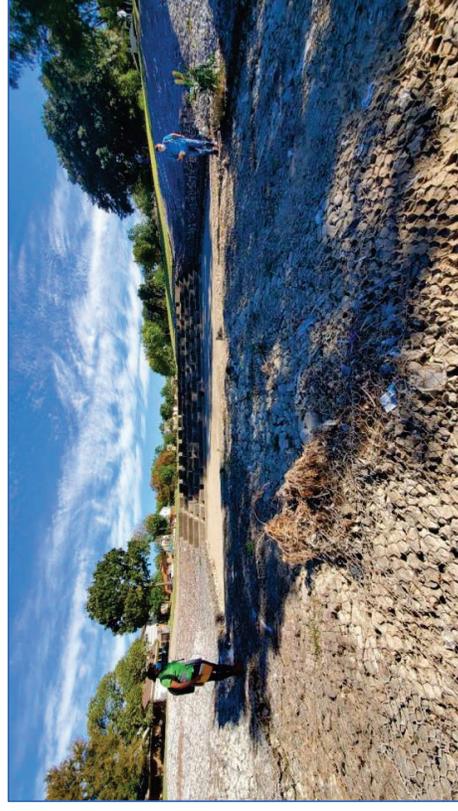
Image 17. Overview of gabion mattress within channel.

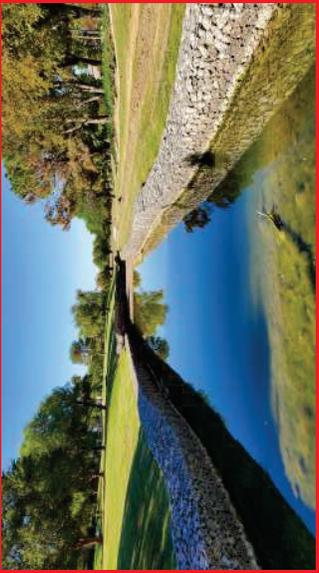
Problem: Leaning gabion wall along the left bank of the channel.

Solution: Replace 50 LF of leaning gabion wall by installing new gabion baskets.

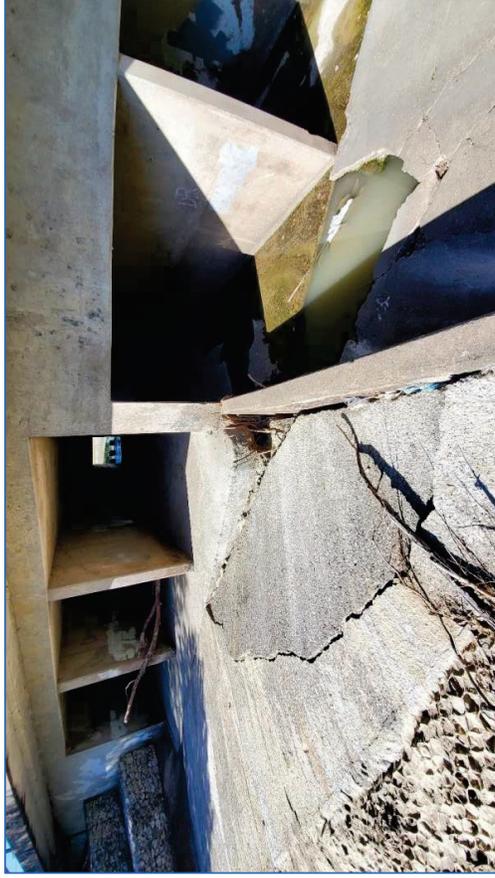
Image 20. Josey Lane damaged concrete riprap.

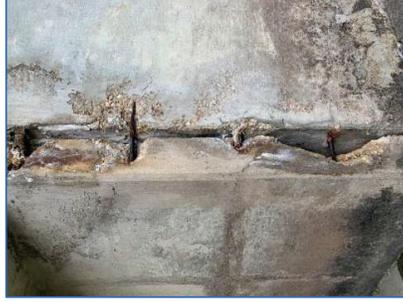
Image 21. Exposed reinforced steel at wingwall connection.

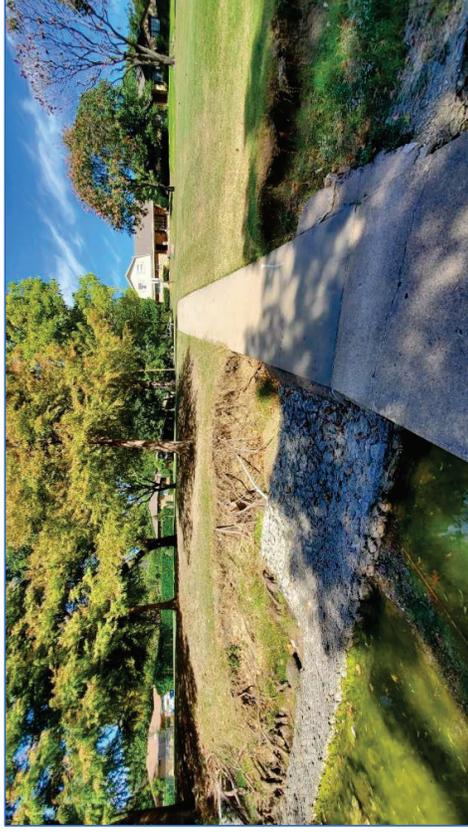
Image 28. Sharp drops in terrain elevation adjacent to pedestrian walkway.

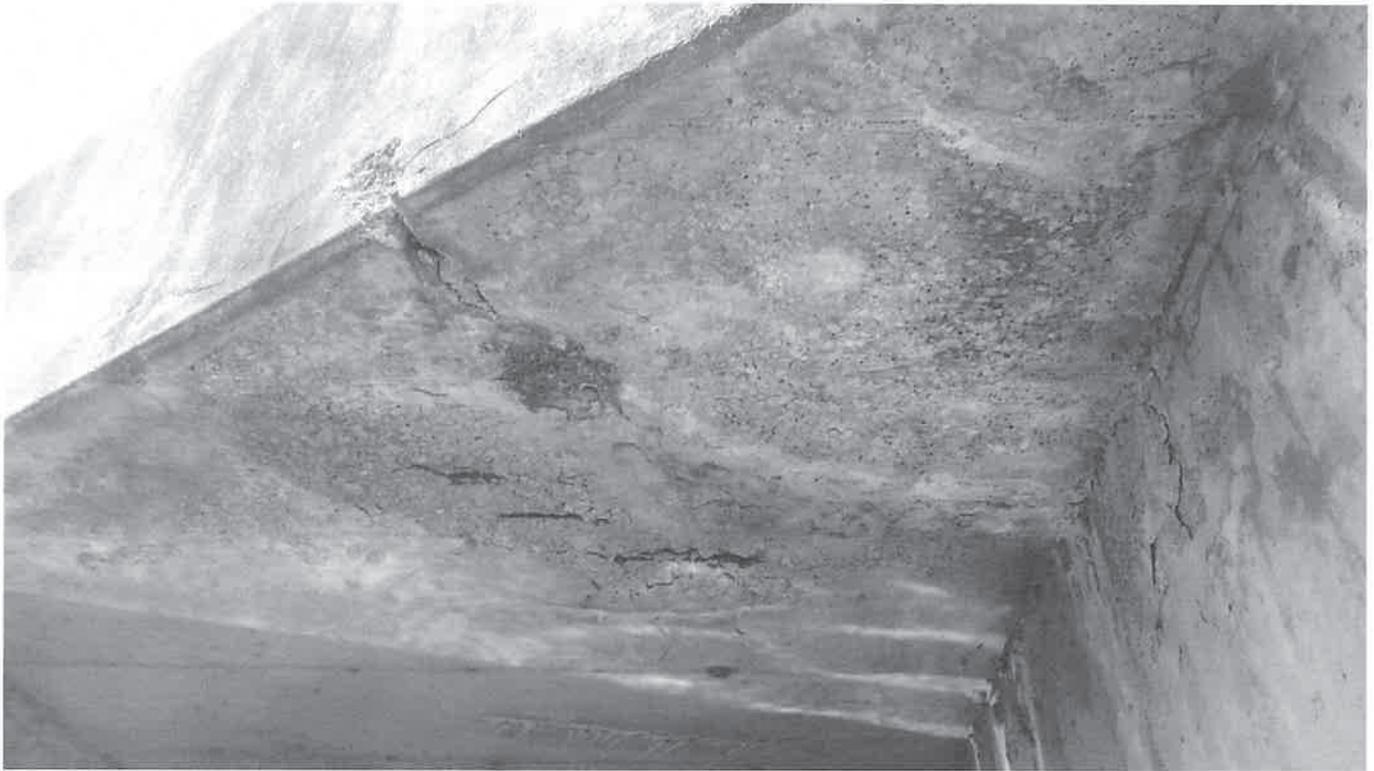
VIEW 8308

NOTE: SOFFIT OF TOP SLAB HAS HONEYCOMB SPALLS WITH EXPOSED CORRODED REBAR AT EAST END.

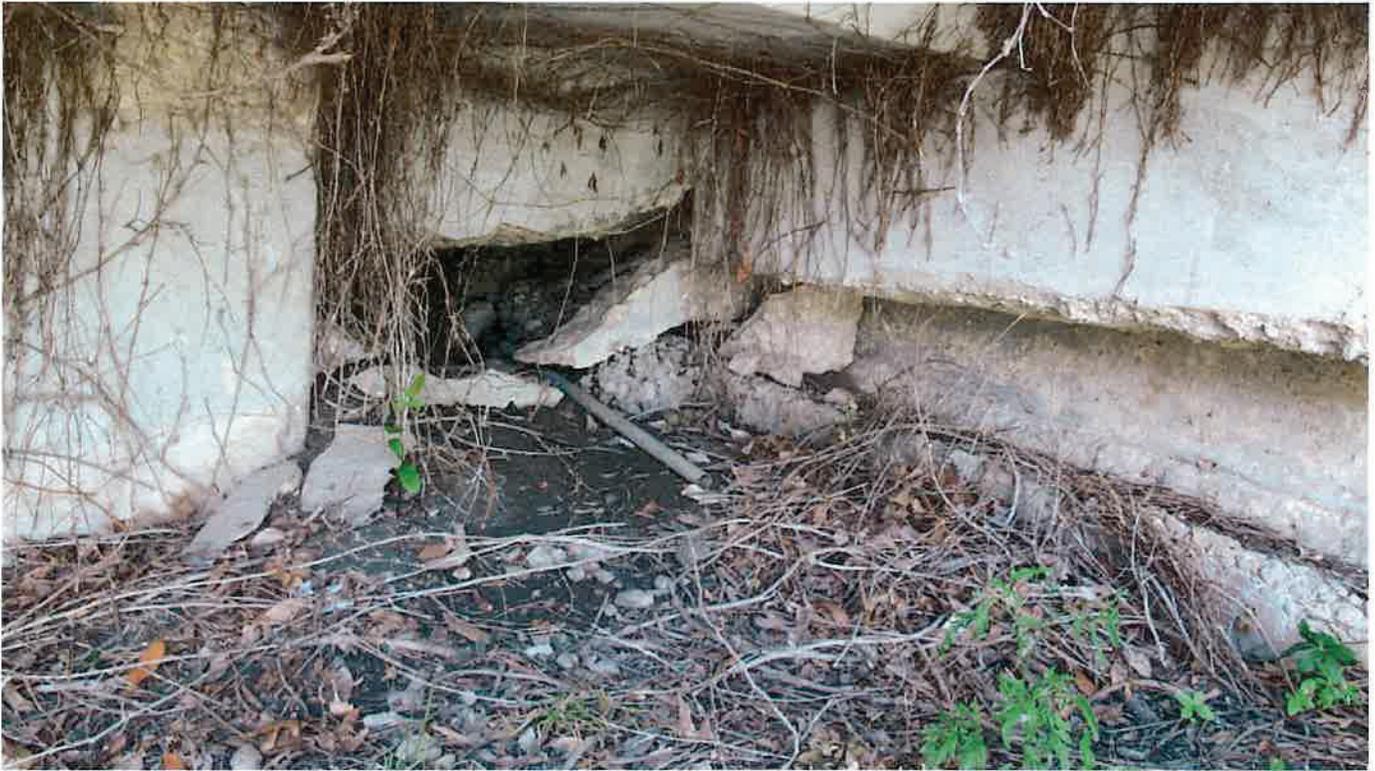
SOUTHWEST CORNER OF CULVERT - LOOKING EAST

NOTE: UNDERMINING GOES 3' BACK UNDER SOUTH APPROACH AT SOUTHWEST CORNER OF CULVERT.

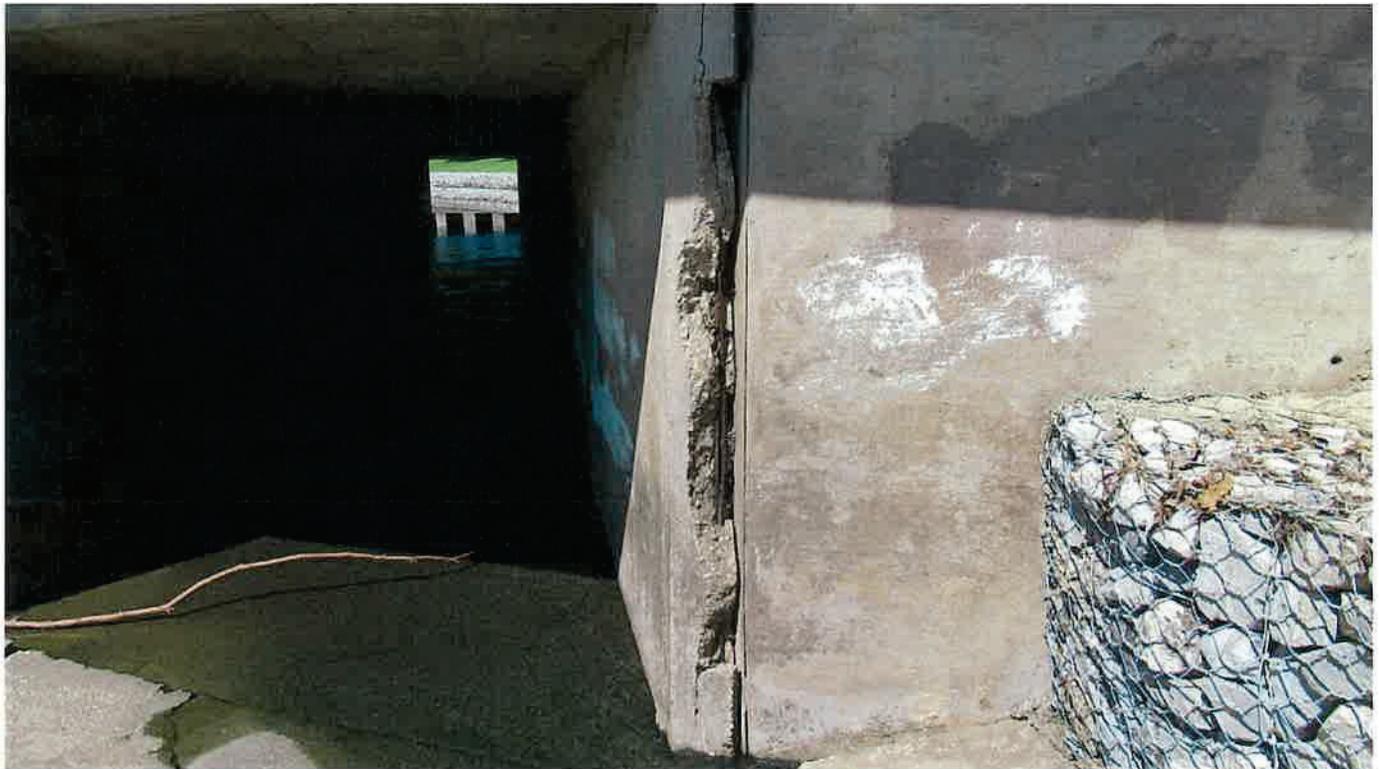
EAST END OF NORTH ABUTMENT - LOOKING NORTH

NOTE: MODERATE SPALLS WITH EXPOSED REBAR IN EAST EDGE OF NORTH ABUTMENT WALL.

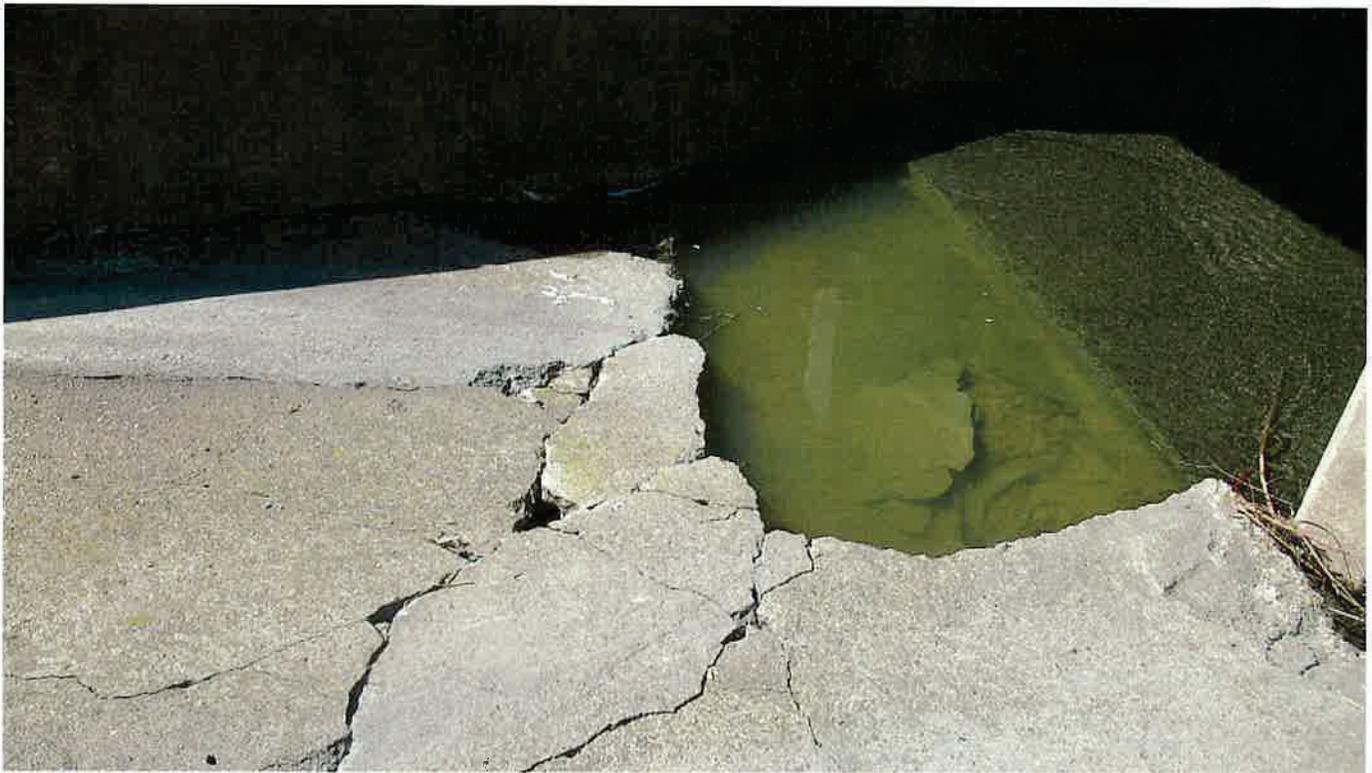
BARREL 4 FROM SOUTH - LOOKING SOUTHWEST

NOTE: CONCRETE LINING ON UPSTREAM SIDE HAS ADVANCED CRACKS AND IS BROKEN 10' X 5' X 1' DEEP WITH EXPOSED REBAR.

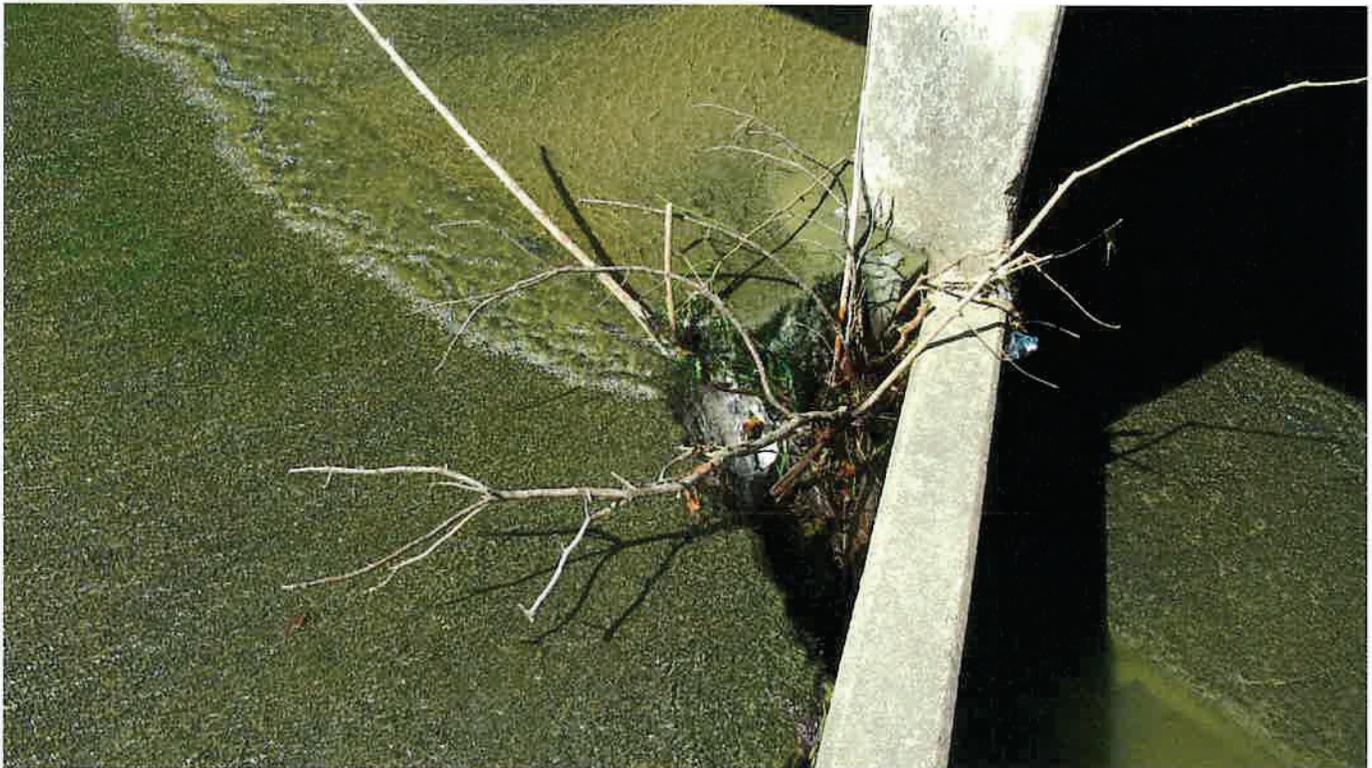
UPSTREAM APRON - LOOKING WEST

NOTE: PIPING HOLE IS 4' DEEP, 4' LONG, 3' WIDE AT UPSTREAM END OF BARREL 3.

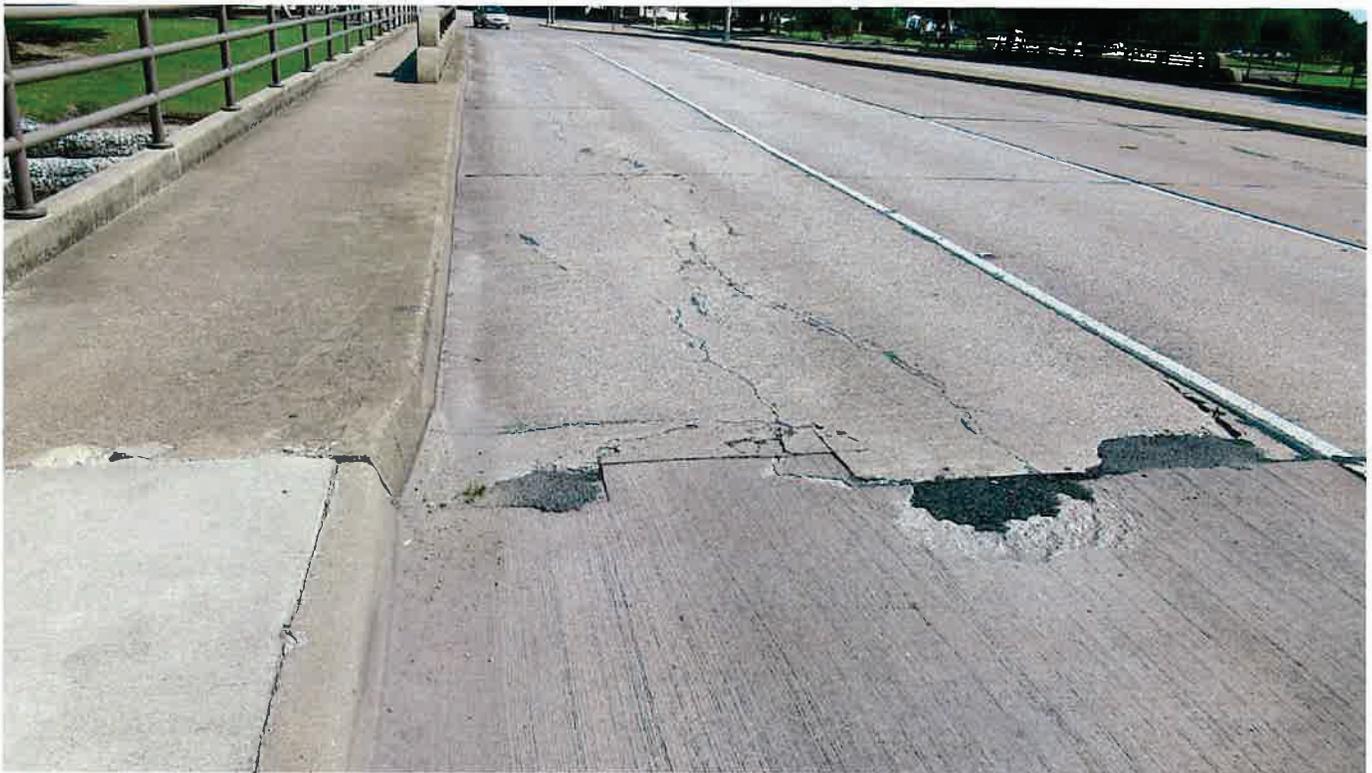
SOUTH APPROACH - LOOKING NORTH

NOTE: Moderate Cracks And Spalls In South Approach Pavement.

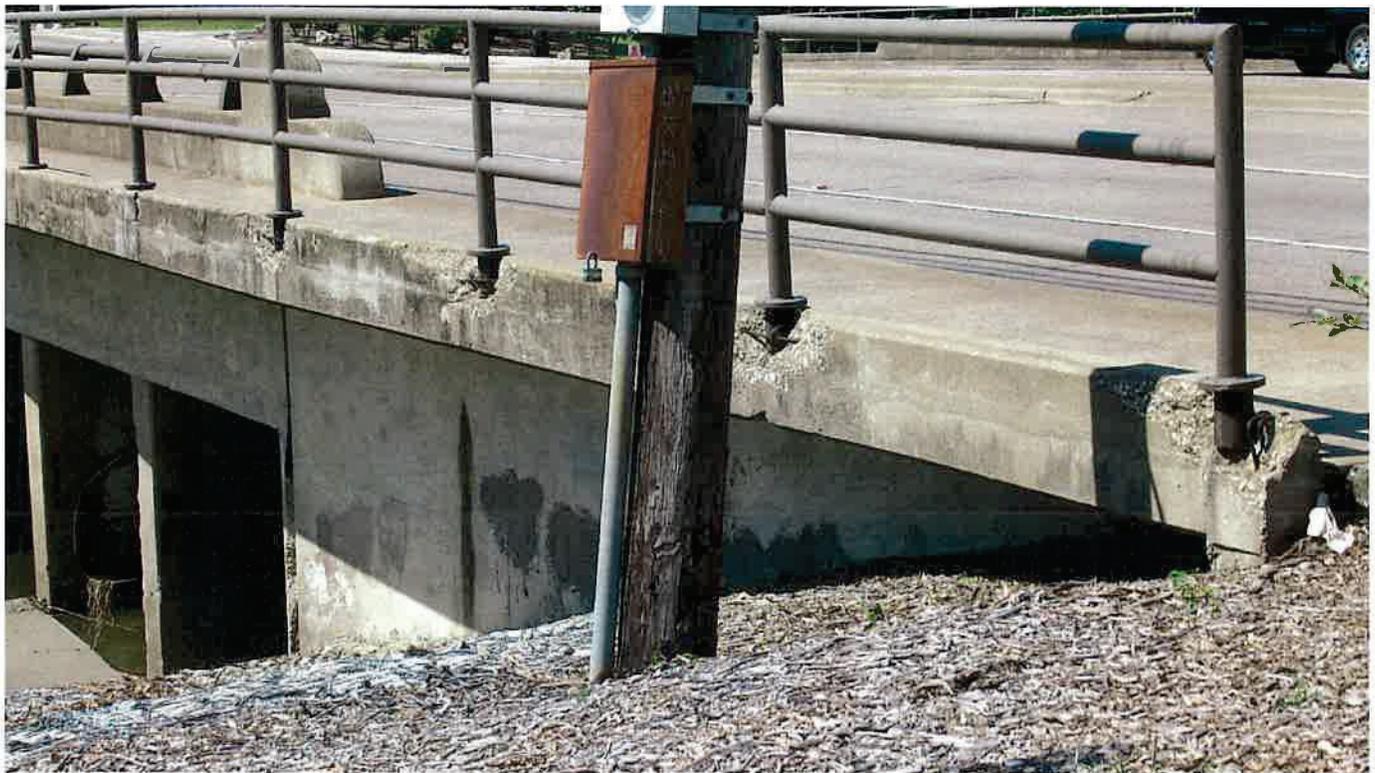
NORTHEAST RAIL POSTS - LOOKING WEST

NOTE: MINOR TO MODERATE SPALLS AT BASE OF RAIL POST AT NORTHEAST CORNER.

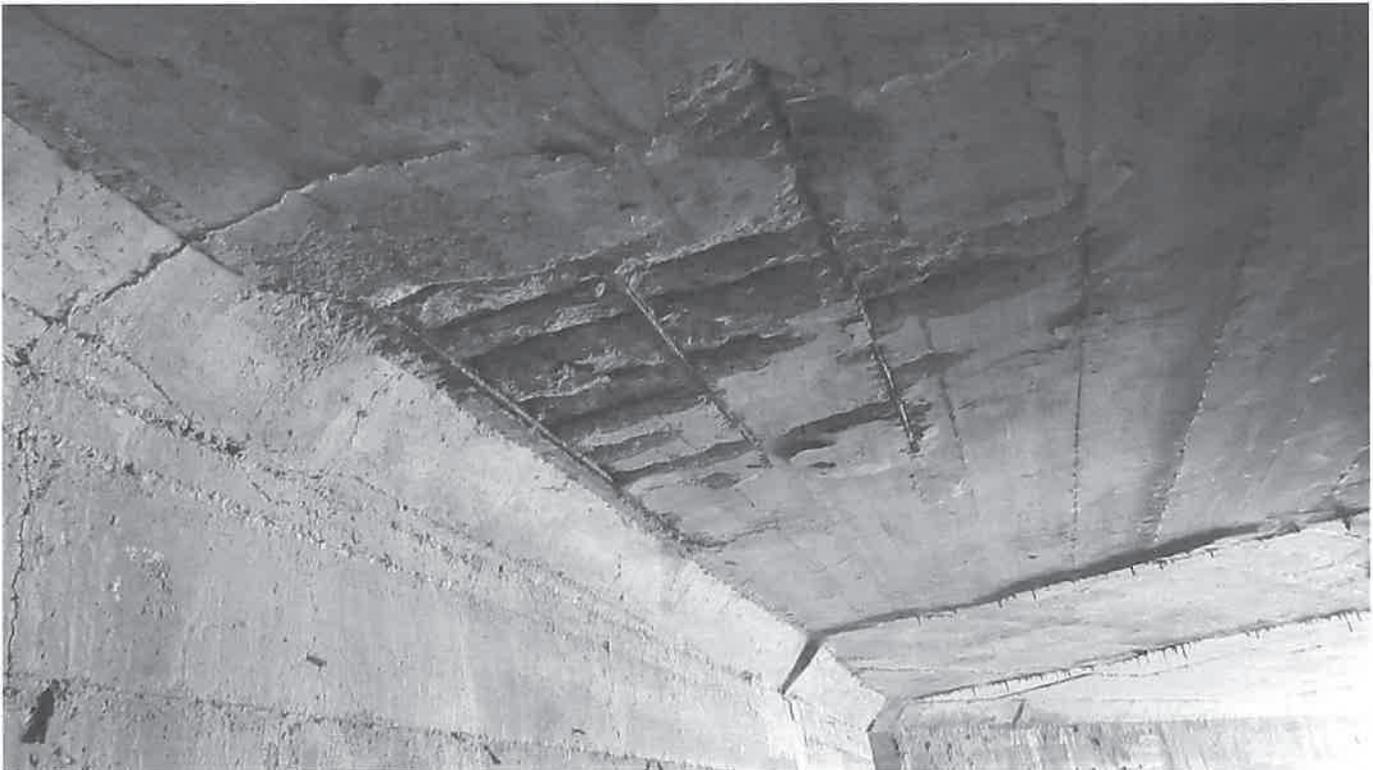
BARREL 2 FROM EAST - LOOKING SOUTHEAST

NOTE: SOFFIT OF BARREL 2 FROM EAST HAS MODERATE SPALL WITH EXPOSED REBAR.

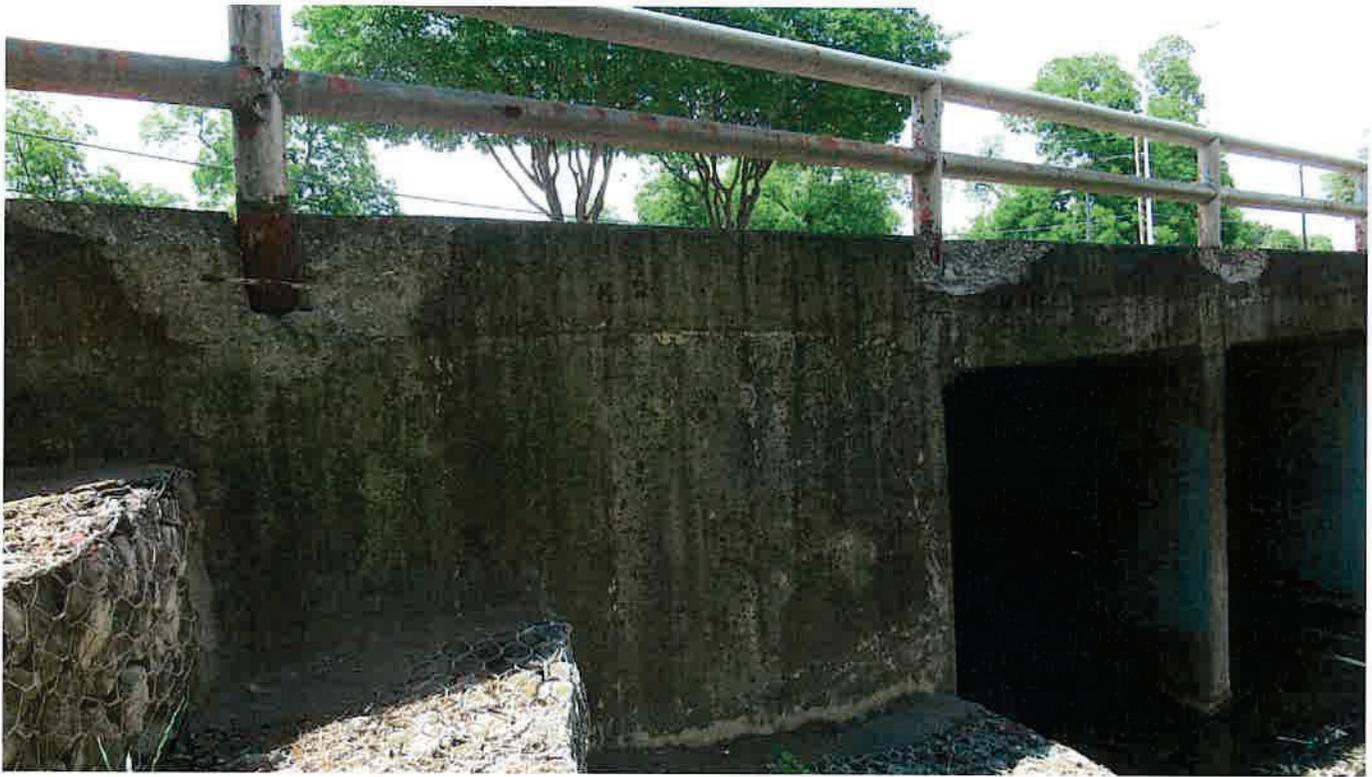
NORTH HEADWALL - LOOKING SOUTHWEST

NOTE: MODERATE SPALLS WITH EXPOSED REBAR IN HEADWALL AT RAIL POST LOCATIONS.
