Wiss, Janney, Elstner Associates, Inc.

## City of Farmers Branch City Light Poles

Structural Condition Assessment

WJE No. 2024.2623.0

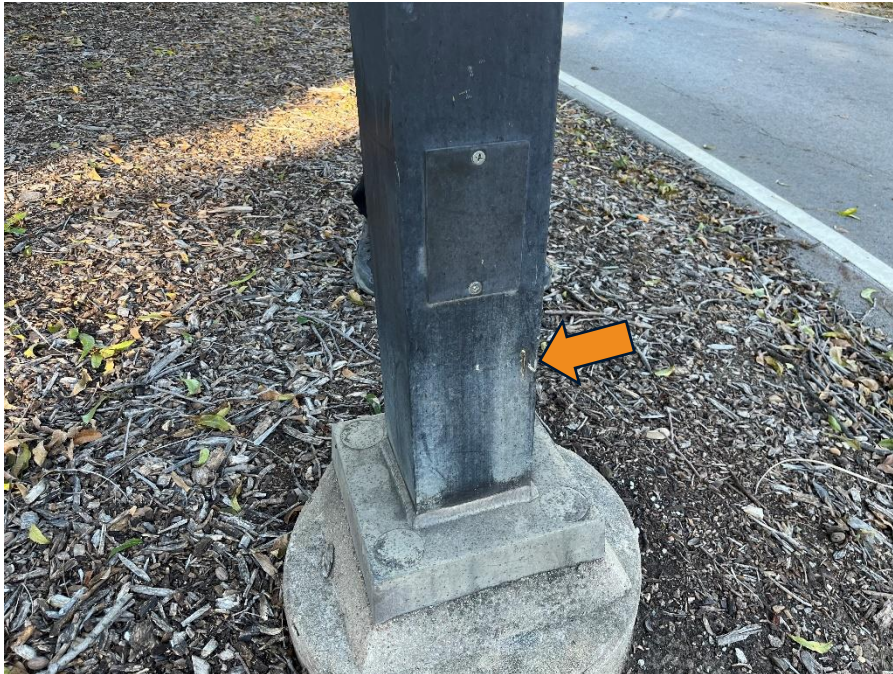
One pole at Gussie Field Watterworth Park (GP 1) was observed to have a dent. The dent observed at the pole does not represent a significant reduction in the structural capacities of this pole and does not require remedial action at this time.

Figure 2. Typical base of a 29-foot aluminum pole at Gussie Field Watterworth Park (GP 1). The orange arrow indicates dent in pole shaft.

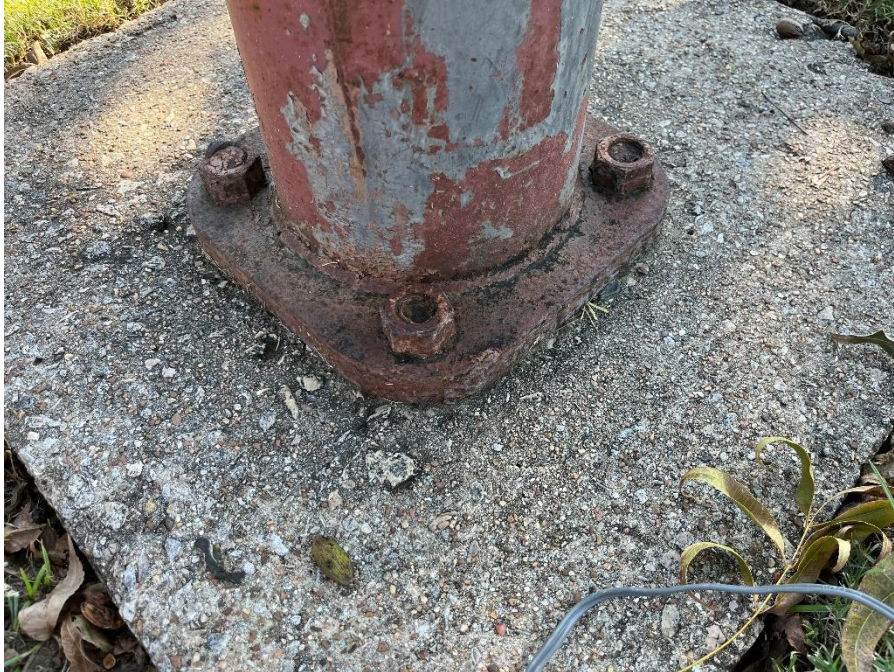
Figure 4. Thirty-one-foot light pole base of pole GP 28 at Gussie Field Watterworth Park.

1. Remove and replace pole GP 28 due to severe corrosion.
2. Remove and replace the short anchor bolts at pole GP 4 (one at a time).
3. Remove the nuts (one at a time), install flat washers, re-install and tighten the nuts at pole GP 32.

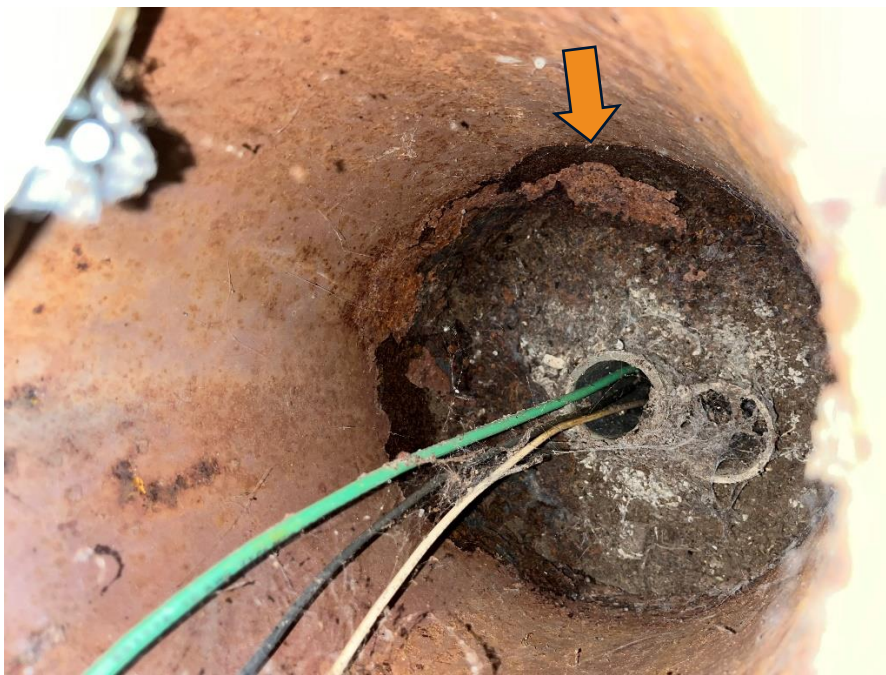
GP 28	Severe (Figure 5)	Failed	No	Moderate	Moderate	Yes
GP 29	None	Sound	No	None	-	-
GP 30	None	Sound	No	None	-	-
GP 31	None	Sound	No	None	-	-
GP 32	None	Failed	No	None	None	No, 4 not engaged properly (Figure 7Figure 6)
GP 33	None	Failed	No	None	None	Yes

Figure 5. Interior image of pole GP 28 at Gussie Field Watterworth Park. The orange arrow indicates the corrosion and section loss this pole has experienced.

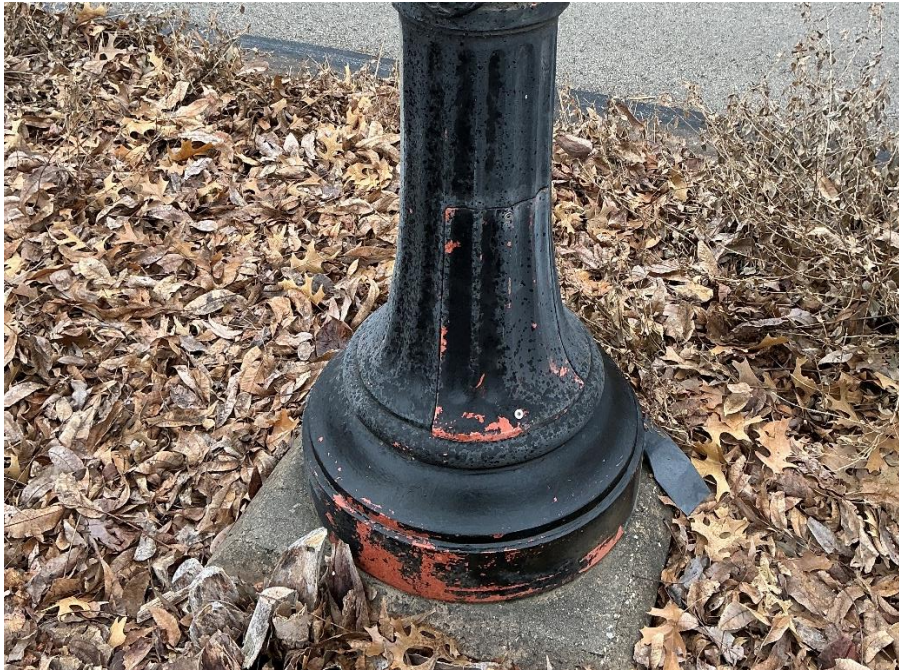
Figure 6. Typical base of a 15-foot aluminum pole at Gussie Field Watterworth Park (GP 32).

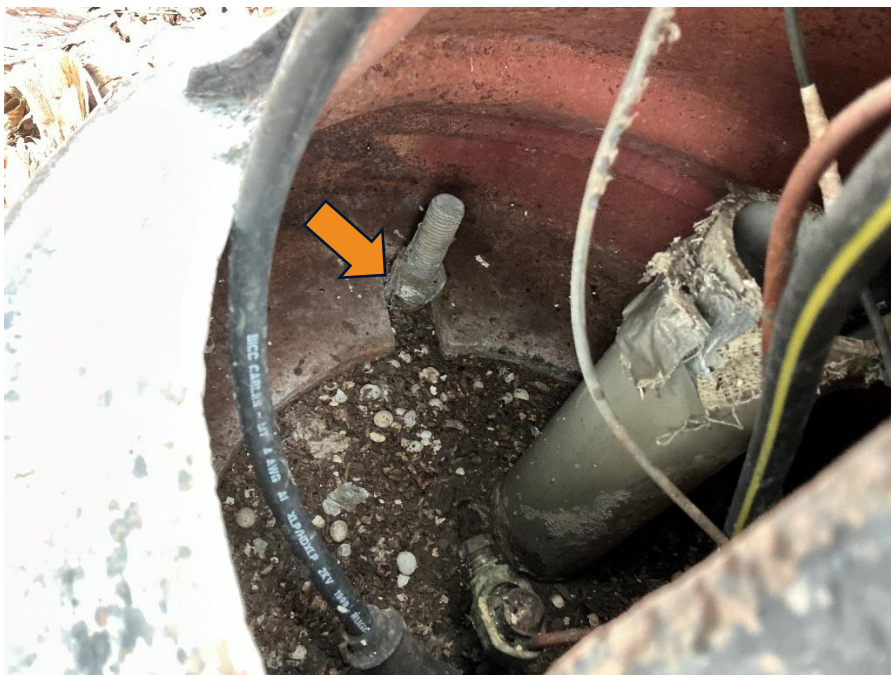
At Gussie Field Watterworth Park, two poles had anchor bolts that were not fully engaged. In addition to allowing pole rocking, bolts that are not fully engaged can contribute to pole deterioration by increasing fatigue stresses on the anchor rods and base plate. Pole GP 4 had short bolts the nuts were not fully engaged. Meanwhile, Pole GP 32 had notches in its base plate at the bolt locations, meaning that without washers, the bolts and nuts are not making proper contact with the base plate. To address these issues, the short anchor bolts on Pole GP 4 should be extended or replaced (one at a time) with properly designed adhesive anchor bolts, and washers should be added to Pole GP 32.

Figure 7. Interior image of pole GP 32 at Gussie Field Watterworth Park. The orange arrow indicates the missing washer and bolt not tight to base of pole.

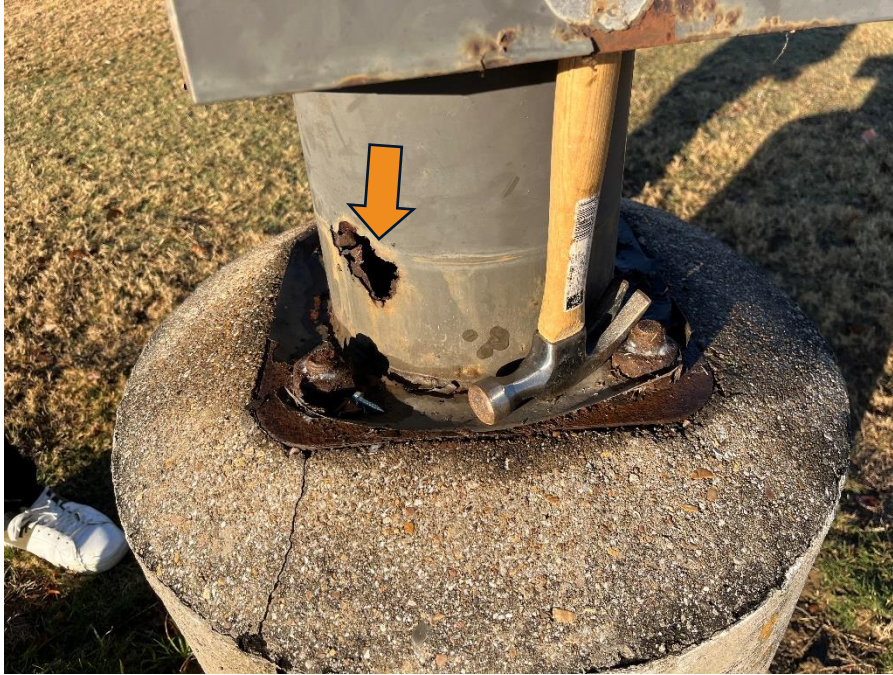
Pole ID	Pole Corrosion	Pole Paint Condition	Pole Dents	Base Plate Corrosion	Anchor Bolts Corrosion	Anchor Bolts Engaged
OP 1	Severe (through-thickness)	Minimal Defects	No	Moderate	Minor	Yes
OP 2	Severe (through-thickness)	Minimal Defects	No	Minor	Minor	Yes
OP 3	Severe (through-thickness) (Figure 9)	Minimal Defects	No	Minor	Minor	Yes

Figure 9. Through-thickness corrosion (orange arrow) at base of Pole OP 3 at Oran Good Park.

4. Remove and replace pole OP 1, OP 2, OP 3, OP 4, and OP 8 due to severe corrosion.

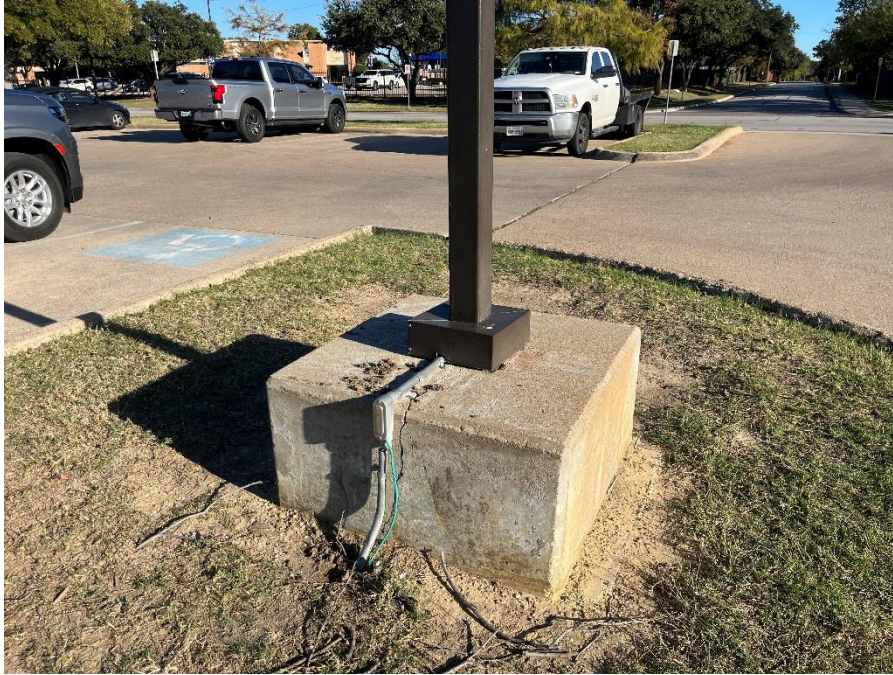
Pole ID	Pole Corrosion	Pole Paint Condition	Pole Dents	Base Plate Corrosion	Anchor Bolts Corrosion	Anchor Bolts Engaged
FB 1	Severe	Minimal Defects	No	None	Minor	Yes
FB 2	Minor	Minimal Defects	No	Minor	Minor	Yes

Figure 11. Typical 14-foot light pole base at Farmers Branch Park (FB 1).

5. Remove and replace pole FB 1 due to severe corrosion.

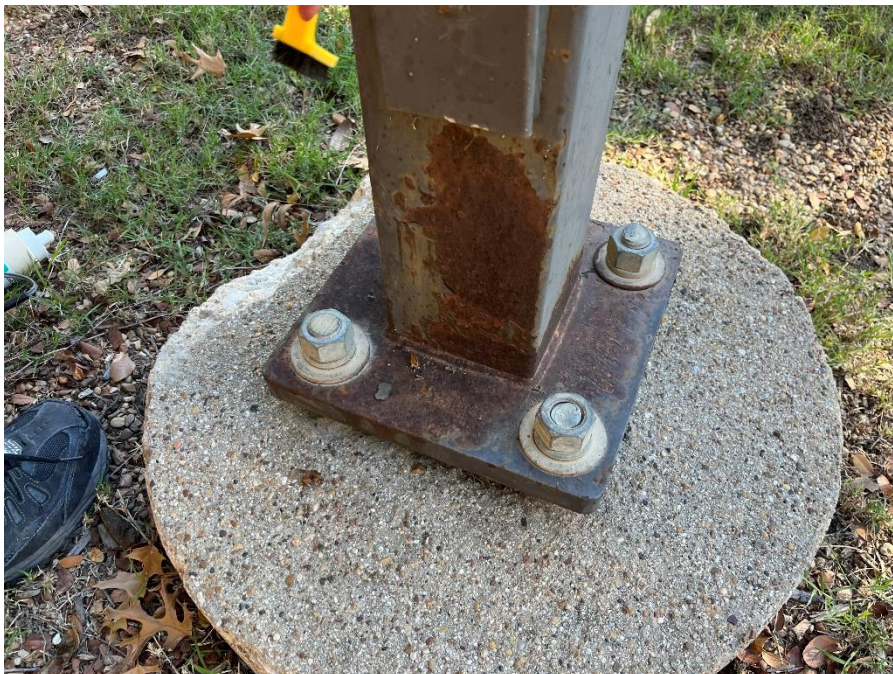
Pole ID	Pole Corrosion	Pole Paint Condition	Pole Dents	Base Plate Corrosion	Anchor Bolts Corrosion	Anchor Bolts Engaged
SP 1	Minor	Minimal Defects	No	Minor	Minor	Yes
SP 6	Severe	Failed (Figure 14)	No	Minor	None	Yes
SP 7	Minor	Minimal Defects	No	None	Minor	Yes
SP 8	Minor	Minimal Defects	No	Minor	Minor	Yes

Figure 14. Severe Corrosion at the base of pole SP 6 at Squire Park.

6. Remove and replace pole SP 6 due to severe corrosion.
