ILIFF &amp; ASSOCIATES INC. "A Roof Asset Management Corporation"

### VISUAL ONLY - ROOF INSPECTION CITY OF FARMERS BRANCH

**DATE OF SURVEY:** April 9, 2026  
**BUILDING NAME:** Fire Station #3/Bob Phelps Fire Administration Building  
**ADDRESS:** 13333 Hutton Dr.  
 Farmers Branch, TX  
**INSPECTOR:** William Allen  
**ROOF CONSTRUCTION:** White mineral surfaced modified bitumen (mop applied)  
 Ridgid insulation over metal deck  
 Architectural standing seam metal panels  
 Ridgid insulation over metal deck  
**ROOF AREA:** Metal section: 16,087 sq. ft. BUR section: 4,903 sq. ft.  
**BLDG. HT:** Varies: 24' - 38'  
**ACCESS METHOD:** Roof hatch - northwest section

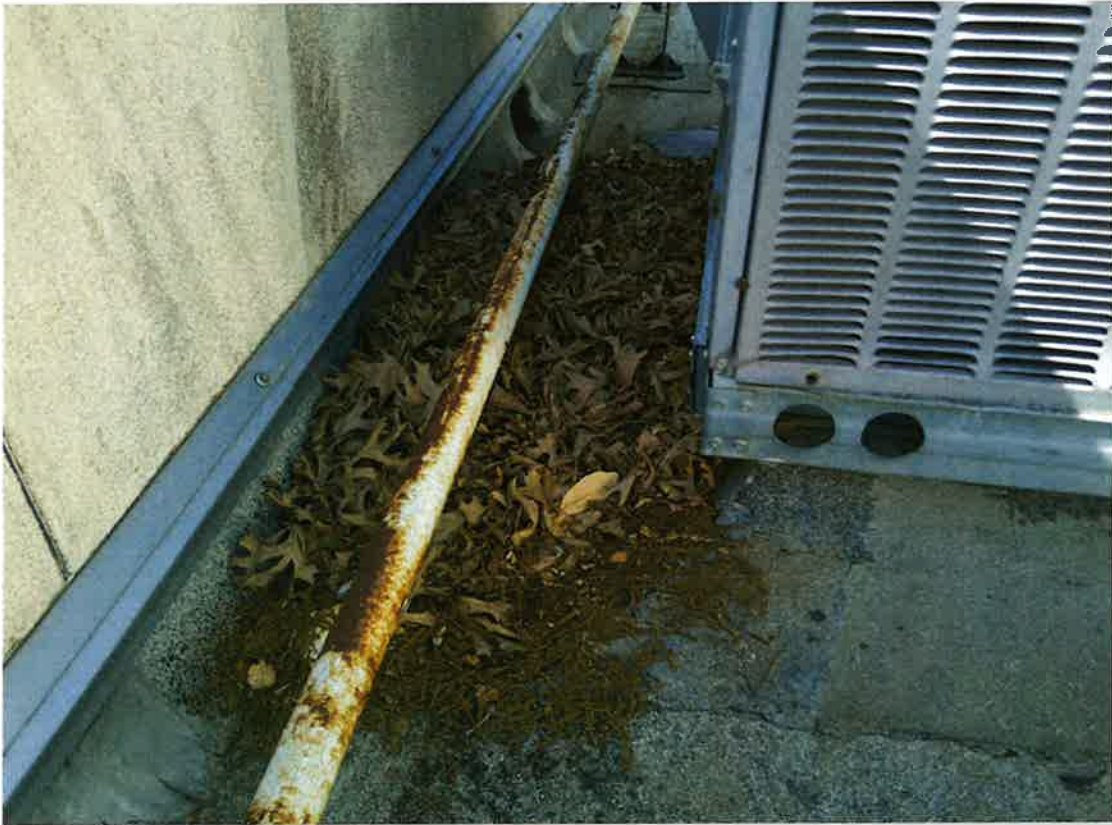
Seasonal leaf debris.

Recommend removal of seasonal leaf debris from roof, **ALL conductor heads** and gutters.

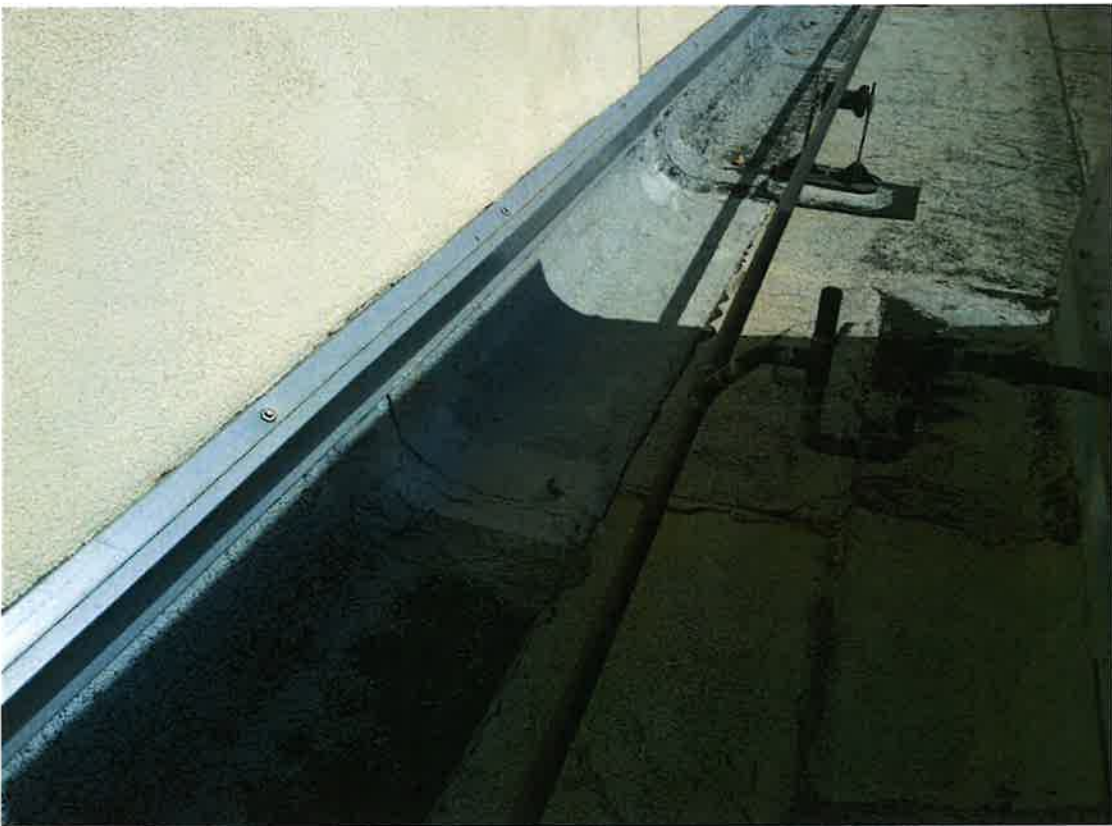
Previous wall flashing repair.

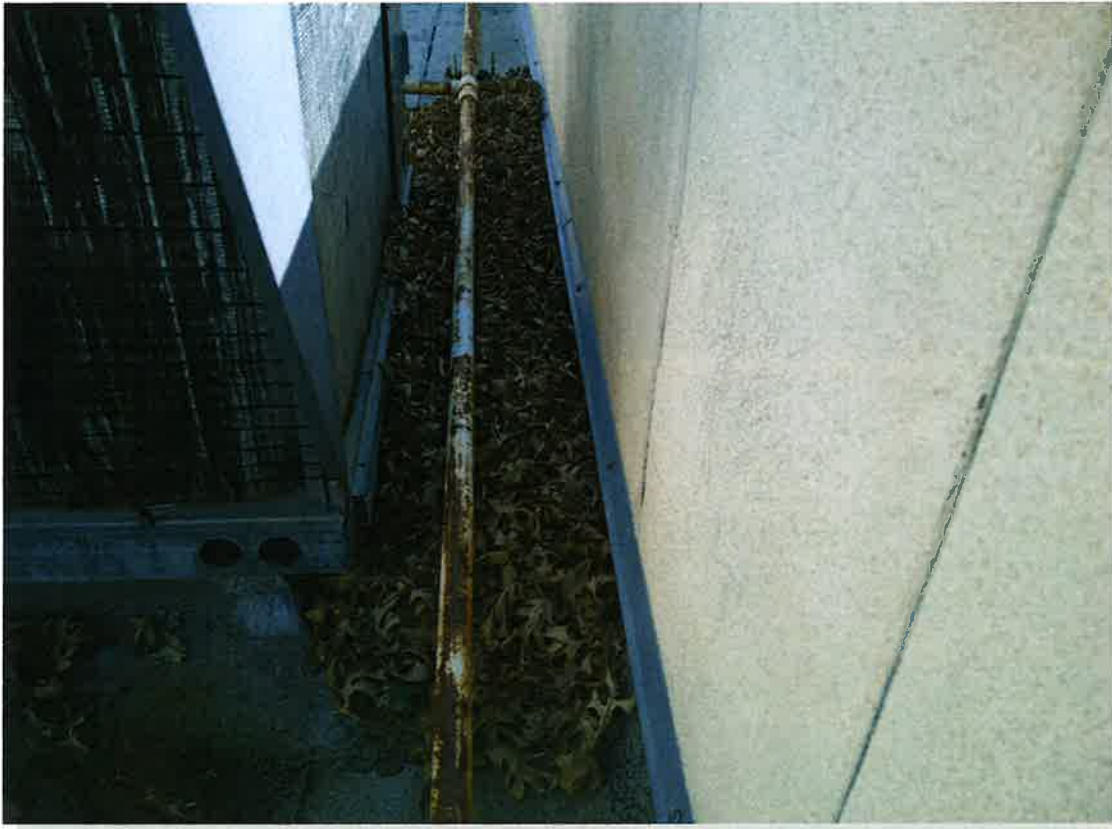
Seasonal leaf debris.

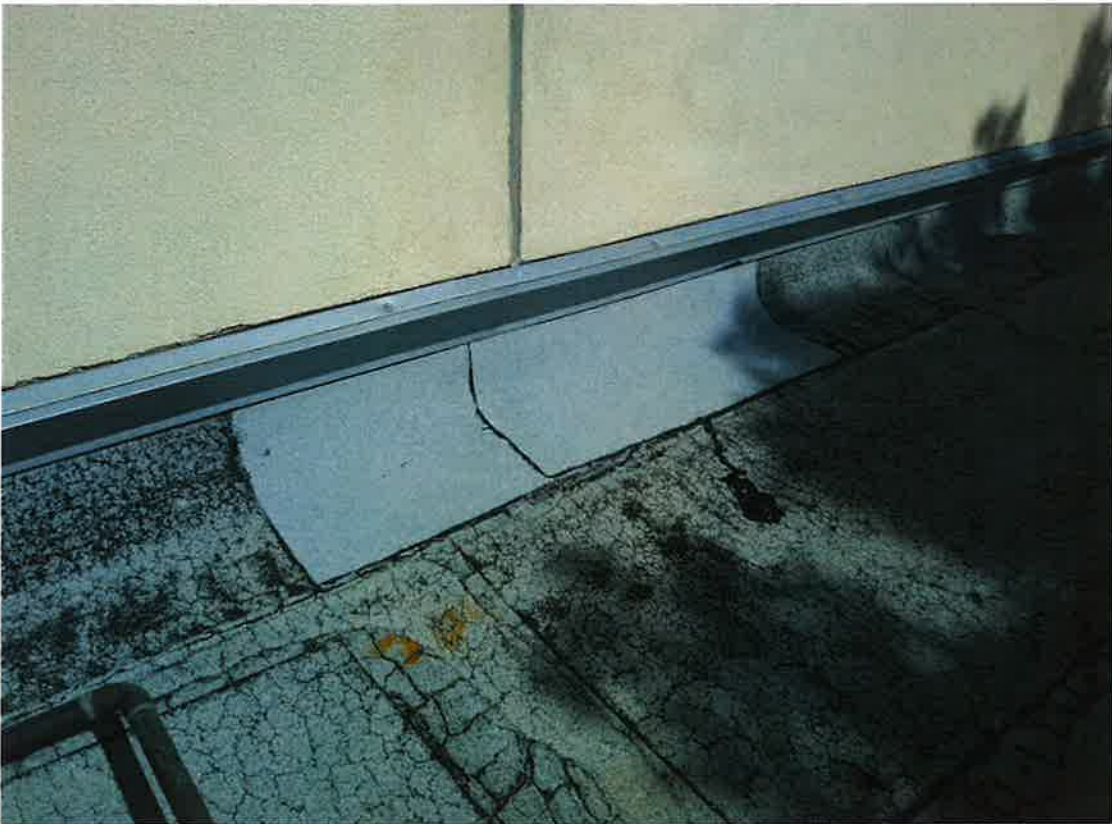
Previous wall flashing repair.

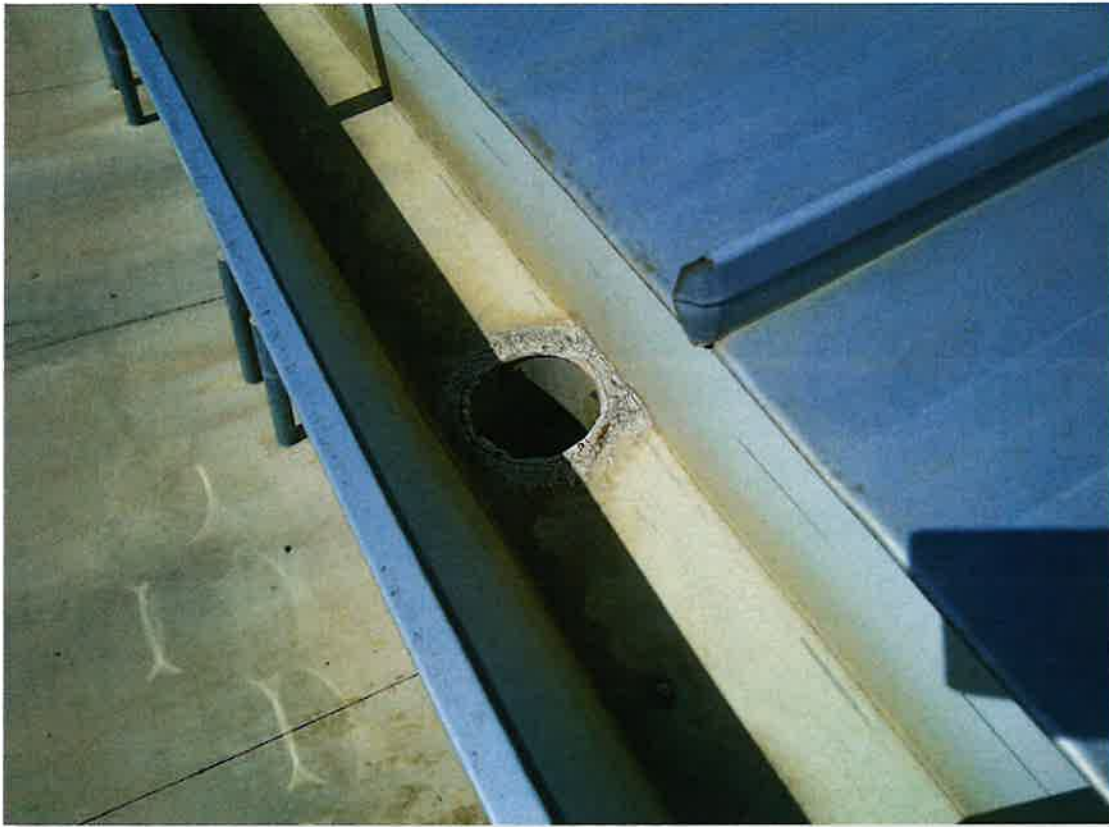
Sealant failure at downspout connection.

1. Remove all debris from all gutters.
2. Properly remove and replace the sealant at all gutter joints and downspout connections.

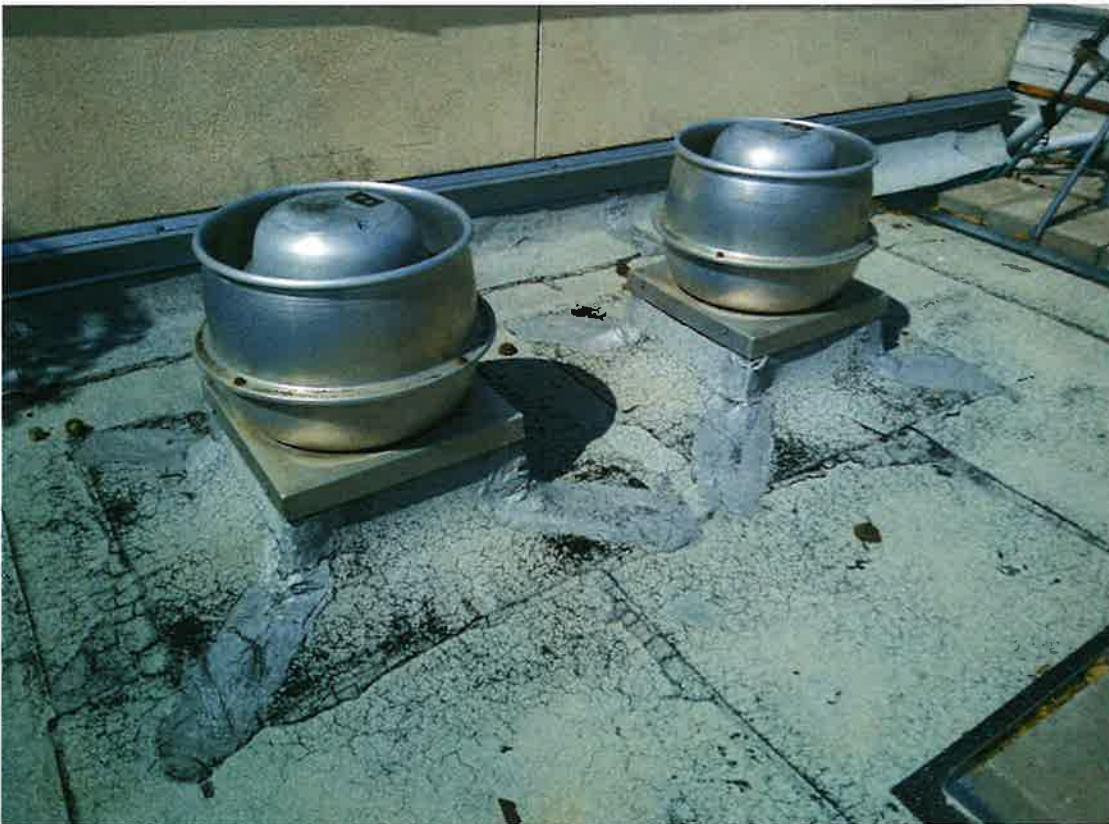
☐ POOR HOOD ATTACHMENT ☐ DAMAGED HOUSING ☒ SATISFACTORY  
BASE FLASHINGS: ☐ HEAVILY WORN ☒ MODERATE TO HEAVILY WORN ☐ FAILED

Overview of exhaust base flashings.

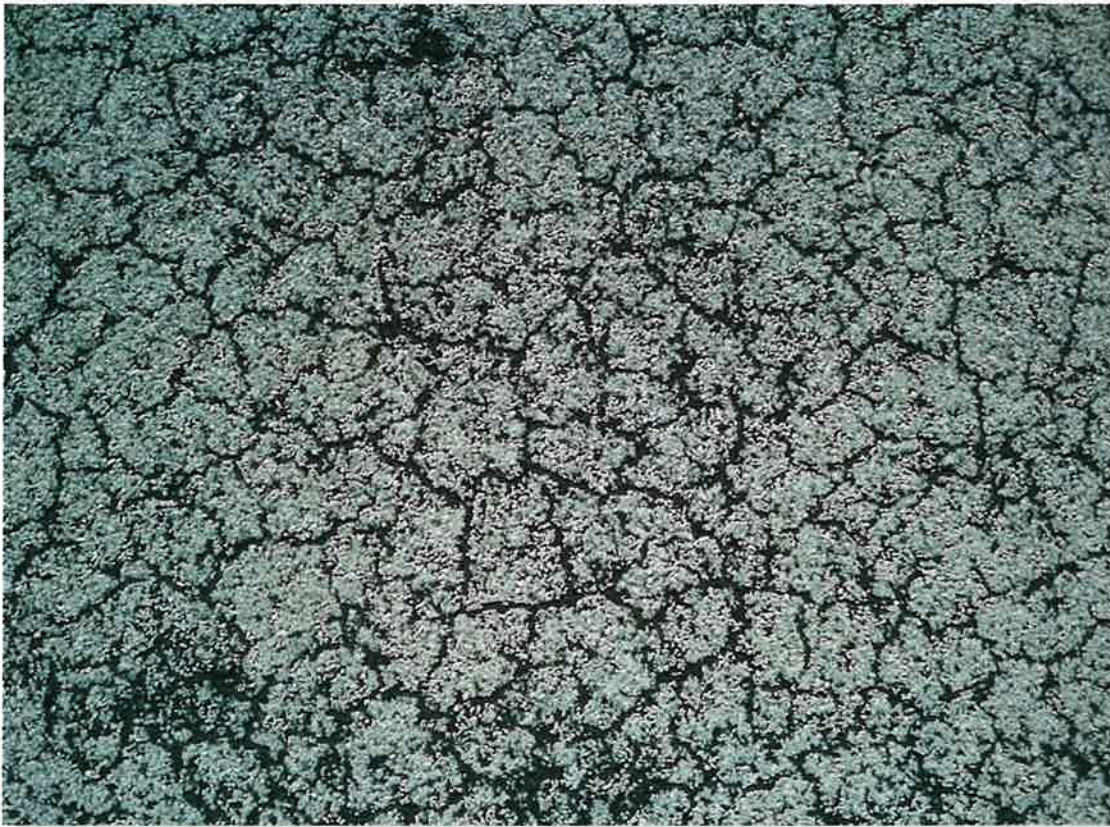
- ☐ SATISFACTORY ☐ FAIR ☒ BORDERLINE ☐ POOR  
☐ ADVANCED AGING/DETERIORATION IN PONDING AREAS  
☒ AREAS OF SURFACE LOSS - Minor  
☐ AREAS OF SURFACE LOSS WITH EXPOSED/DETERIORATED FELTS  
☐ MEMBRANE "SCRUBBING" AT PIPE SUPPORT BLOCKING  
☒ MEMBRANE "CHECKING"  
☐ IMPROPER REPAIRS  
☐ PUNCTURES/DAMAGE  
☐ IMPROPERLY INSTALLED EQUIPMENT: \_\_\_\_\_
-

Membrane "checking".

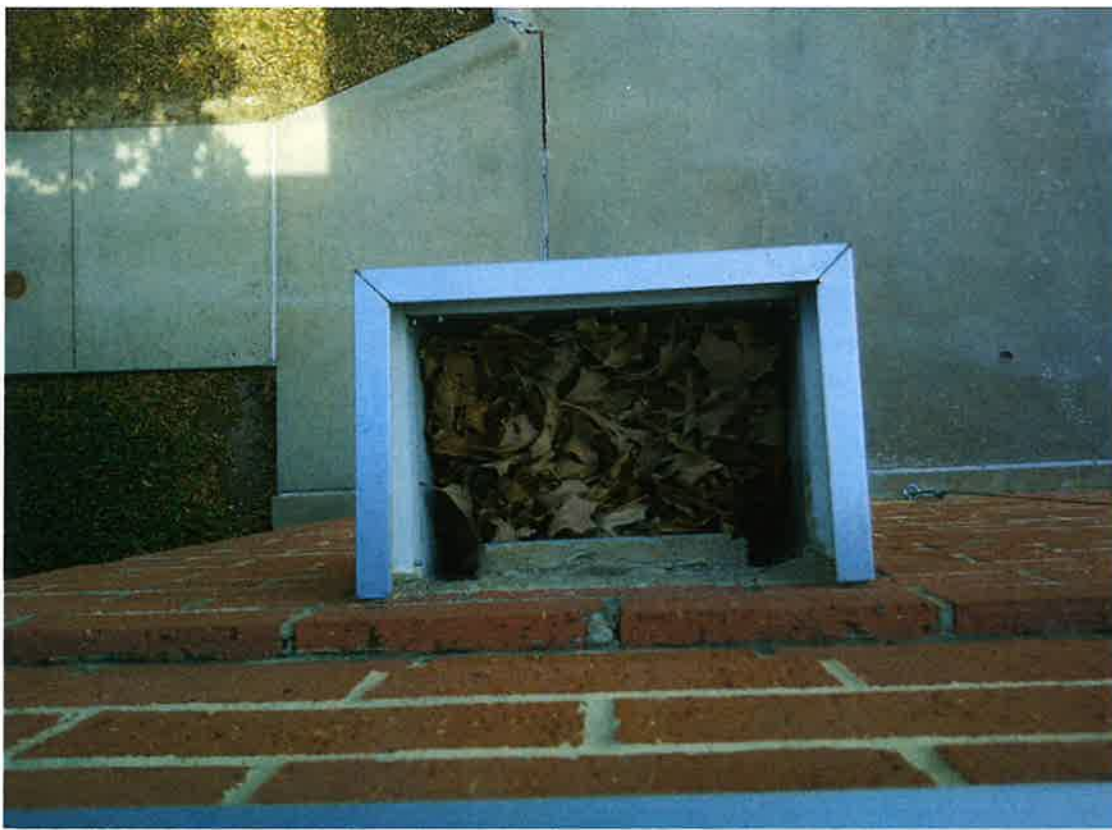
Leaf debris in conductor head.

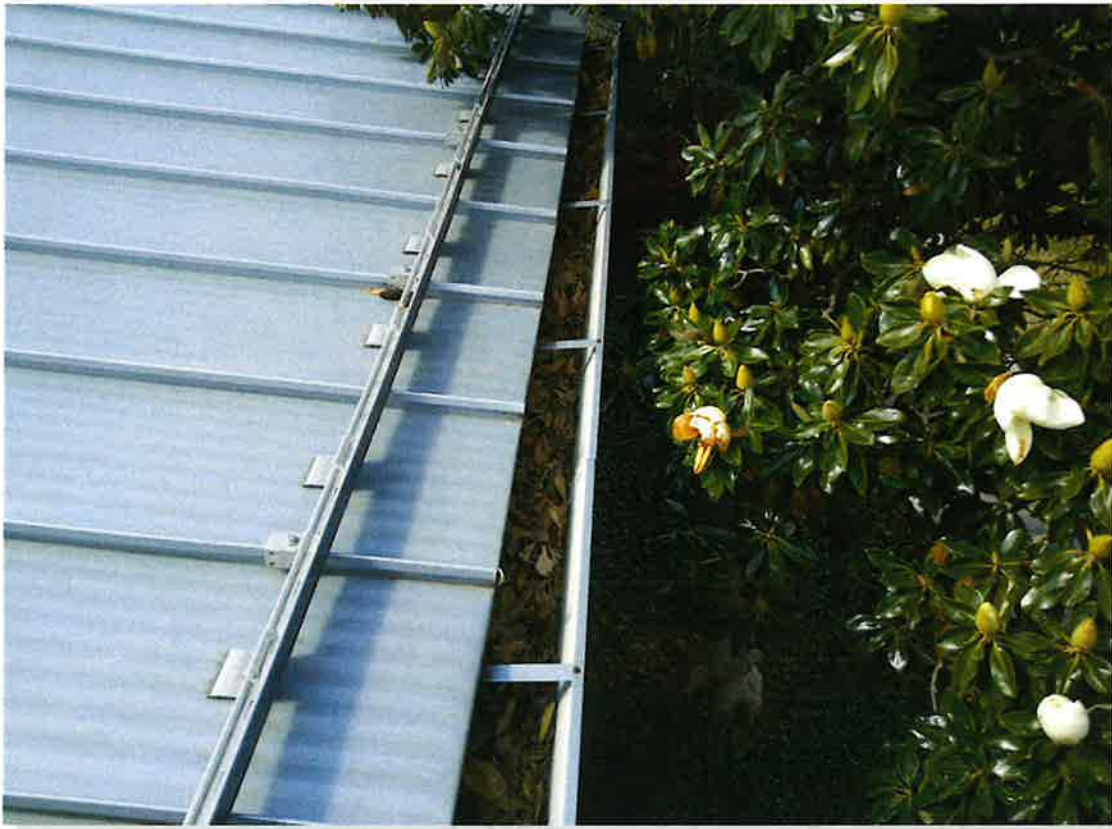
Leaf debris and gutter.

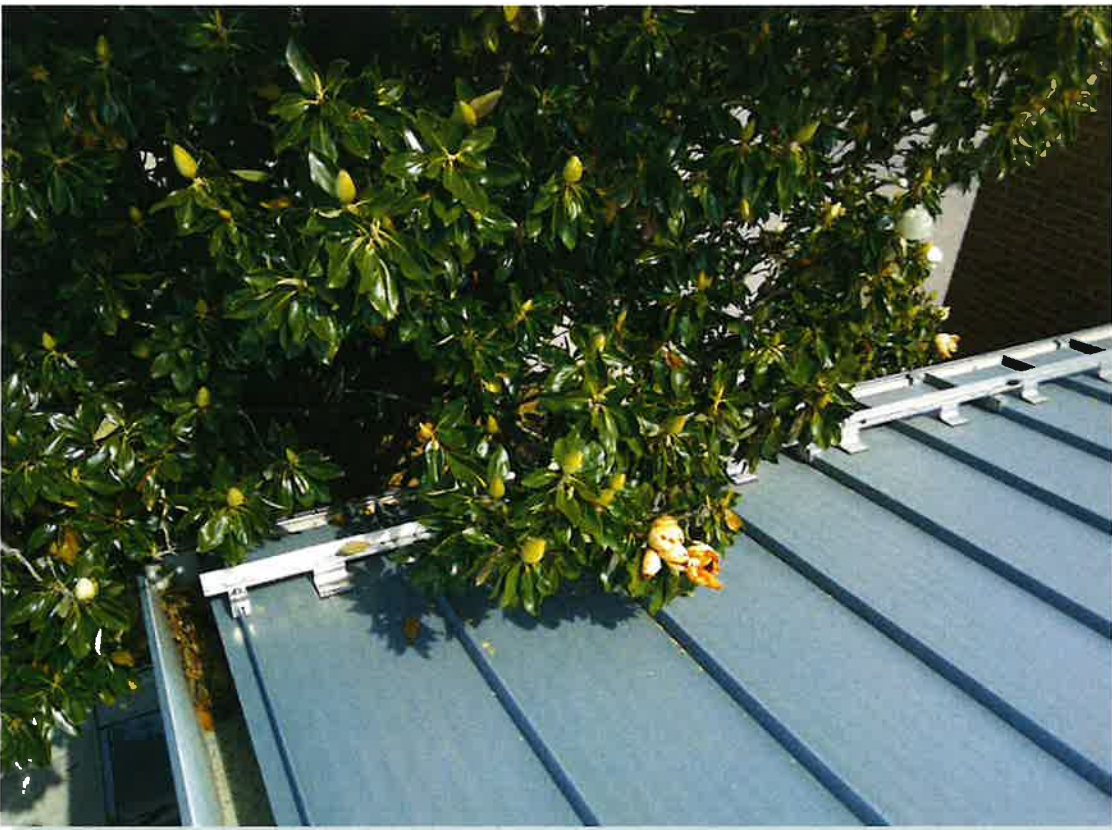
OTHER: Overhanging tree limbs.

Overhanging tree limbs.

Recommend landscaping contractor trim back over hanging tree limbs that are scrubbing the roof surface.
