ILIFF & ASSOCIATES INC. "A Roof Asset Management Corporation"

**VISUAL ONLY - ROOF INSPECTION
SINGLE-PLY
CITY OF FARMERS BRANCH**

DATE OF SURVEY: March 20, 2024
BUILDING NAME: Service Center
ADDRESS: 13333 Senlac Drive
Farmers Branch, TX
INSPECTOR: Mike Zwick
ROOF CONSTRUCTION: Fully adhered EPDM membrane
Ridgid insulation over lightweight concrete deck
Fully adhered TPO
Ridgid insulation over lightweight concrete deck
ROOF AREA: Approximately 7,708 sq. ft. - East EPDM sections
Approximately 4,321 sq. ft. - West TPO sections
BLDG. HT: Varies 15' to 20'
ACCESS METHOD: None

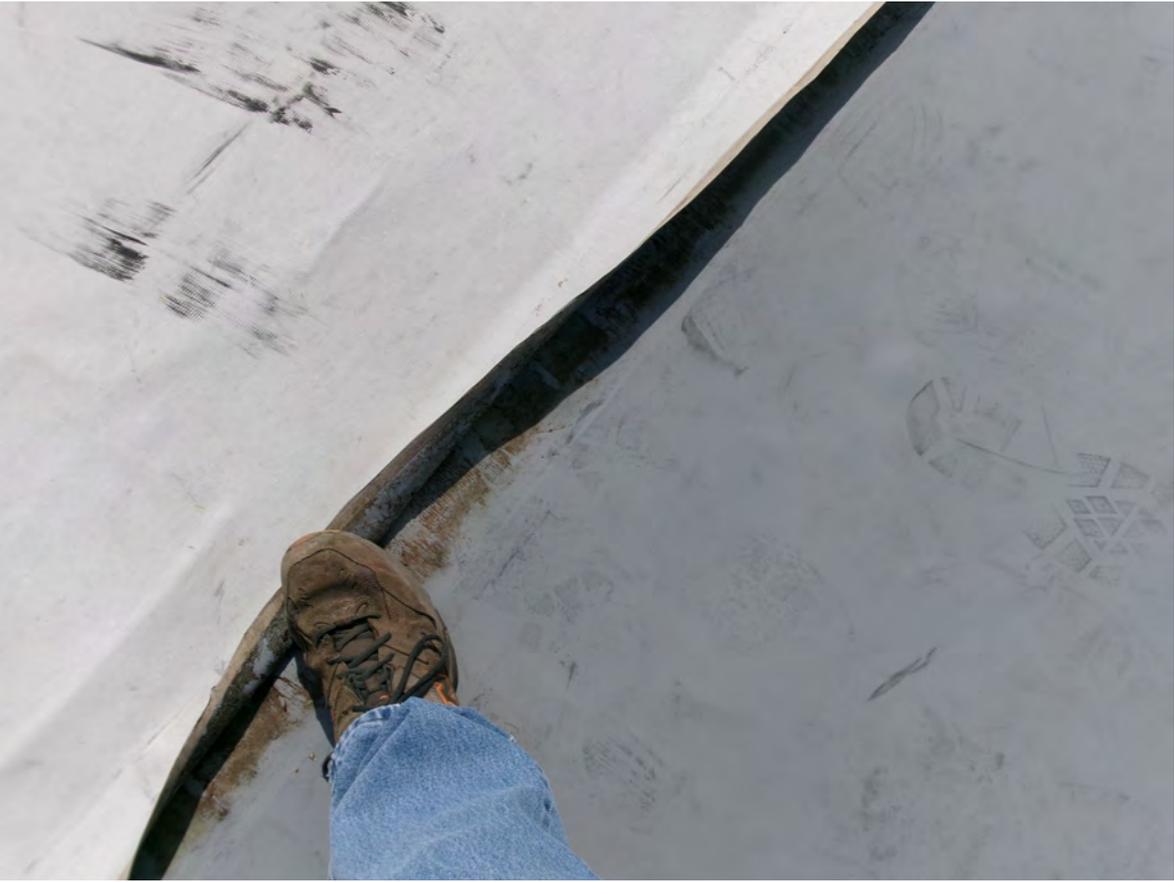
- SATISFACTORY BORDERLINE - TPO BORDERLINE POOR - EPDM
 - ADVANCED AGING/DETERIORATION IN PONDING AREAS - TPO
 - DELAMINATING SEAMS - EPDM recover areas.
 - PREVIOUS REPAIRS - TPO
 - DISPLACED GRAVEL AT AREAS OF LEAK INVESTIGATION
 - MEMBRANE "SCRUBBING" AT PIPE SUPPORT BLOCKING
 - IMPROPER REPAIRS
 - SPLIT/TORN
 - IMPROPERLY INSTALLED EQUIPMENT: _____
-

Delaminating seams at EPDM recover.

1. Properly repair the delaminating seams at the EPDM recover areas.

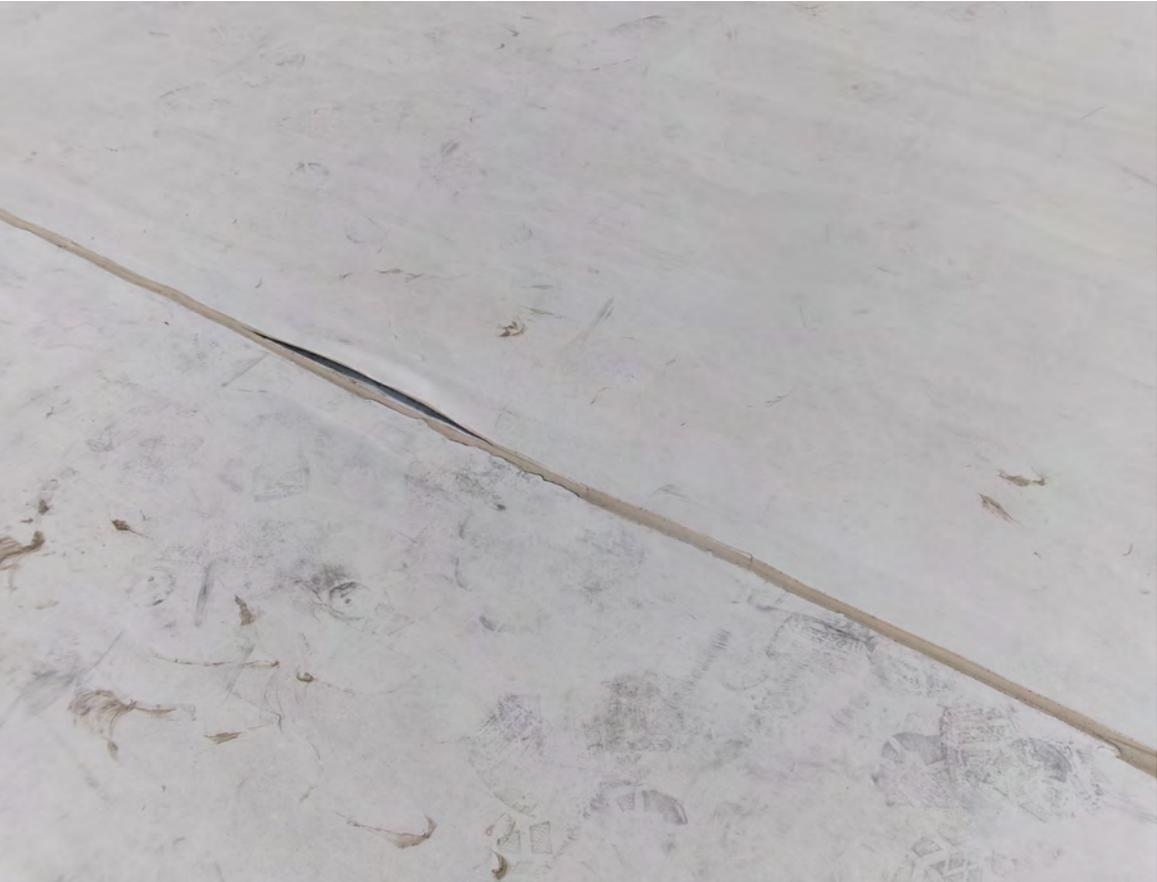
Delaminated seams at EPDM recover.

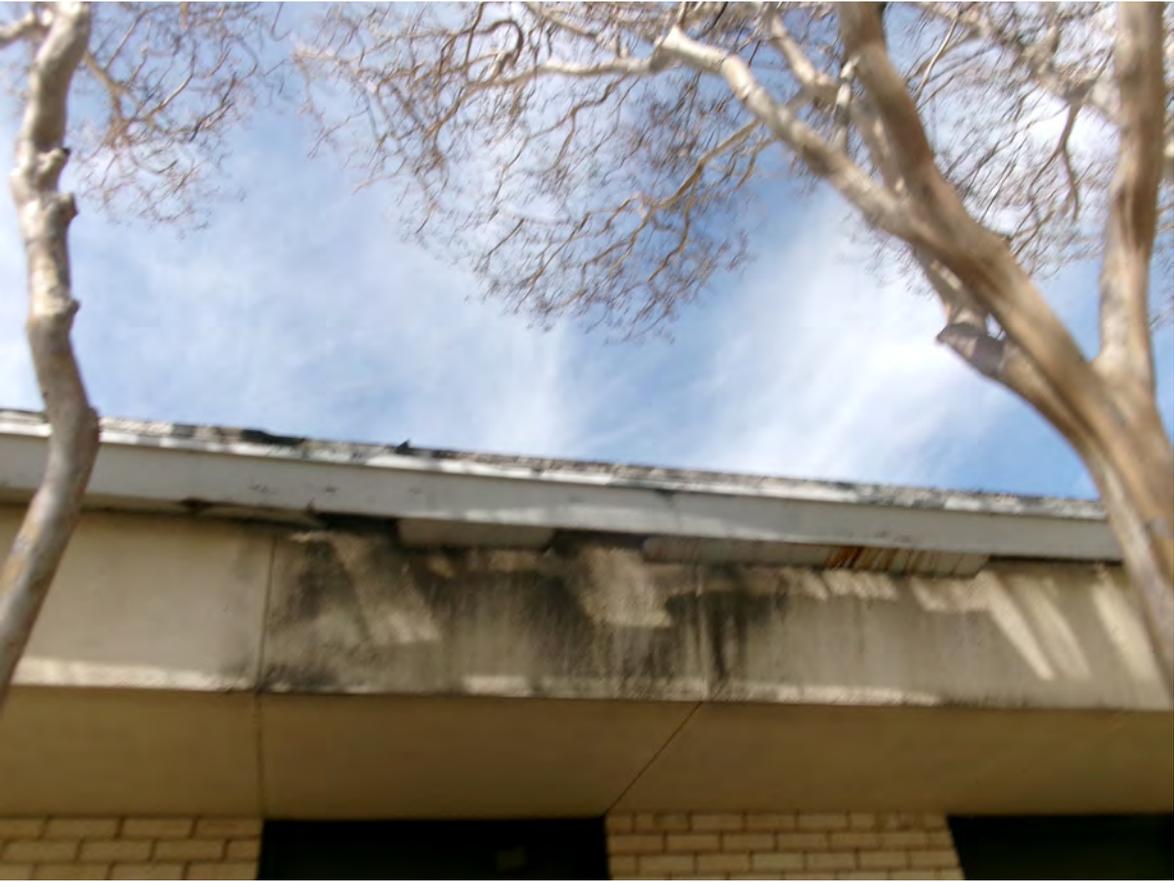
Rusted through gutter.

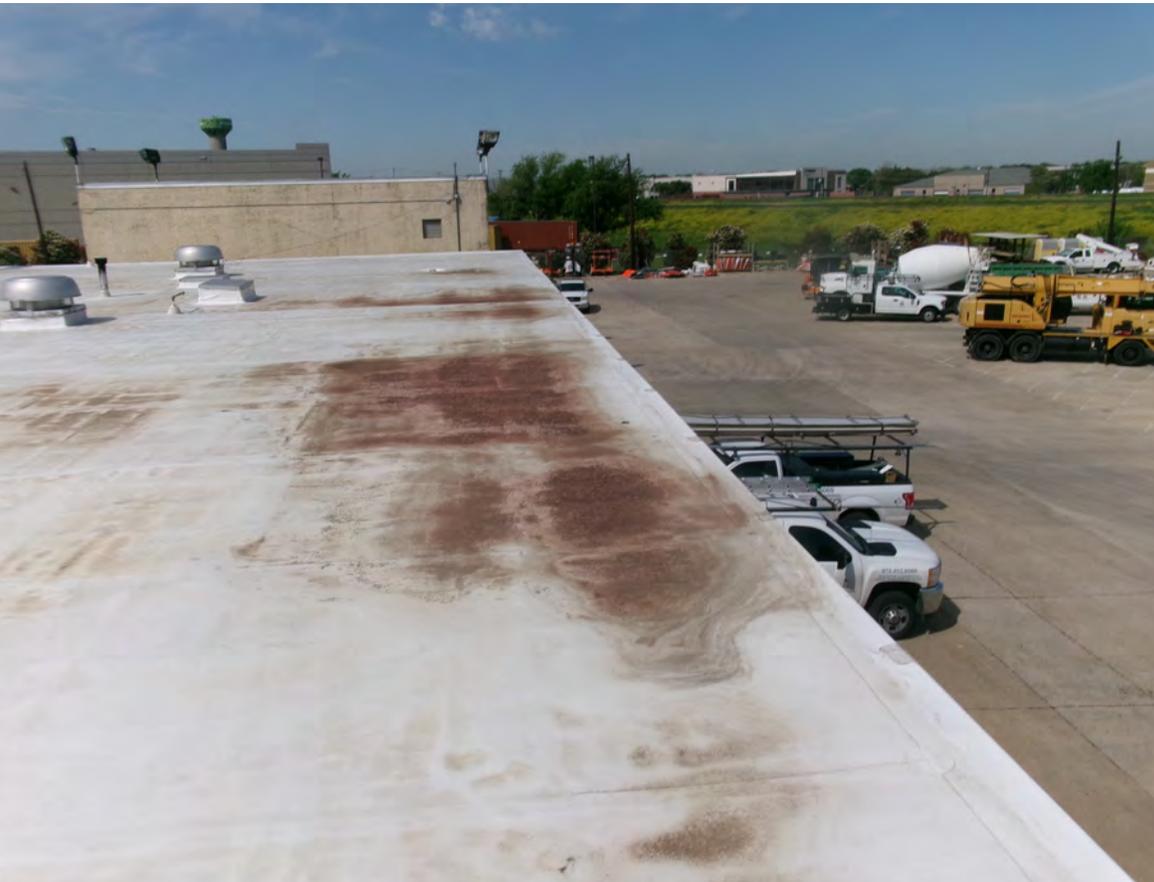
Advanced aging / deterioration in ponding water areas.

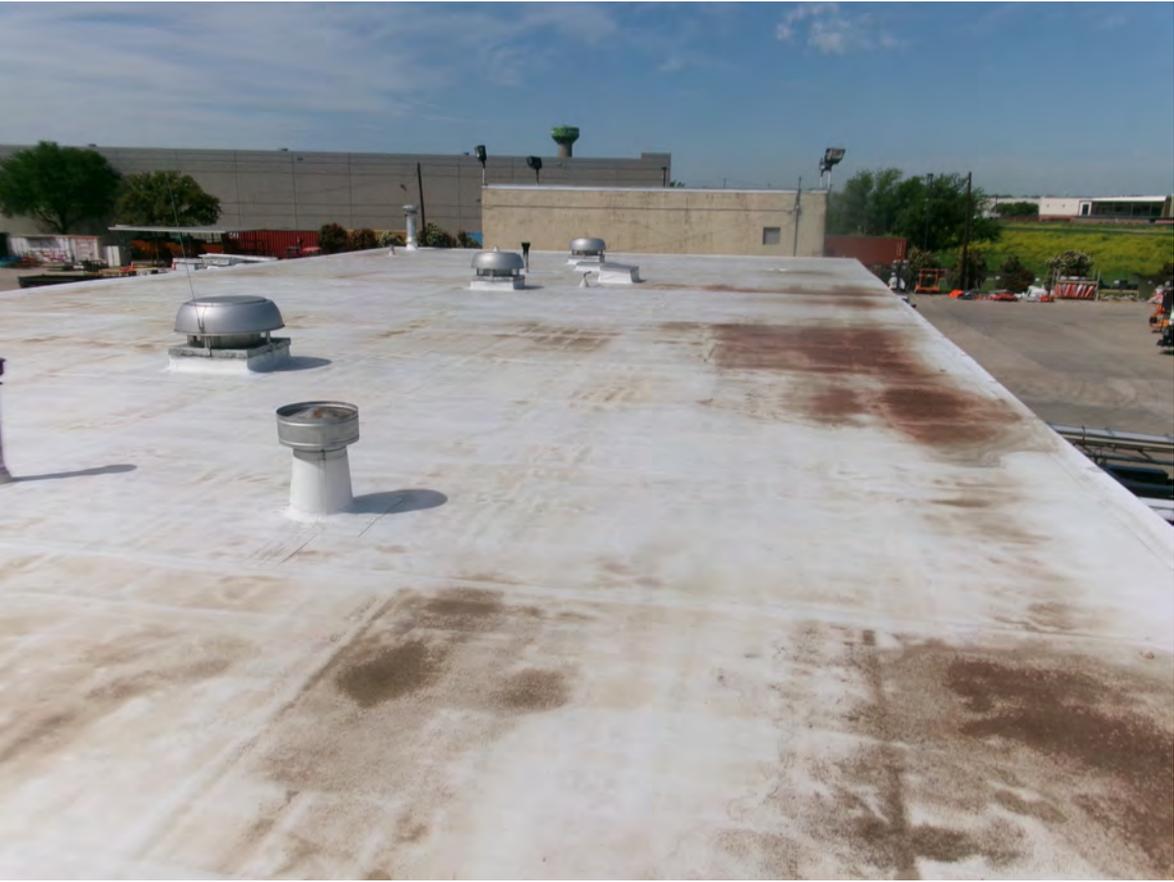
PONDING LOCATION: Throughout field of roof - TPO.

Ponding water through-out TPO roof section.
