Reference: **Asbestos Survey of Target Areas at the Site Related to Proposed Renovation Activities**
Equipment Services
13333 Senlac Dr. Farmers Branch, TX 75234
Ridgeline Project No. 240520.64

REPORT OF ASBESTOS INVESTIGATION

EQUIPMENT SERVICES

13333 SENLAC DR.

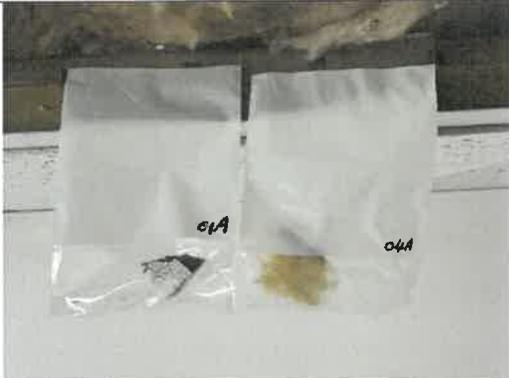
<p>PHOTOGRAPH 1:</p> <p>SAMPLE NUMBERS – 01A,04A</p> <p>MATERIAL: 2’x4’ Ceiling Tiles, Insulation (Yellow)</p> <p>ASBESTOS CONTENT:</p> <p>(NAD) No Asbestos Detected</p>

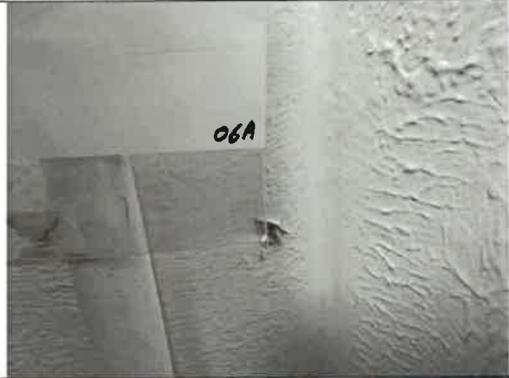
<p>PHOTOGRAPH 2:</p> <p>SAMPLE NUMBERS – 06A</p> <p>MATERIAL: Textured Wallboard & Joint Compound</p> <p>ASBESTOS CONTENT:</p> <p>(NAD) No Asbestos Detected</p>

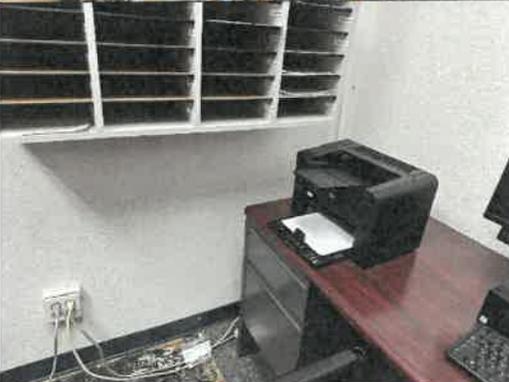
<p>PHOTOGRAPH 4:</p> <p>HOMOGENOUS AREA – 01,04,06,07,09</p> <p>MATERIAL: 2’x4’ Ceiling Tiles, Insulation (Yellow), Textured Wallboard & Joint Compound, Cove Base (Black), 12”x12” VCT White/ Black Mastic</p> <p>Asbestos Contant: 2% Chrysotile Asbestos Detected</p>

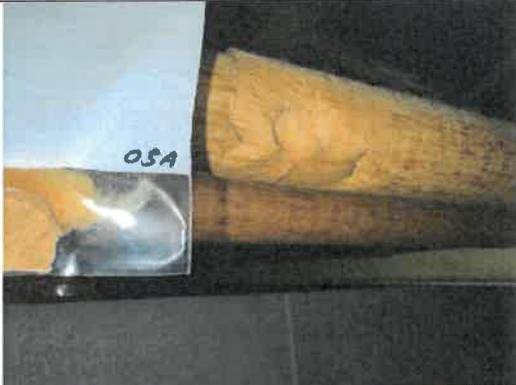
<p>PHOTOGRAPH 5:</p> <p>SAMPLE NUMBERS – 05A</p> <p>MATERIAL: Pipe Insulation</p> <p>ASBESTOS CONTENT:</p> <p>(NAD) No Asbestos Detected</p>

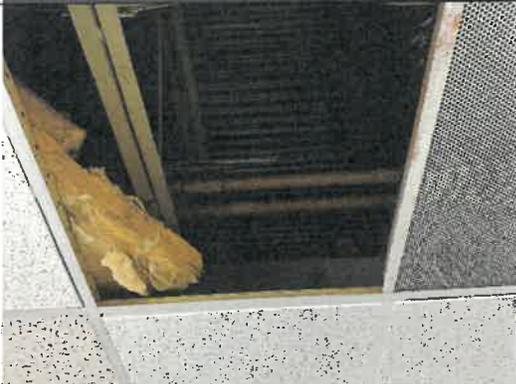
<p>PHOTOGRAPH 6:</p> <p>HOMOGENOUS AREA – 05</p> <p>MATERIAL: Pipe Insulation</p> <p>ASBESTOS CONTENT:</p> <p>(NAD) No Asbestos Detected</p>

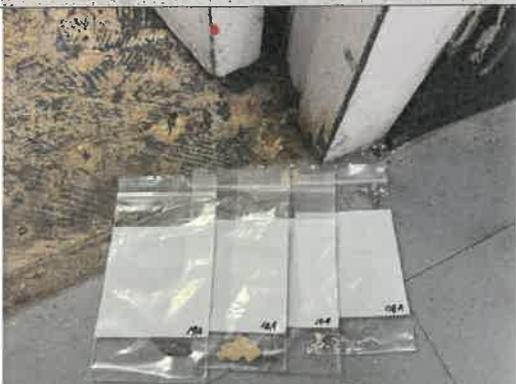
<p>PHOTOGRAPH 7:</p> <p>SAMPLE NUMBERS – 08A,10A,14A,19A</p> <p>MATERIAL: CMU Block, 12"x12" VCT Gray w/ Black Mastic, Caulk, Leveling Compound</p> <p>ASBESTOS CONTENT:</p> <p>2% Chrysotile Asbestos Detected</p>

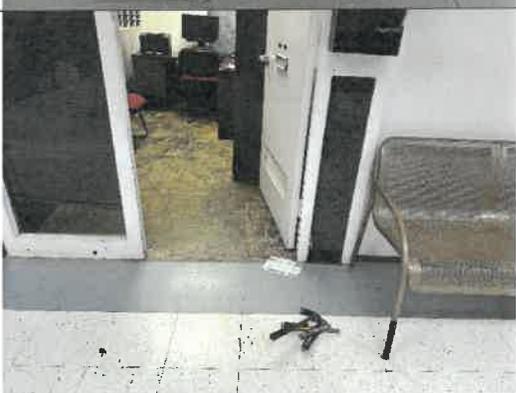
<p>PHOTOGRAPH 8:</p> <p>HOMOGENOUS AREA – 08,10,14,19</p> <p>MATERIAL: CMU Block, 12"x12" VCT Gray w/ Yellow & Black Mastic, Caulk, Leveling Compound</p> <p>ASBESTOS CONTENT:</p> <p>2% Chrysotile Asbestos Detected</p>

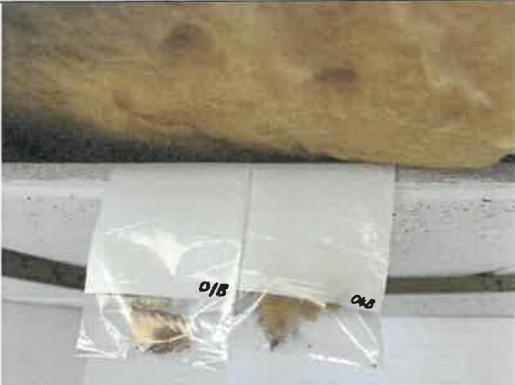
<p>PHOTOGRAPH 9:</p> <p>SAMPLE NUMBERS – 01B,04B</p> <p>MATERIAL: 2’x4’ Ceiling Tiles, Insulation (Yellow)</p> <p>ASBESTOS CONTENT:</p> <p>(NAD) No Asbestos Detected</p>

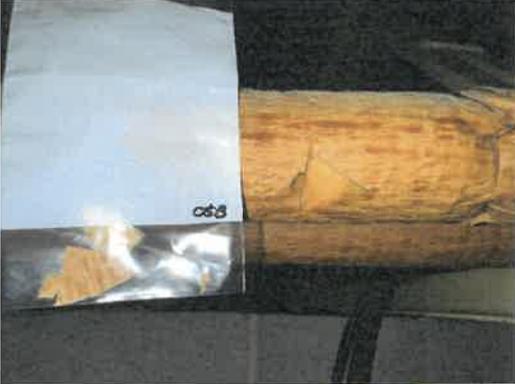
<p>PHOTOGRAPH 10:</p> <p>SAMPLE NUMBERS – 05B</p> <p>MATERIAL: Pipe Insulation</p> <p>ASBESTOS CONTENT:</p> <p>(NAD) No Asbestos Detected</p>

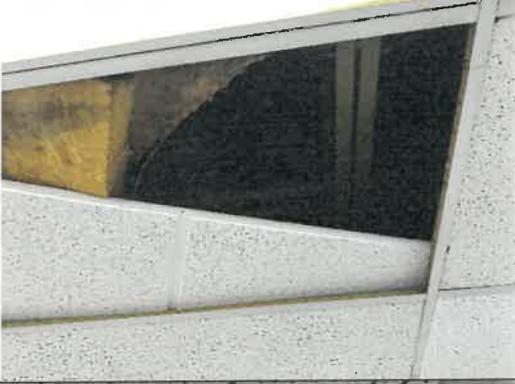
<p>PHOTOGRAPH 4:</p> <p>HOMOGENOUS AREA – 01,04,05</p> <p>MATERIAL: 2’x4’ Ceiling Tiles, Insulation (Yellow), Pipe Insulation</p> <p>ASBESTOS CONTENT:</p> <p>(NAD) No Asbestos Detected</p>

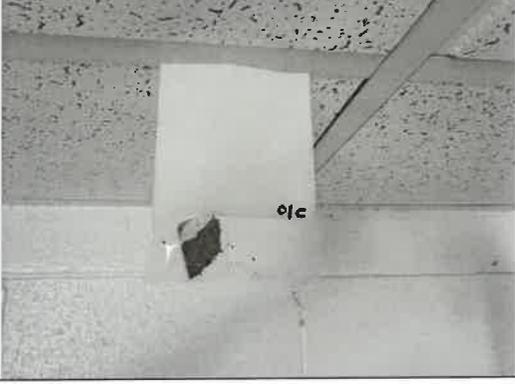
<p>PHOTOGRAPH 11</p> <p>SAMPLE NUMBERS – 01C</p> <p>MATERIAL: 2’x4’ Ceiling Tiles,</p> <p>ASBESTOS CONTENT:</p> <p>(NAD) No Asbestos Detected</p>

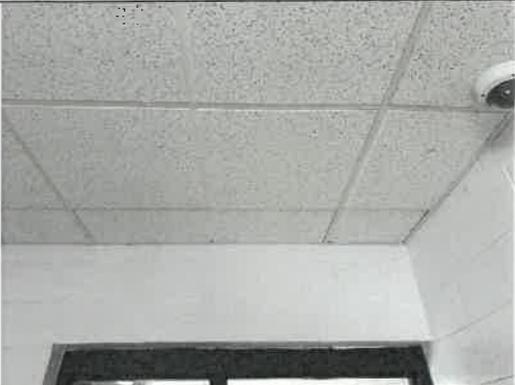
<p>PHOTOGRAPH 12:</p> <p>HOMOGENOUS AREA – 01</p> <p>MATERIAL: 2’x4’ Ceramic Tiles</p> <p>ASBESTOS CONTENT:</p> <p>(NAD) No Asbestos Detected</p>

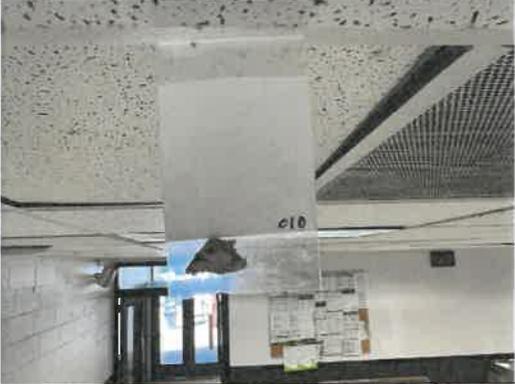
<p>PHOTOGRAPH 13:</p> <p>SAMPLE NUMBERS – 01D</p> <p>MATERIAL: 2’x4’ Ceiling Tiles</p> <p>ASBESTOS CONTENT:</p> <p>(NAD) No Asbestos Detected</p>

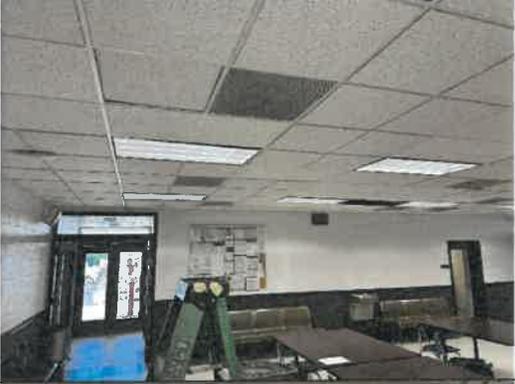
<p>PHOTOGRAPH 4:</p> <p>HOMOGENOUS AREA – 01</p> <p>MATERIAL: 2’x4’ Ceiling Tiles</p> <p>ASBESTOS CONTENT:</p> <p>(NAD) No Asbestos Detected</p>

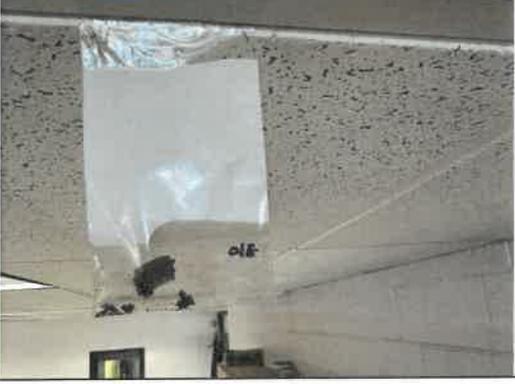
<p>PHOTOGRAPH 14:</p> <p>SAMPLE NUMBERS – 01E</p> <p>MATERIAL: 2’x4’ Ceiling Tiles</p> <p>ASBESTOS CONTENT:</p> <p>(NAD) No Asbestos Detected</p>

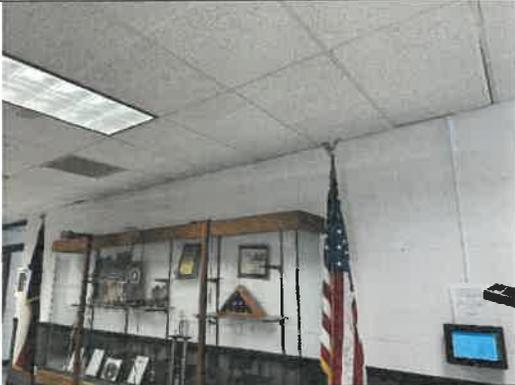
<p>PHOTOGRAPH 15:</p> <p>HOMOGENOUS AREA – 01</p> <p>MATERIAL: 2'x4' Ceiling Tiles</p> <p>ASBESTOS CONTENT:</p> <p>(NAD) No Asbestos Detected</p>

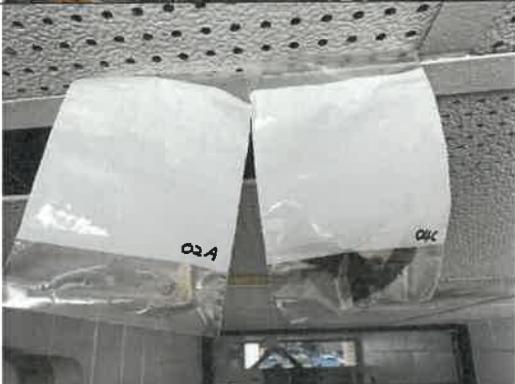
<p>PHOTOGRAPH 16:</p> <p>SAMPLE NUMBERS – 02A,04C</p> <p>MATERIAL: 2'x2' Transite Ceiling Tiles, Insulation (Yellow)</p> <p>ASBESTOS CONTENT:</p> <p>40% Chrysotile Asbestos Detected</p>

- a. Material which is identified as friable or non-friable asbestos-containing material that will be disturbed by the renovation, or other activities, should be removed as soon as possible by properly licensed personnel in accordance with applicable laws and regulations.

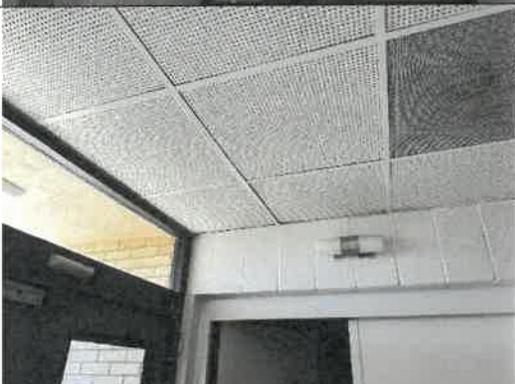
<p>PHOTOGRAPH 17:</p> <p>HOMOGENOUS AREA – 02,04</p> <p>MATERIAL: 2'x2' Transite Ceiling Tiles, Insulation (Yellow)</p> <p>ASBESTOS CONTENT:</p> <p>40% Chrysotile Asbestos Detected</p>

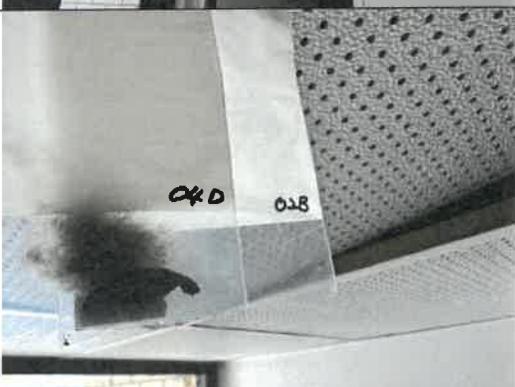
<p>PHOTOGRAPH 18:</p> <p>SAMPLE NUMBERS – 02B,04D</p> <p>MATERIAL: 2'x2' Transite Ceiling Tiles, Insulation (Yellow)</p> <p>ASBESTOS CONTENT:</p> <p>40% Chrysotile Asbestos Detected</p>

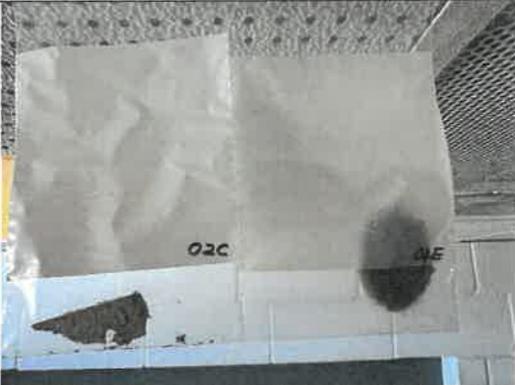
<p>PHOTOGRAPH 19:</p> <p>SAMPLE NUMBERS – 02C,04E</p> <p>MATERIAL: 2’x2’ Transite Ceiling Tiles, Insulation (Yellow)</p> <p>ASBESTOS CONTENT:</p> <p>40% Chrysotile Asbestos Detected</p>

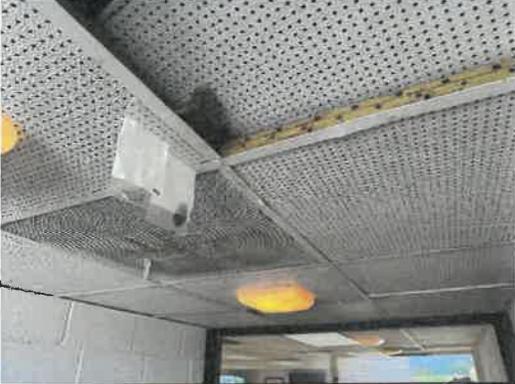
<p>PHOTOGRAPH 20:</p> <p>HOMOGENOUS AREA – 02,04</p> <p>MATERIAL: 2’x2’ Transite Ceiling Tiles, Insulation (Yellow)</p> <p>ASBESTOS CONTENT:</p> <p>40% Chrysotile Asbestos Detected</p>

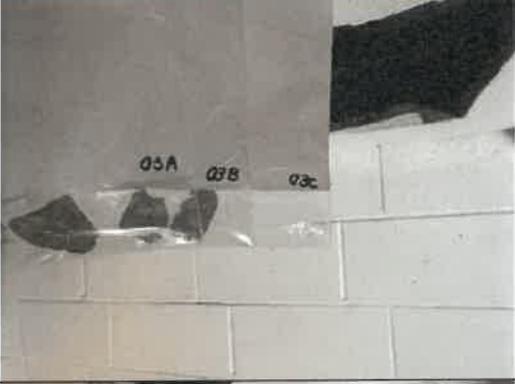
<p>PHOTOGRAPH 21:</p> <p>SAMPLE NUMBERS – 03ABC</p> <p>MATERIAL: Ceiling Plaster</p> <p>ASBESTOS CONTENT:</p> <p>(NAD) No Asbestos Detected</p>

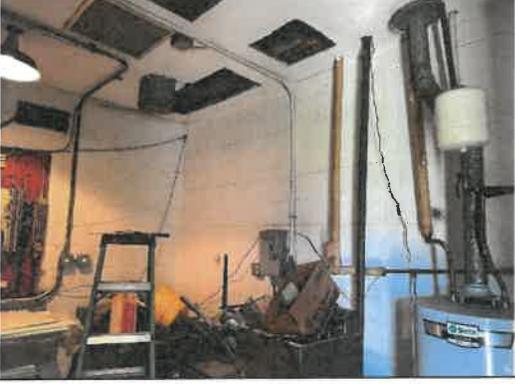
<p>PHOTOGRAPH 22:</p> <p>HOMOGENOUS AREA – 03</p> <p>MATERIAL: Ceiling Plaster</p> <p>ASBESTOS CONTENT:</p> <p>(NAD) No Asbestos Detected</p>

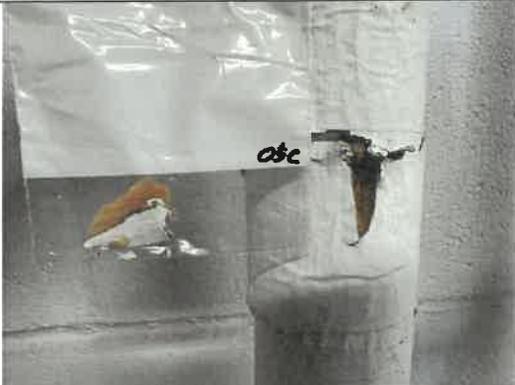
<p>PHOTOGRAPH 23:</p> <p>SAMPLE NUMBERS – 05C</p> <p>MATERIAL: Pipe Insulation</p> <p>ASBESTOS CONTENT:</p> <p>(NAD) No Asbestos Detected</p>

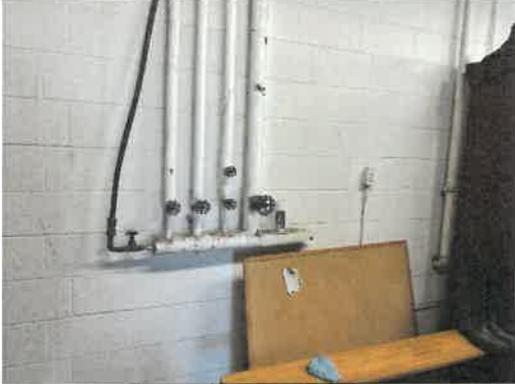
<p>PHOTOGRAPH 24:</p> <p>HOMOGENOUS AREA – 05</p> <p>MATERIAL: Pipe Insulation</p> <p>ASBESTOS CONTENT:</p> <p>(NAD) No Asbestos Detected</p>

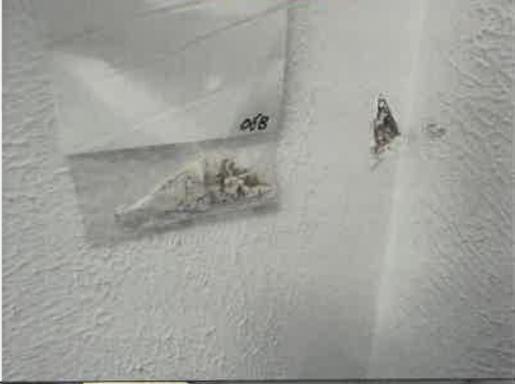
<p>PHOTOGRAPH 25:</p> <p>SAMPLE NUMBERS – 06B</p> <p>MATERIAL: Textured Wallboard & Joint Compound</p> <p>ASBESTOS CONTENT:</p> <p>(NAD) No Asbestos Detected</p>

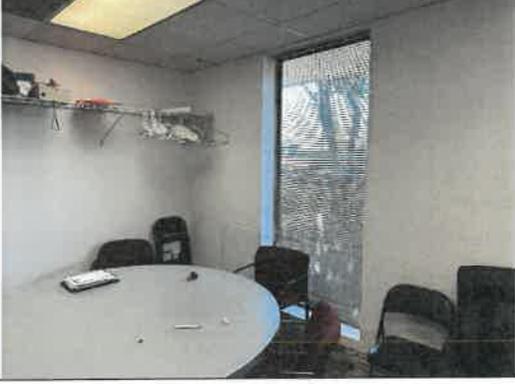
<p>PHOTOGRAPH 26:</p> <p>HOMOGENOUS AREA – 06</p> <p>MATERIAL: Textured Wallboard & Joint Compound</p> <p>ASBESTOS CONTENT:</p> <p>(NAD) No Asbestos Detected</p>

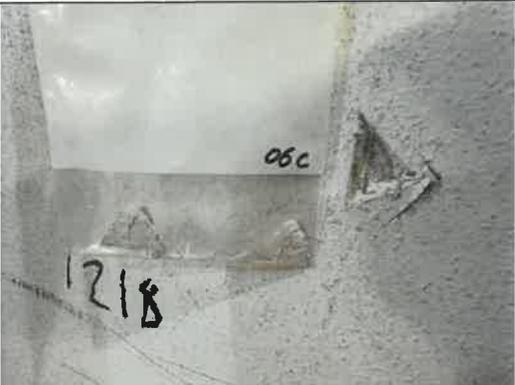
<p>PHOTOGRAPH 27:</p> <p>SAMPLE NUMBERS – 06C</p> <p>MATERIAL: Textured Wallboard & Joint Compound</p> <p>ASBESTOS CONTENT:</p> <p>2% Chrysotile Asbestos Detected</p>

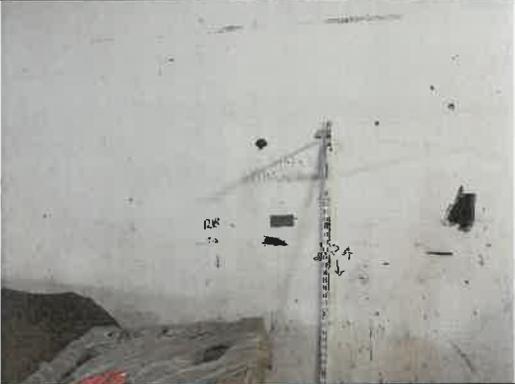
<p>PHOTOGRAPH 28:</p> <p>HOMOGENOUS AREA – 06</p> <p>MATERIAL: Textured Wallboard & Joint Compound</p> <p>ASBESTOS CONTENT:</p> <p>2% Chrysotile Asbestos Detected</p>

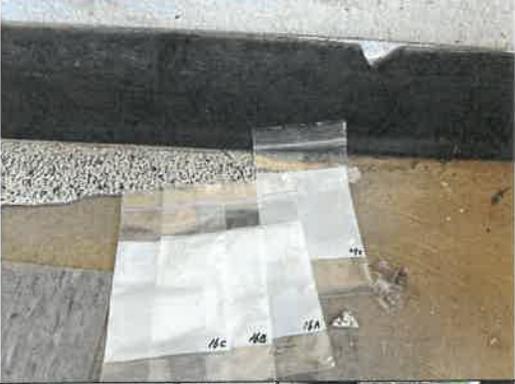
<p>PHOTOGRAPH 29:</p> <p>SAMPLE NUMBERS – 07C,16ABC</p> <p>MATERIAL: Cove Base (Black), 12"x12" VCT Blue w/ Yellow Mastic</p> <p>ASBESTOS CONTENT:</p> <p>(NAD) No Asbestos Detected</p>

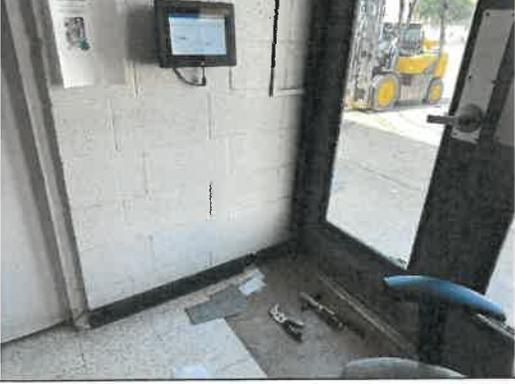
<p>PHOTOGRAPH 30:</p> <p>HOMOGENOUS AREA – 07,16</p> <p>MATERIAL: Cove Base (Black), 12"x12" VCT Blue w/ Yellow Mastic</p> <p>ASBESTOS CONTENT:</p> <p>(NAD) No Asbestos Detected</p>

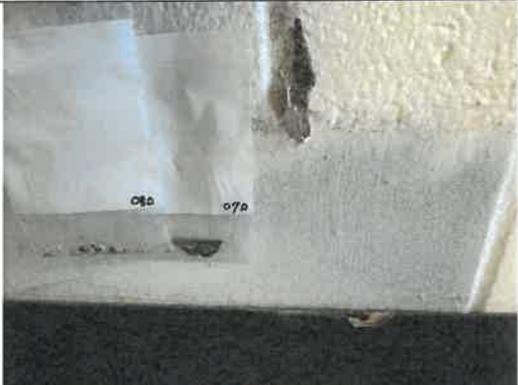
<p>PHOTOGRAPH 31:</p> <p>SAMPLE NUMBERS – 07D,08D</p> <p>MATERIAL: Cove Base (Black), CMU Block</p> <p>ASBESTOS CONTENT:</p> <p>(NAD) No Asbestos Detected</p>

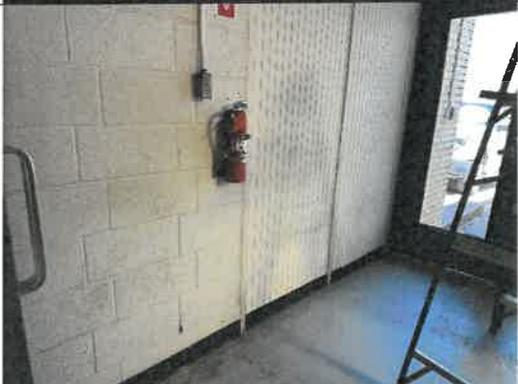
<p>PHOTOGRAPH 32:</p> <p>HOMOGENOUS AREA – 07,08</p> <p>MATERIAL: Cove Base (Black), CMU Block</p> <p>ASBESTOS CONTENT:</p> <p>(NAD) No Asbestos Detected</p>

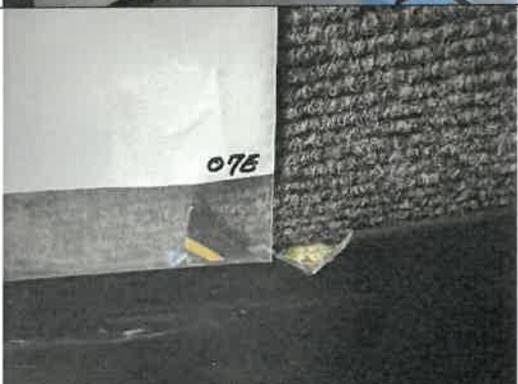
<p>PHOTOGRAPH 353:</p> <p>SAMPLE NUMBERS – 07E</p> <p>MATERIAL: Cove Base (Black)</p> <p>ASBESTOS CONTENT:</p> <p>(NAD) No Asbestos Detected</p>

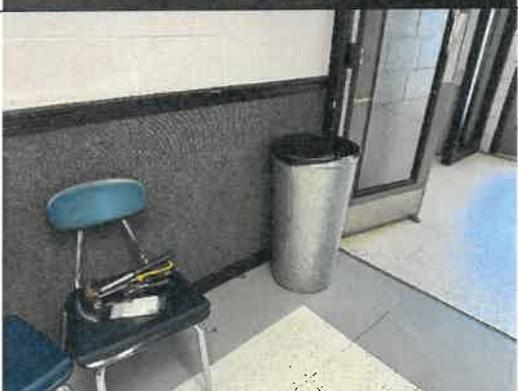
<p>PHOTOGRAPH 34:</p> <p>HOMOGENOUS AREA – 07</p> <p>MATERIAL: Cove Base (Black)</p> <p>ASBESTOS CONTENT:</p> <p>(NAD) No Asbestos Detected</p>

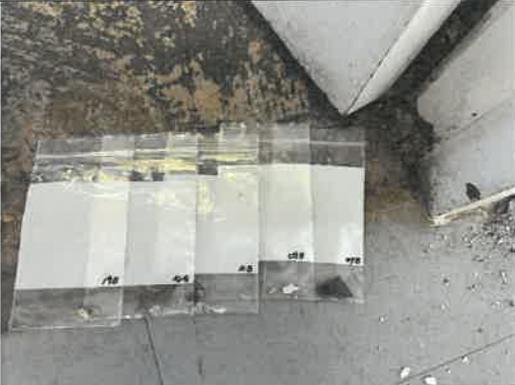
<p>PHOTOGRAPH 35:</p> <p>SAMPLE NUMBERS – 07B,08B,10B,14B,19B,</p> <p>MATERIAL: Cove Base (Black), CMU Block, 12”x12” VCT Gray w/ Black Mastic, Caulk, Leveling Compound</p> <p>ASBESTOS CONTENT:</p> <p>2% Chrysotile Asbestos Detected</p>

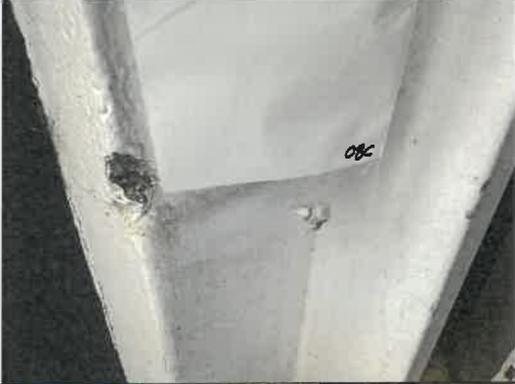
<p>PHOTOGRAPH 36:</p> <p>SAMPLE NUMBERS – 08C</p> <p>MATERIAL: CMU Block</p> <p>ASBESTOS CONTENT:</p> <p>2% Chrysotile Asbestos Detected</p>

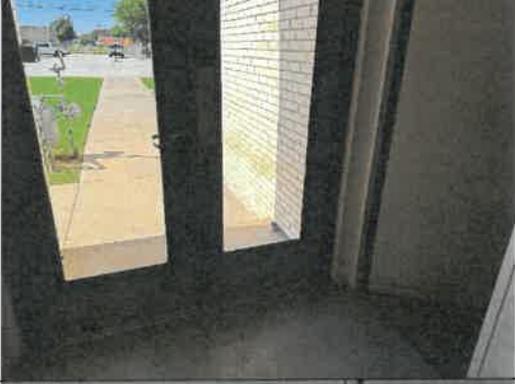
<p>PHOTOGRAPH 37:</p> <p>HOMOGENOUS AREA – 07,08,10,14,19</p> <p>MATERIAL: Cove Base (Black), CMU Block, 12”x12” VCT Gray w/ Black Mastic, Caulk, Leveling Compound</p> <p>ASBESTOS CONTENT:</p> <p>2% Chrysotile Asbestos Detected</p>

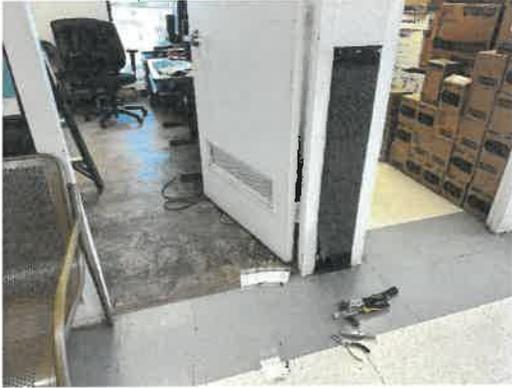
PHOTOGRAPH 39:

2% Chrysotile Asbestos Detected

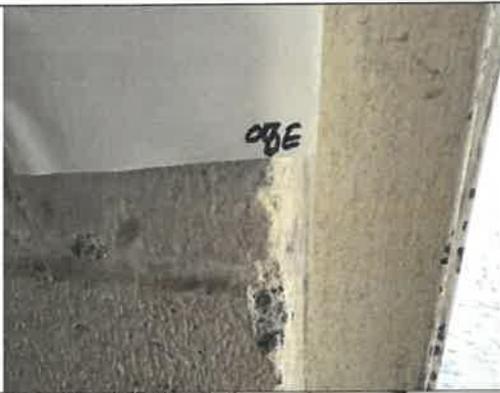
PHOTOGRAPH 40:

2% Chrysotile Asbestos Detected

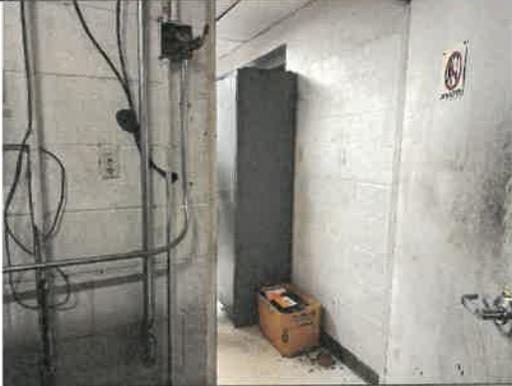
PHOTOGRAPH 41:

2% Chrysotile Asbestos Detected

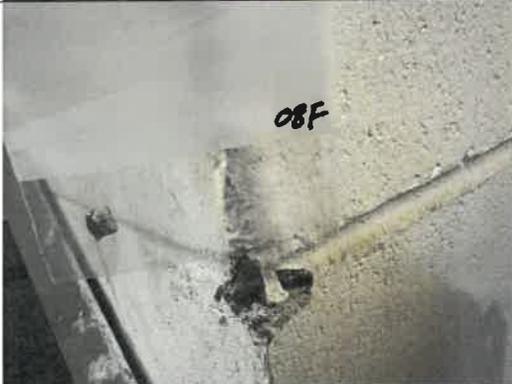
PHOTOGRAPH 42:

(NAD) No Asbestos Detected

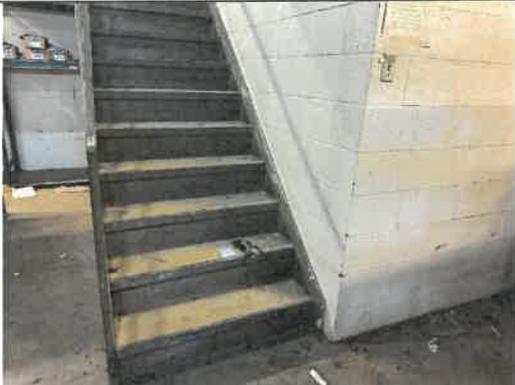
<p>PHOTOGRAPH 43:</p> <p>HOMOGENOUS AREA – 02</p> <p>MATERIAL: CMU Block</p> <p>ASBESTOS CONTENT:</p> <p>(NAD) No Asbestos Detected</p>

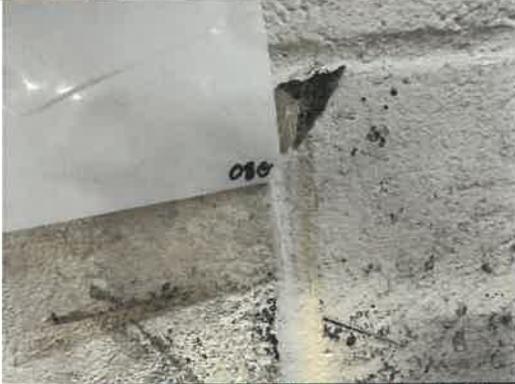
<p>PHOTOGRAPH 44:</p> <p>SAMPLE NUMBERS – 08G</p> <p>MATERIAL: CMU Block</p> <p>ASBESTOS CONTENT:</p> <p>2% Chrysotile Asbestos Detected</p>

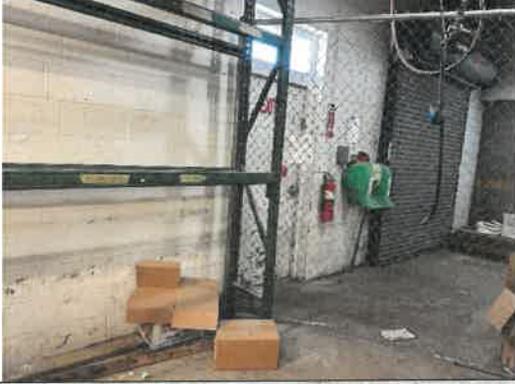
<p>PHOTOGRAPH 45:</p> <p>HOMOGENOUS AREA – 02</p> <p>MATERIAL: CMU Block</p> <p>ASBESTOS CONTENT:</p> <p>(NAD) No Asbestos Detected</p>

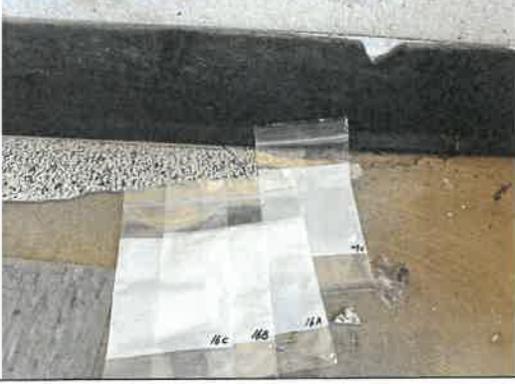
<p>PHOTOGRAPH 46:</p> <p>SAMPLE NUMBERS – 10</p> <p>MATERIAL: Cove Base (Black), 12"x12" VCT Blue w/ Yellow Mastic</p> <p>ASBESTOS CONTENT:</p> <p>(NAD) No Asbestos Detected</p>

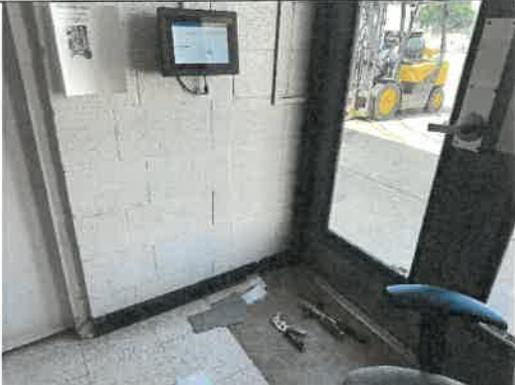
<p>PHOTOGRAPH 47:</p> <p>HOMOGENOUS AREA – 02</p> <p>MATERIAL: Cove Base (Black), 12"x12" VCT Blue w/ Yellow Mastic</p> <p>ASBESTOS CONTENT:</p> <p>(NAD) No Asbestos Detected</p>

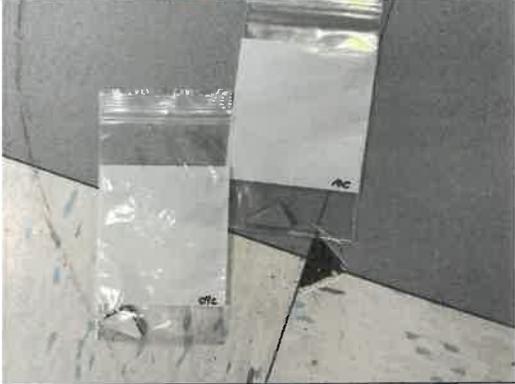
<p>PHOTOGRAPH 48:</p> <p>SAMPLE NUMBERS – 09C,10C</p> <p>MATERIAL: 12"x12" VCT White/ Black Mastic, 12"x12" VCT Gray/Yellow Mastic</p> <p>ASBESTOS CONTENT:</p> <p>(NAD) No Asbestos Detected</p>

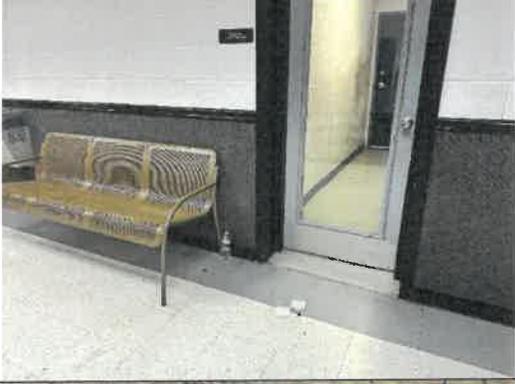
<p>PHOTOGRAPH 49:</p> <p>HOMOGENOUS AREA – 09,10</p> <p>MATERIAL: 12"x12" VCT White/ Black Mastic, 12"x12" VCT Gray /Yellow Mastic</p> <p>ASBESTOS CONTENT:</p> <p>(NAD) No Asbestos Detected</p>

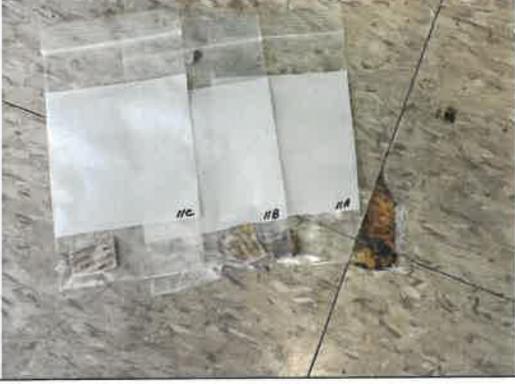
<p>PHOTOGRAPH 50:</p> <p>SAMPLE NUMBERS – 10</p> <p>MATERIAL: 12"x12" VCT Beige / Yellow Mastic</p> <p>ASBESTOS CONTENT:</p> <p>(NAD) No Asbestos Detected</p>

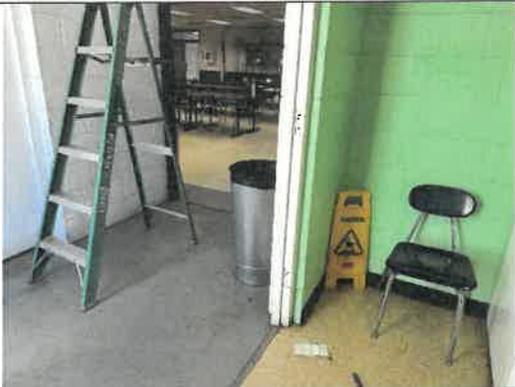
<p>PHOTOGRAPH 51:</p> <p>HOMOGENOUS AREA – 02</p> <p>MATERIAL: 12”x12” VCT Beige / Yellow Mastic</p> <p>ASBESTOS CONTENT:</p> <p>(NAD) No Asbestos Detected</p>

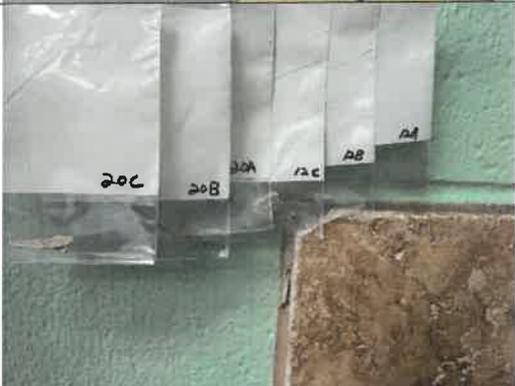
<p>PHOTOGRAPH 52:</p> <p>SAMPLE NUMBERS – 12ABC,20ABC</p> <p>MATERIAL: 8”x8” Ceramic Wall Tile, Caulk (Brown/Sanded)</p> <p>ASBESTOS CONTENT:</p> <p>(NAD) No Asbestos Detected</p>

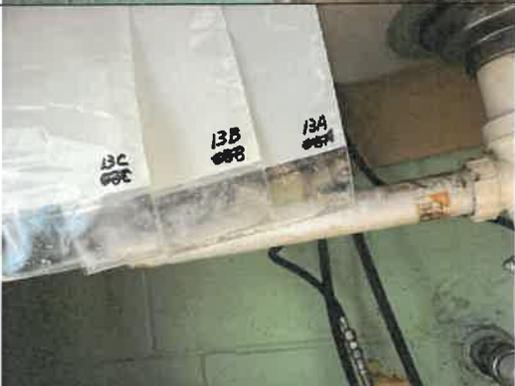
<p>PHOTOGRAPH 35:</p> <p>SAMPLE NUMBERS – 13ABC</p> <p>MATERIAL: Sink Coating</p> <p>ASBESTOS CONTENT:</p> <p>(NAD) No Asbestos Detected</p>

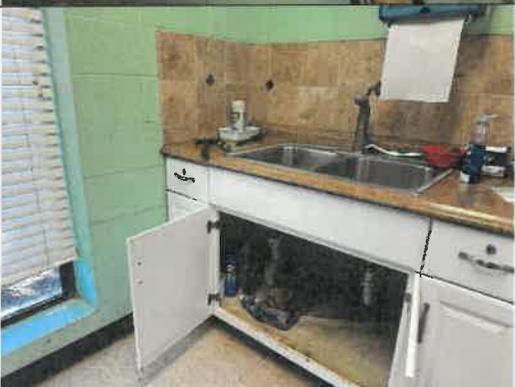
<p>PHOTOGRAPH 53:</p> <p>HOMOGENOUS AREA – 12,20,13</p> <p>MATERIAL: 8”x8” Ceramic Wall Tile, Caulk (Brown/Sanded), Sink Coating</p> <p>ASBESTOS CONTENT:</p> <p>(NAD) No Asbestos Detected</p>

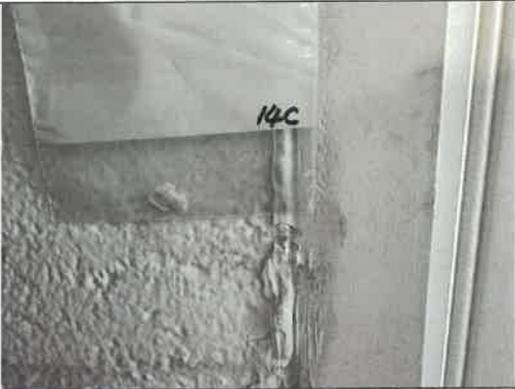
<p>PHOTOGRAPH 54:</p> <p>SAMPLE NUMBERS – 14C</p> <p>MATERIAL: Caulk</p> <p>ASBESTOS CONTENT:</p> <p>(NAD) No Asbestos Detected</p>

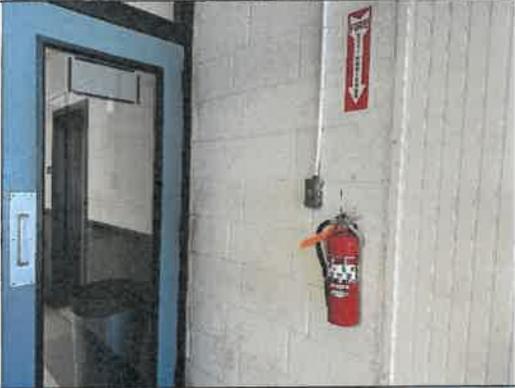
<p>PHOTOGRAPH 55:</p> <p>HOMOGENOUS AREA –14</p> <p>MATERIAL: Caulk</p> <p>ASBESTOS CONTENT:</p> <p>(NAD) No Asbestos Detected</p>

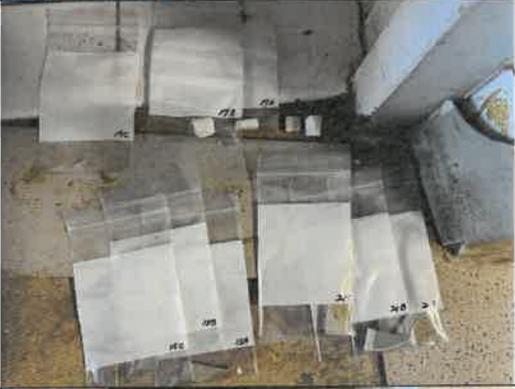
<p>PHOTOGRAPH 35:</p> <p>SAMPLE NUMBERS – 15ABC 17AB,19C,21ABC</p> <p>MATERIAL: 4"x4" Ceramic Wall Tile, Leveling Compound, 12"x12" VCT Light Gray, Cove Base (Gray)/Tan Mastic</p> <p>ASBESTOS CONTENT:</p> <p>(NAD) No Asbestos Detected</p>

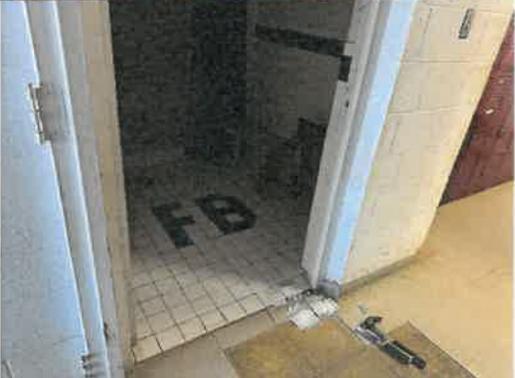
<p>PHOTOGRAPH 56:</p> <p>HOMOGENOUS AREA – 15,17,19,21</p> <p>MATERIAL: 4"x4" Ceramic Wall Tile, Leveling Compound, 12"x12" VCT Light Gray, Cove Base (Gray)/Tan Mastic</p> <p>ASBESTOS CONTENT:</p> <p>(NAD) No Asbestos Detected</p>

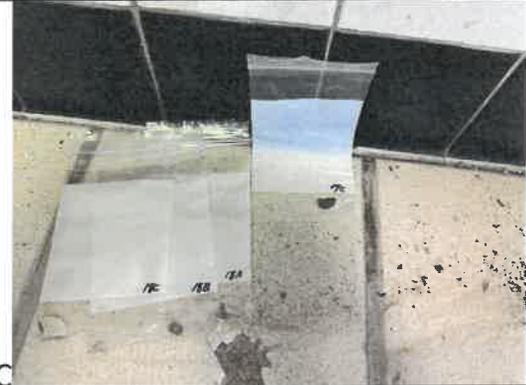
<p>PHOTOGRAPH 57:</p> <p>SAMPLE NUMBERS – 17C,18ABC</p> <p>MATERIAL: Cove Base (Gray)/Tan Mastic, 8"x8" Ceramic Floor Tile</p> <p>ASBESTOS CONTENT:</p> <p>(NAD) No Asbestos Detected</p>

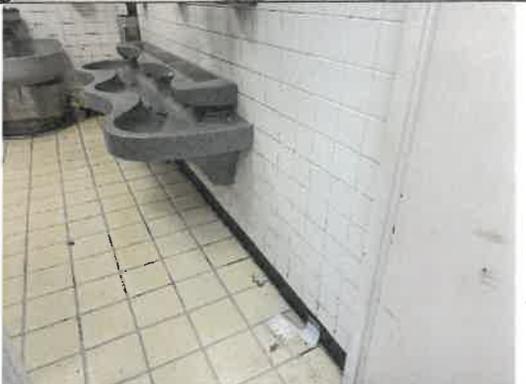
<p>PHOTOGRAPH 58:</p> <p>HOMOGENOUS AREA – 17,18</p> <p>MATERIAL: Cove Base (Gray)/Tan Mastic, 8"x8" Ceramic Floor Tile</p> <p>ASBESTOS CONTENT:</p> <p>(NAD) No Asbestos Detected</p>

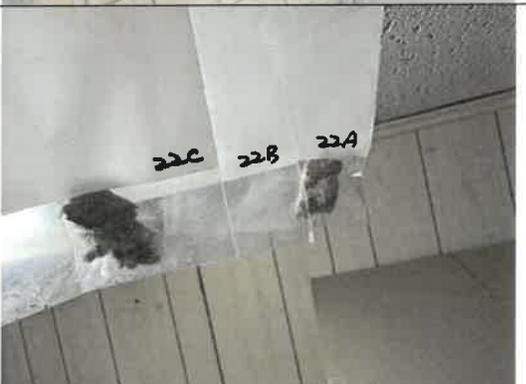
<p>PHOTOGRAPH 35:</p> <p>SAMPLE NUMBERS – 22ABC</p> <p>MATERIAL: 2"x2" Ceiling Tile</p> <p>ASBESTOS CONTENT:</p> <p>(NAD) No Asbestos Detected</p>

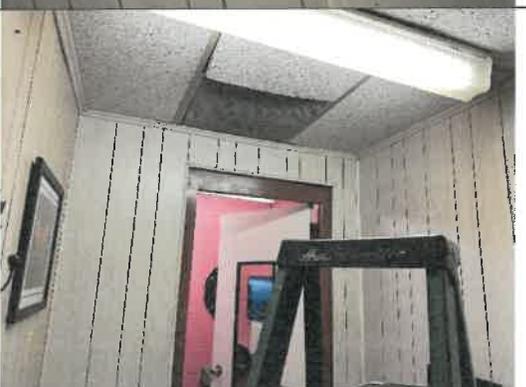
<p>PHOTOGRAPH 59:</p> <p>HOMOGENOUS AREA – 22</p> <p>MATERIAL: 2"x2" Ceiling Tile</p> <p>ASBESTOS CONTENT:</p> <p>(NAD) No Asbestos Detected</p>

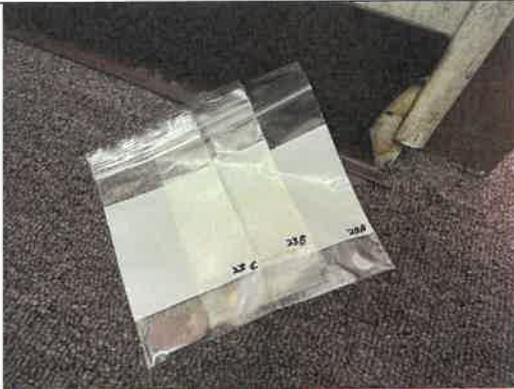
PHOTOGRAPH 60:
SAMPLE NUMBERS – 23ABC
MATERIAL: Cove Base (Red)/Tan Mastic
ASBESTOS CONTENT:
(NAD) No Asbestos Detected

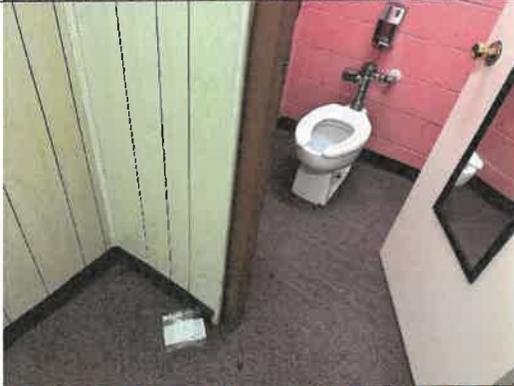
PHOTOGRAPH 61:
HOMOGENOUS AREA – 23
MATERIAL: Cove Base (Red)/Tan Mastic
ASBESTOS CONTENT:
(NAD) No Asbestos Detected
