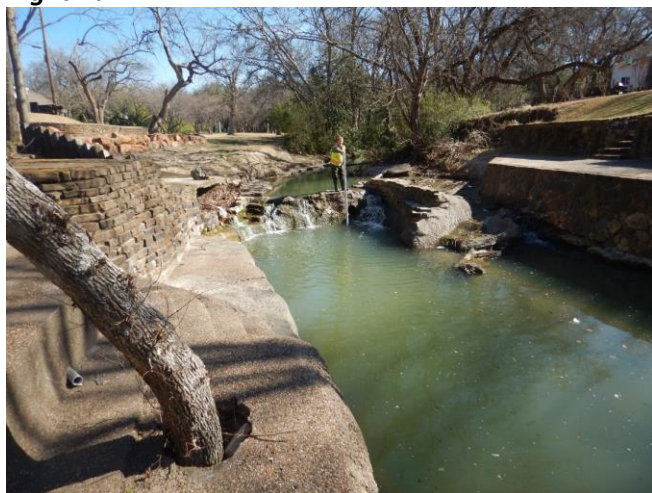
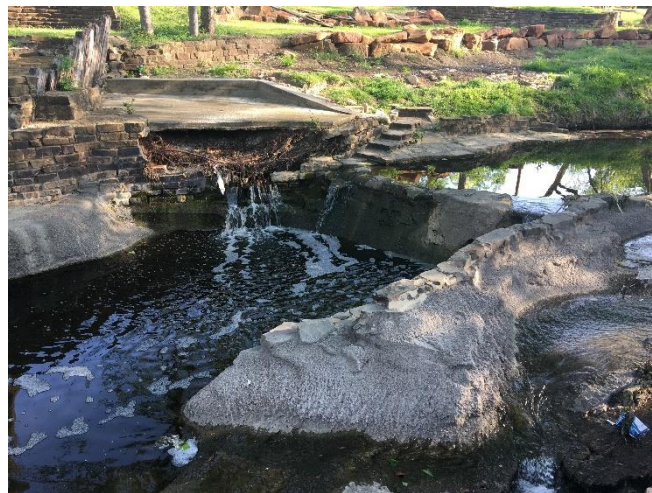
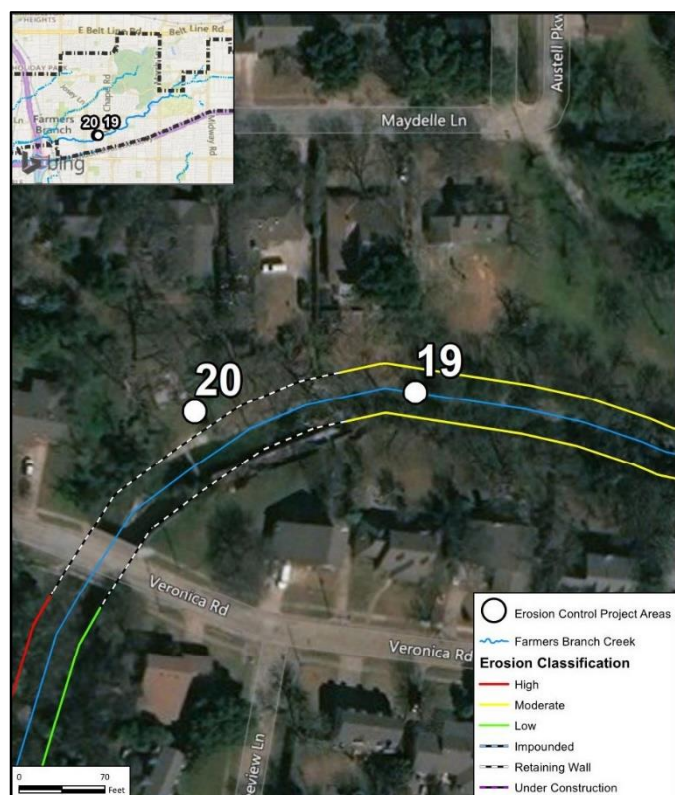
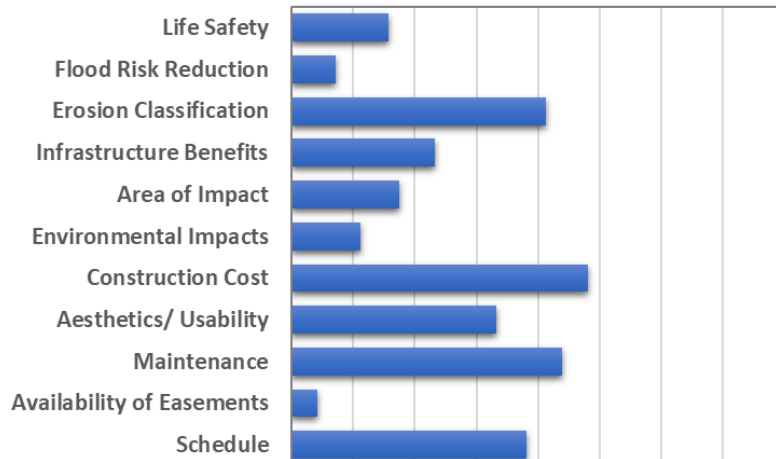
Right Bank

Reference Address:	2900 Block of Maydelle Ln		
Project ID: E-19	CIP Rank: 12 of 29	Score: 13.7	Estimated Cost: \$47,320
Problem Description:	Erosion of right retaining wall (flow through wall)		
Proposed Improvement:	Repair undermined wall structure with CIP concrete.

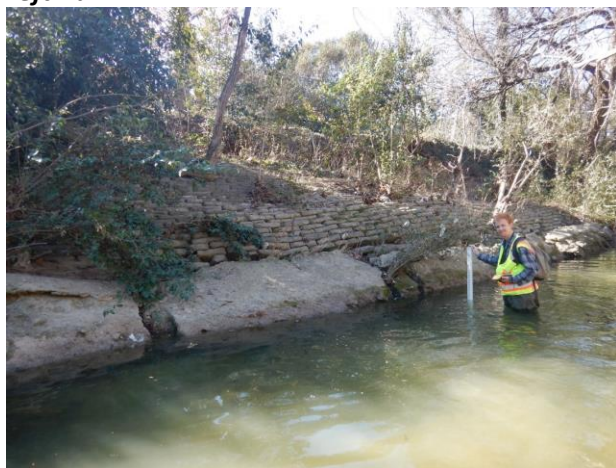
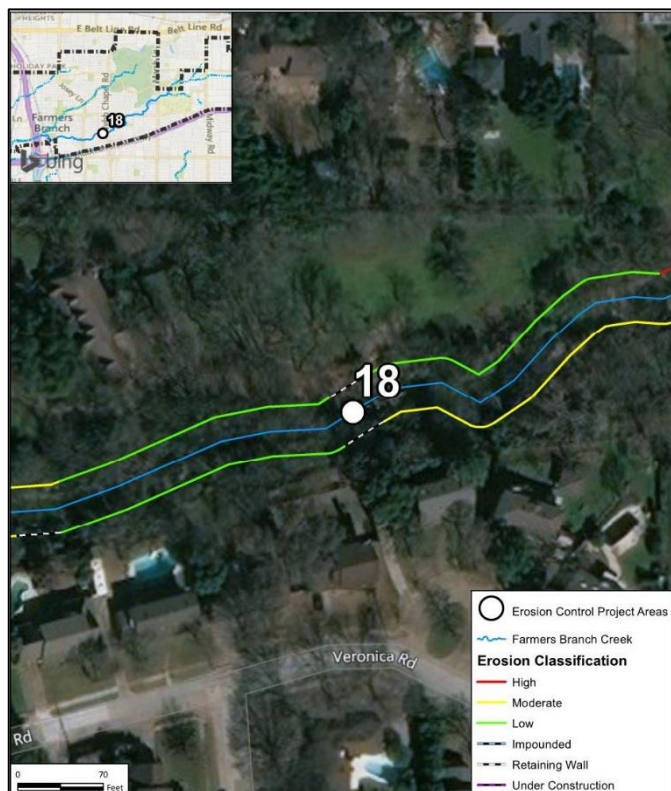
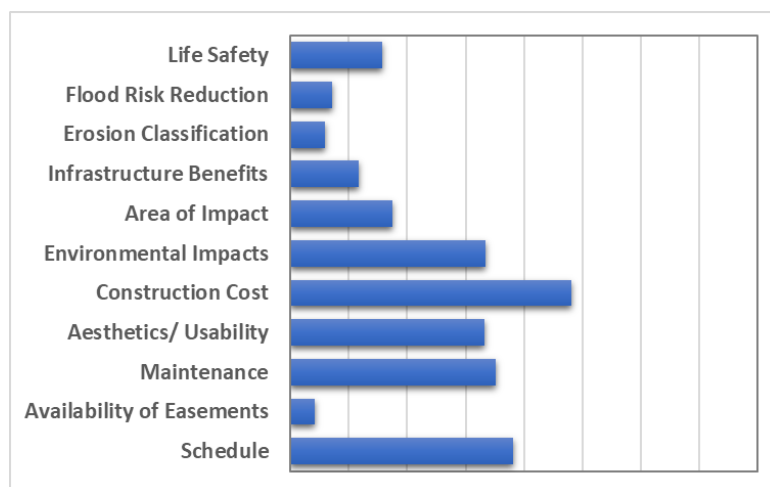
Left Bank

Reference Address:	2900 Block of Maydelle Ln		
Project ID: E-18	CIP Rank: 18 of 29	Score: 12.1	Estimated Cost: \$29,700
Problem Description:	Collapsed bag wall and damaged fence from rotational failure		
Proposed Improvement:	Bag wall and rock toe to remain for slope stabilization. Plant and live-stake over bag wall. Promote natural revegetation.

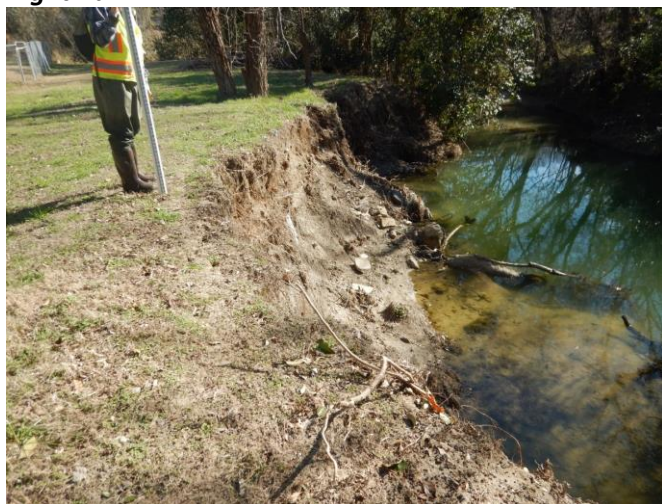
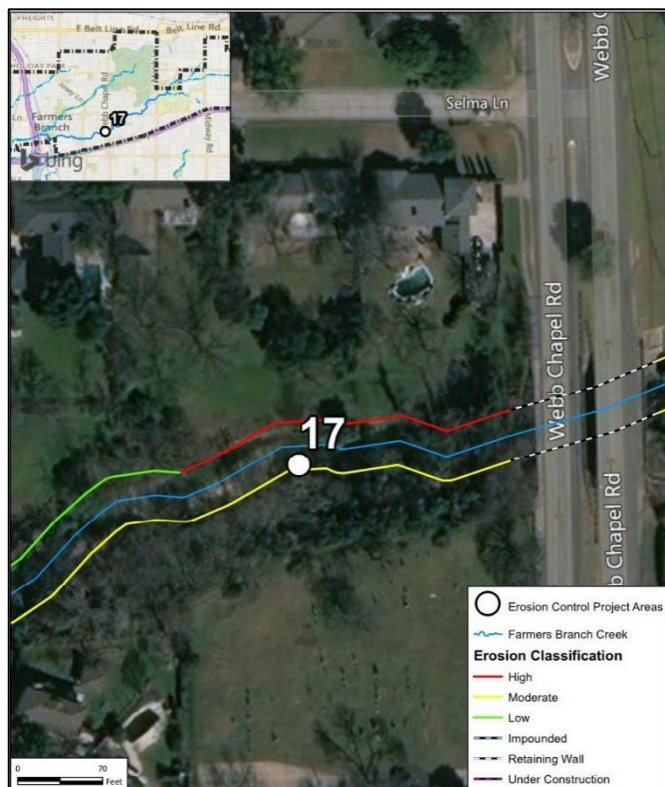
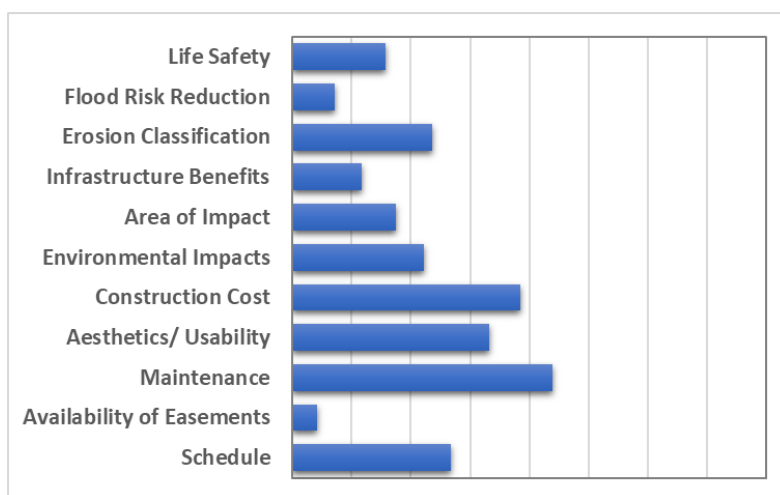
Right Bank

Reference Address:	3000 Block of Selma Ln		
Project ID: E-17	CIP Rank: 19 of 29	Score: 11.8	Estimated Cost: \$131,950
Problem Description:	10-FT tall, south-facing, unvegetated bank; tension cracks, high erosion		
Proposed Improvement:	Restore natural bank slope and reestablish vegetation along 290 LF right bank.
