**FARMERS
BRANCH**

Farmers Branch Watershed Study
June 14, 2018

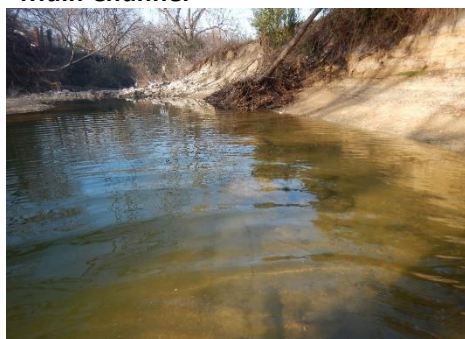
Main Channel

Reference Address:	3100 Block of Brookhollow Dr		
Project ID: E-12	CIP Rank: 2 of 29	Score: 17.3	Estimated Cost: \$764,340
Problem Description:	Pipe exposed downstream of manhole; pipe exposed on bed; Manhole in center of channel at a junction of three lines; Eroded right bank next to manhole; exposed pipes show >12 FT of erosion		
Proposed Improvement:	Encase 50 LF exposed sanitary sewer line. Monitor existing sanitary sewer manhole and consider removal and relocation. Install 100 LF, 15-FT tall MSE wall with 5 FT stone toe protection through concrete-lined portion of the channel.

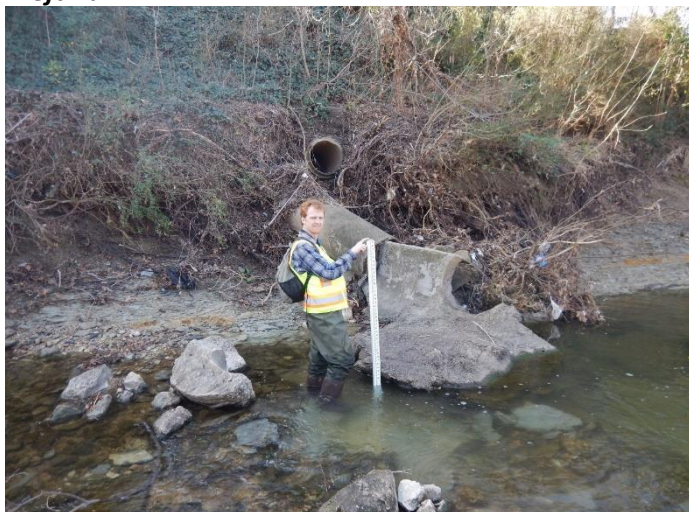
Left Bank

Reference Address:	3200 Block of Brincrest Dr		
Project ID: E-14	CIP Rank: 11 of 29	Score: 14.3	Estimated Cost: \$42,550
Problem Description:	Collapsed headwall and section of pipe, evidence of widening		
Proposed Improvement:	Install 24" CIP headwall. Install rock rip rap protection around outfall.

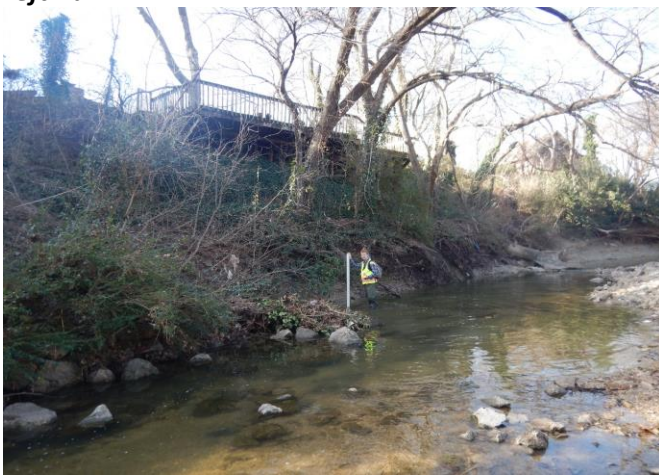
Left Bank

Reference Address:	Lost Vally Dr		
Project ID: E-13	CIP Rank: 13 of 29	Score: 13.7	Estimated Cost: \$163,980
Problem Description:	Deck at top of unprotected bank appears to be leaning toward stream		
Proposed Improvement:	Install 40 LF, 5-FT stone toe protection. Geotechnical evaluation may be necessary to assess shoring and stability of deck structure. Install 24" CIP headwall. Install rock rip rap protection around outfall.
