Reference Address:	3100 Block of Brookhollow Dr			
Project ID: E-12	CIP Rank: 2 of 29	Score: 17.3	Estimated Cost: \$764,340	
Problem Description:	Pipe exposed downstream of manhole; pipe exposed on bed; Manhole in center of channel at a junction of three lines; Eroded right bank next to manhole; exposed pipes show >12 FT of erosion			
Proposed Improvement:	Encase 50 LF exposed sanitary sewer line. Monitor existing sanitary sewer manhole and consider removal and relocation. Install 100 LF, 15-FT tall MSE wall with 5 FT stone toe protection through concrete-lined portion of the channel.

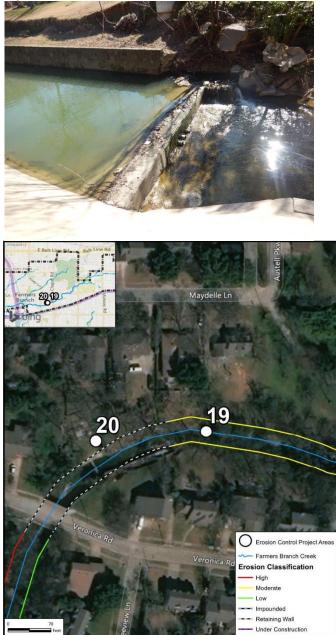
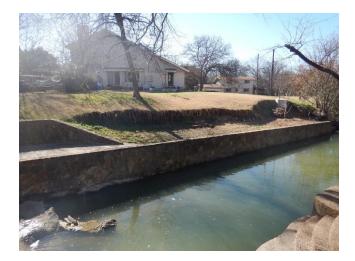
Left Bank

<b>Reference Address:</b>	2900 Block of Maydelle Ln			
Project ID: E-20	CIP Rank: 3 of 29	Score: 16.7	Estimated Cost: \$76,560	
Problem Description:	Erosion of left bank above retaining wall, exposing manhole at downstream end			
Proposed Improvement:	Install riprap to protect existing manhole. Repair undermined wall structure with CIP concrete. Consider repairs or unclogging to low level outlet structure.

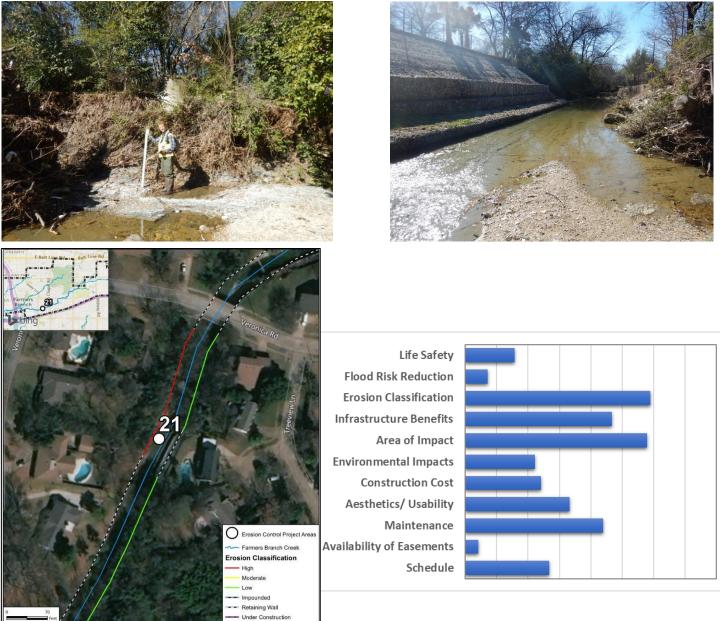
## Right Bank

Reference Address:	12200 Block of Treeview Ln			
Project ID: E-21	CIP Rank: 4 of 29	Score: 16.5	Estimated Cost: \$243,330	
Problem Description:	Manhole threatened by high bank erosion			
Proposed Improvement:	Extend anchored gabions 50 LF downstream to protect existing manhole. Install gabion mattress around bend. Add rock rip rap protection around manhole and downstream of gabion structure.

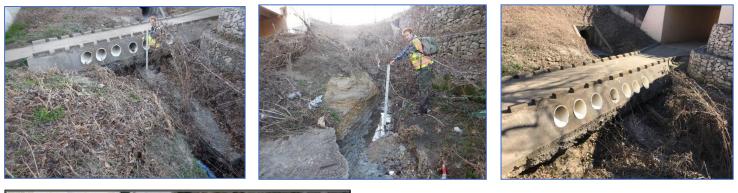
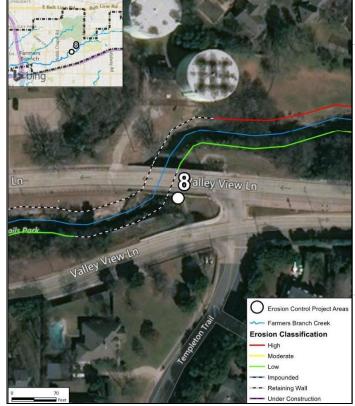
## Main Channel

<b>Reference Address:</b>	3300 Block of Valley View Ln			
Project ID: E-8	CIP Rank: 8 of 29	Score: 14.7	Estimated Cost: \$128,230	
Problem Description:	Gully undercutting trail crossing near Valley View Lane; shale on bed of gully			
Proposed Improvement:	Backfill undercut outlet structure. Install 20 FT x 20 FT x 4.5 FT gabion mattress downstream of outfall. Embed below flowline. Connect to existing gabion wall. Install riprap upstream of outlet structure and downstream of mattress. Establish natural slope and riparian vegetation 100 LF downstream of mattress or as necessary.
