Rawhide Creek Infrastructure Assessment

Final Technical Memorandum

December 18, 2020

TO: Marc Bentley, PE
FROM: David Rivera, PhD, PE, CFM
SUBJECT: Rawhide Creek Infrastructure Assessment
DATE: 12/18/2020
PROJECT: FBR20638 – Rawhide Infrastructure Assessment

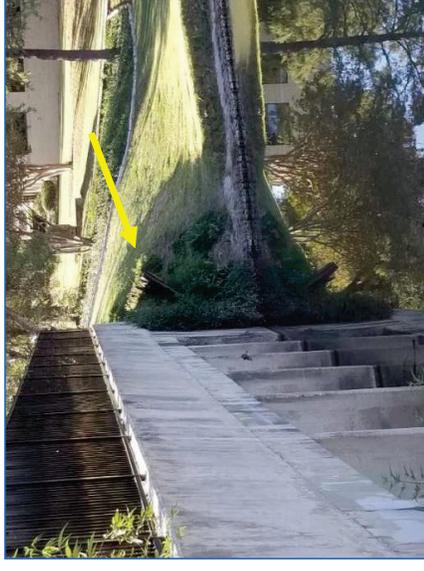
Reference Address:	13800 Block of Webb Chapel Road – Webb Chapel Road Bridge (downstream)	
Project Area: 1	Priority: Medium	Estimated Cost: (included in upstream cost)
Problem Description: (Continued)	Existing timber retaining wall at southwestern corner has failed (Images 6 and 7). The sidewalk has settled as a consequence of this failure (Image 8).	
Proposed Improvement:	Remove and replace the timber retaining wall with a concrete retaining wall. Perform site grading to reestablish slope and remove and replace damaged portion of sidewalk. Allow native vegetation to reestablish to further stabilize slope.

Image 7 (right). Leaning retaining wall within culvert (on far, southeast side).

Problem: Failed/leaning timber retaining wall.
Solution: Replace with new concrete retaining wall.

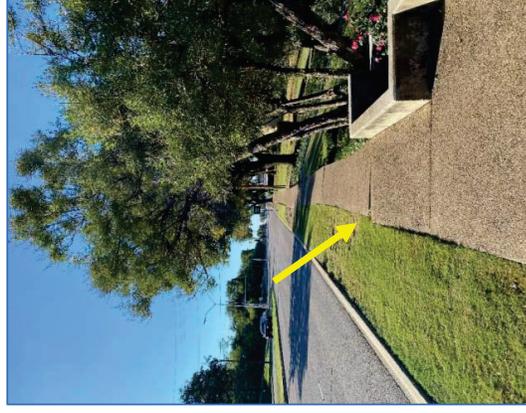
Image 8 (left). Webb Chapel Road sidewalk displacement.

Problem: Displacement in adjacent sidewalk.
Solution: Remove and replace damaged portion of sidewalk. Restore grade.

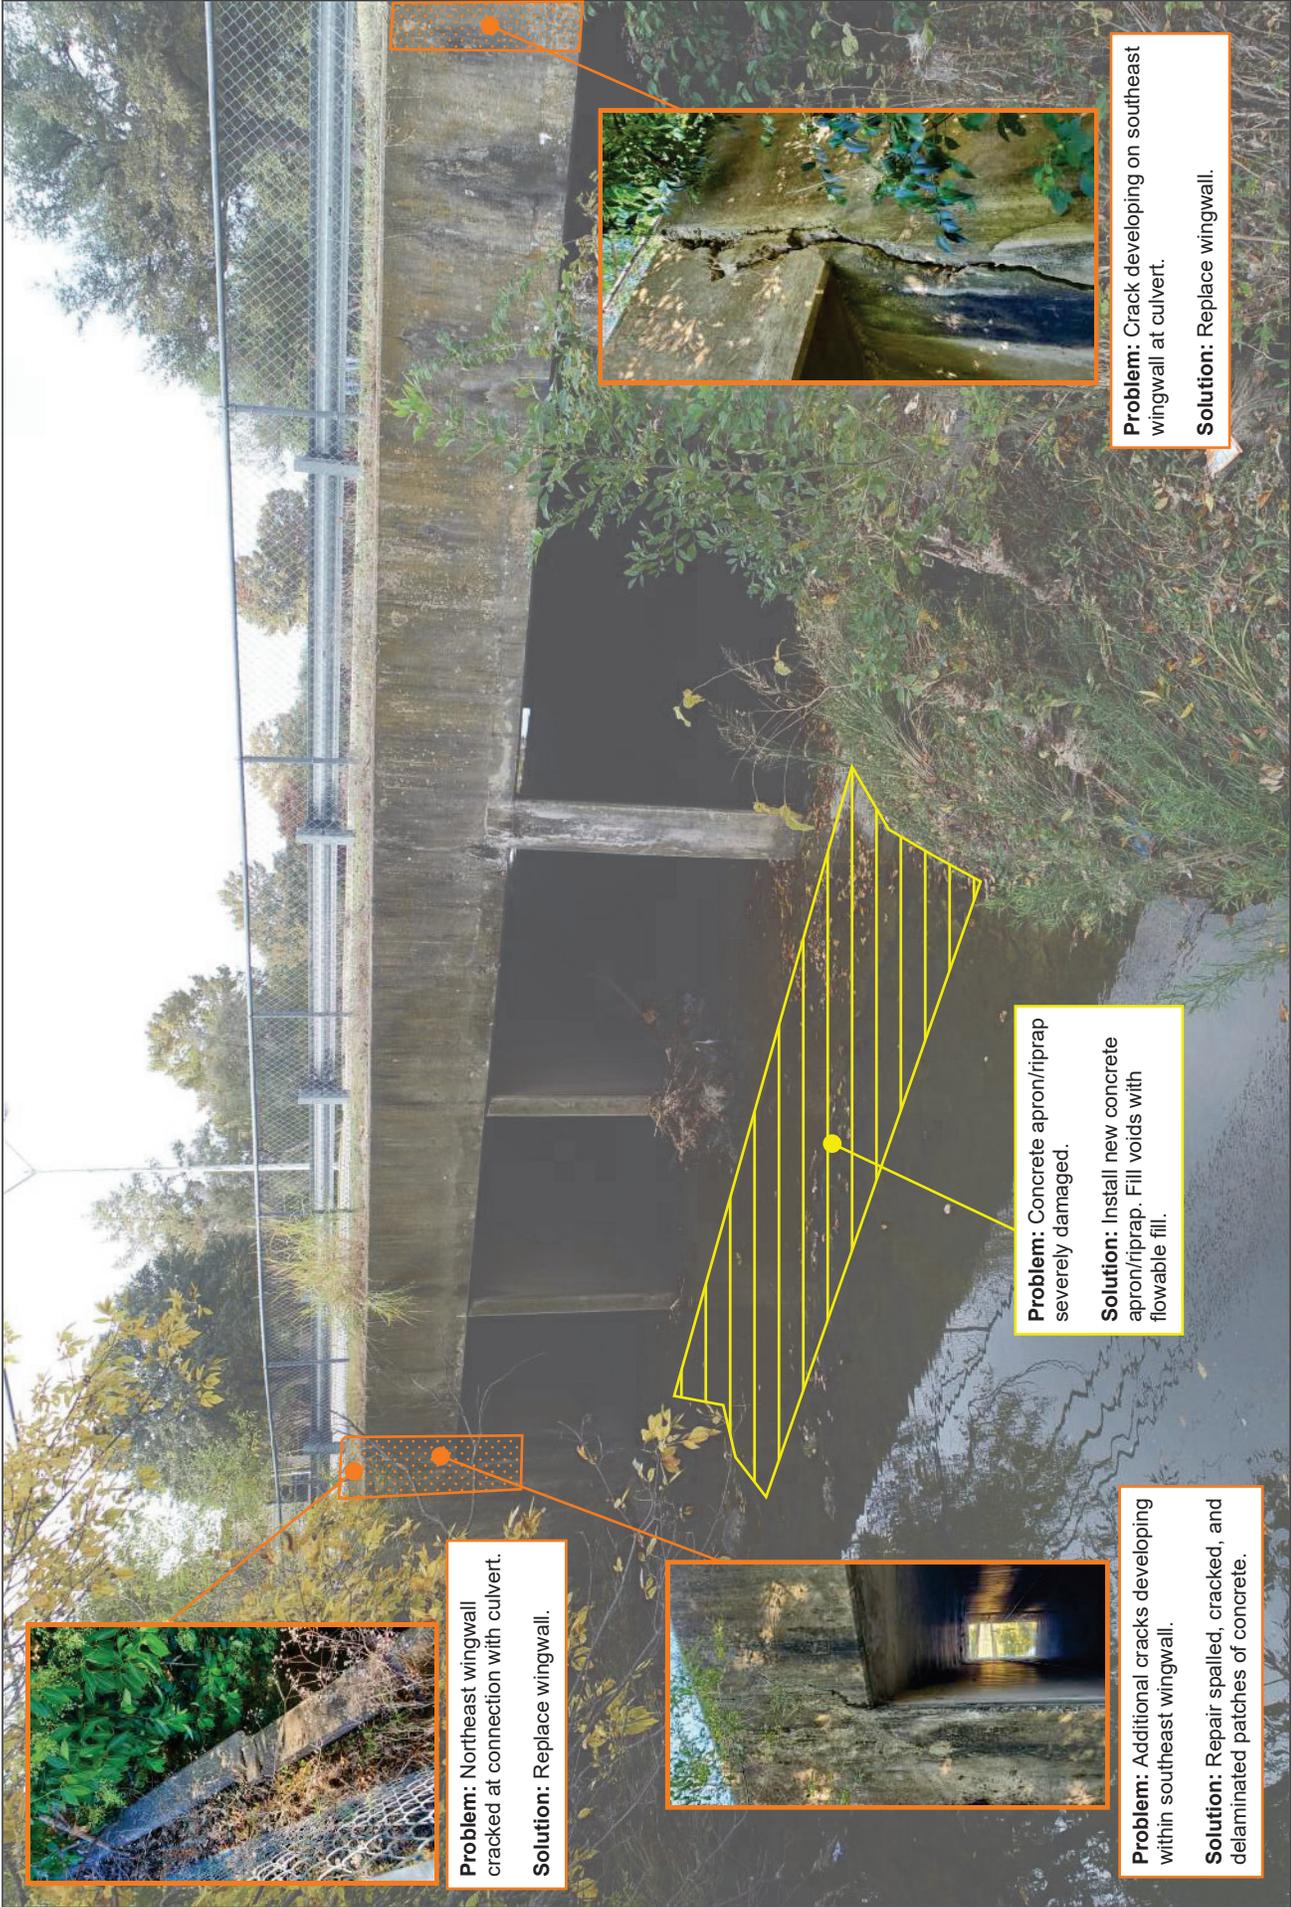
Figure I. Project Area 1 (Upstream)

Problem: Northeast wingwall cracked at connection with culvert.
Solution: Replace wingwall.

Problem: Crack developing on southeast wingwall at culvert.
Solution: Replace wingwall.

Problem: Additional cracks developing within southeast wingwall.
Solution: Repair spalled, cracked, and delaminated patches of concrete.

Problem: Concrete apron/riprap severely damaged.
Solution: Install new concrete apron/riprap. Fill voids with flowable fill.

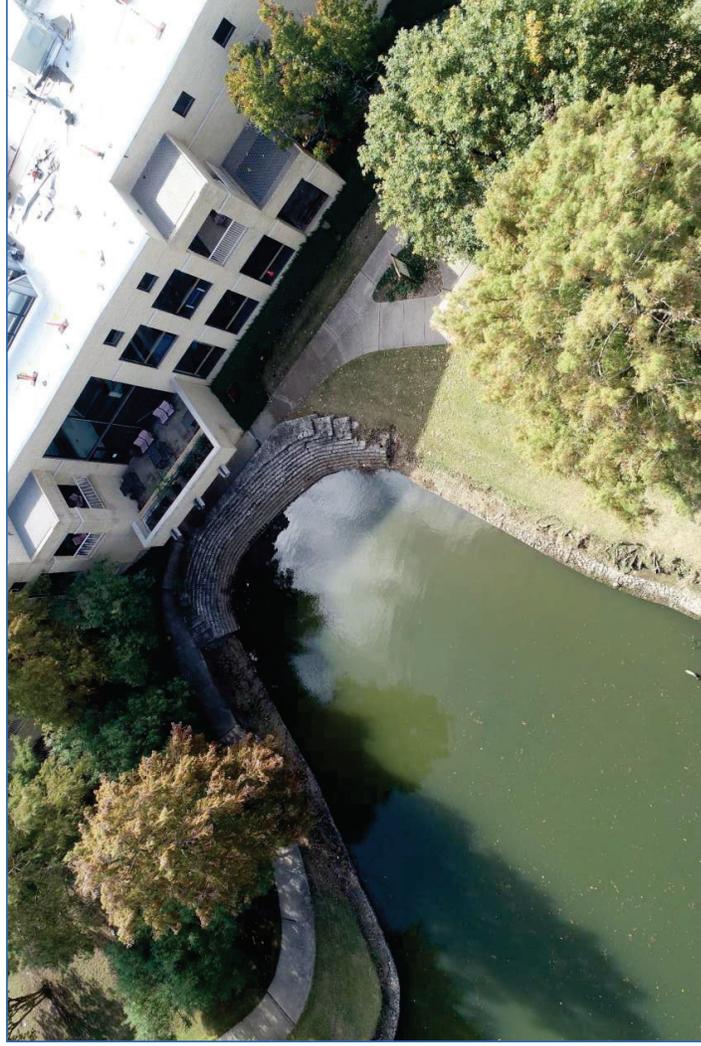
Figure 1. Aerial Drone Imagery of Project Area 2.
Shot on DJI Phantom 4 Pro Version 2.0 at 100' agl (above ground level).

Reference Address:	Farmers Branch Manske Library (13613 Webb Chapel Road)
Project Area: 2	Priority: Low Estimated Cost: \$249,000
Problem Description:	Erosion of bank has caused damage to stone retaining wall and gabion baskets adjacent to library (Image 9). Minor erosion observed at transition from gabion wall to natural ground (Image 11).
Proposed Improvement:	Remove and replace 400 SF damaged stone retaining wall system. Remove and replace 190 LF of damaged gabion wall. Perform bank grading to establish a gradual and uniform slope at the transition from top of gabion wall to natural ground.

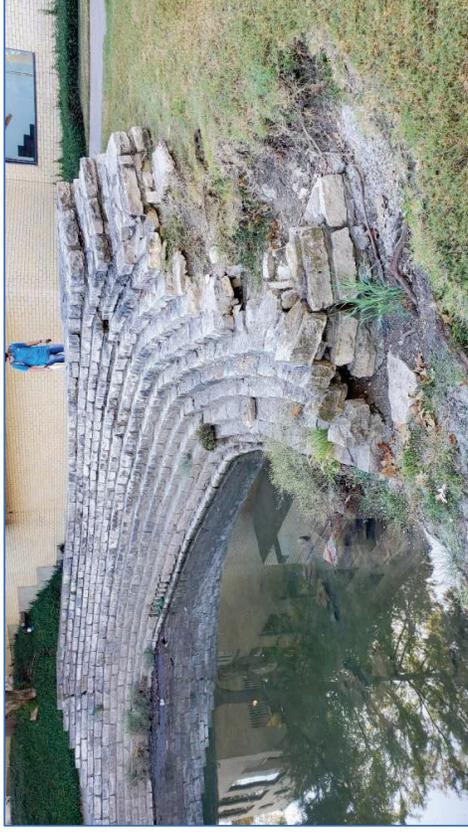
Image 9. Manske Library eroded retaining wall.

Solution: Remove and replace 400 SF of stone retaining wall.

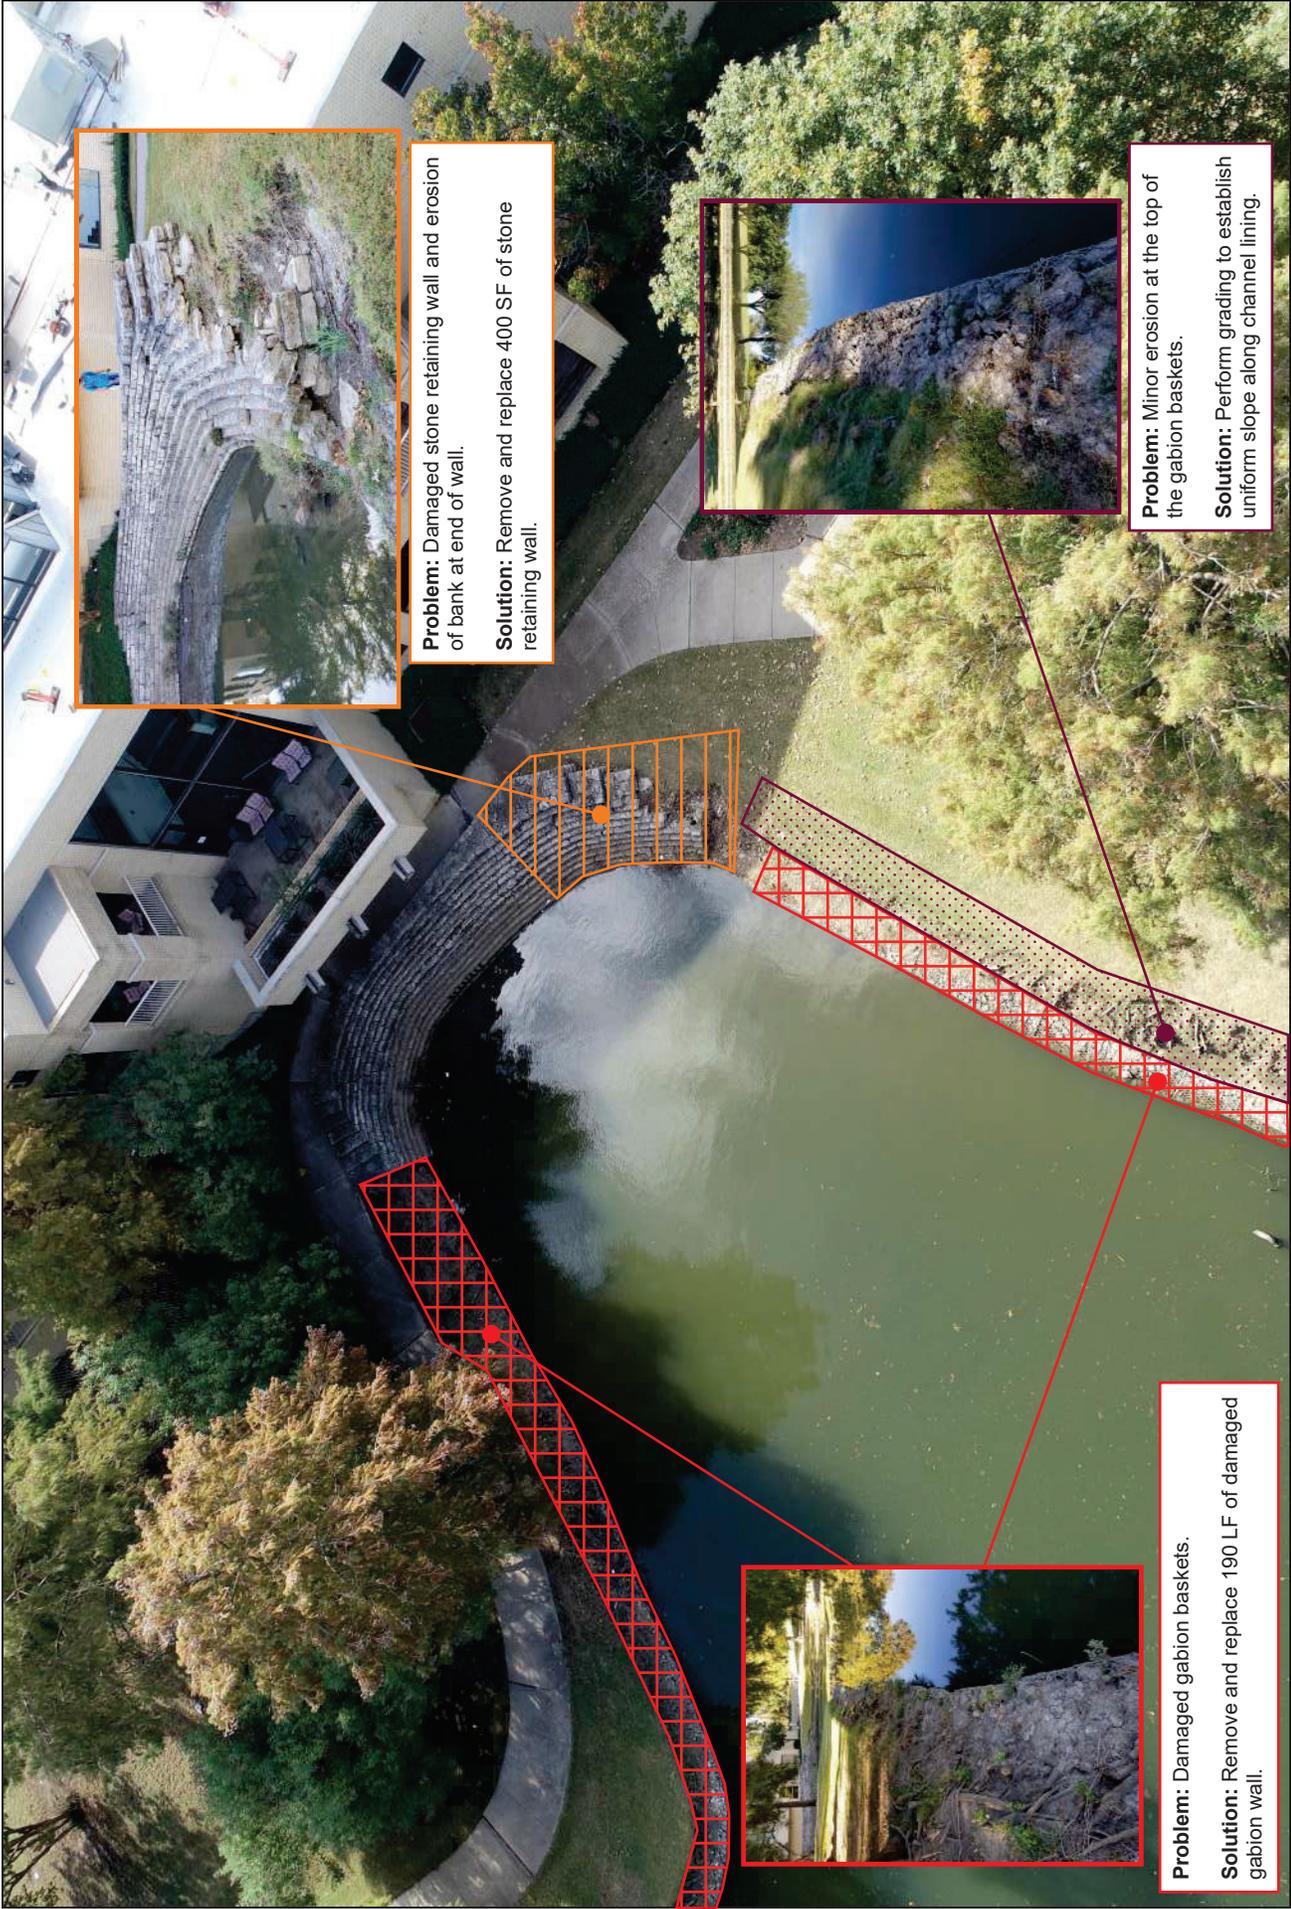
Figure III. Project Area 2

Problem: Damaged stone retaining wall and erosion of bank at end of wall.

Problem: Damaged gabion baskets.

Solution: Remove and replace 190 LF of damaged gabion wall.

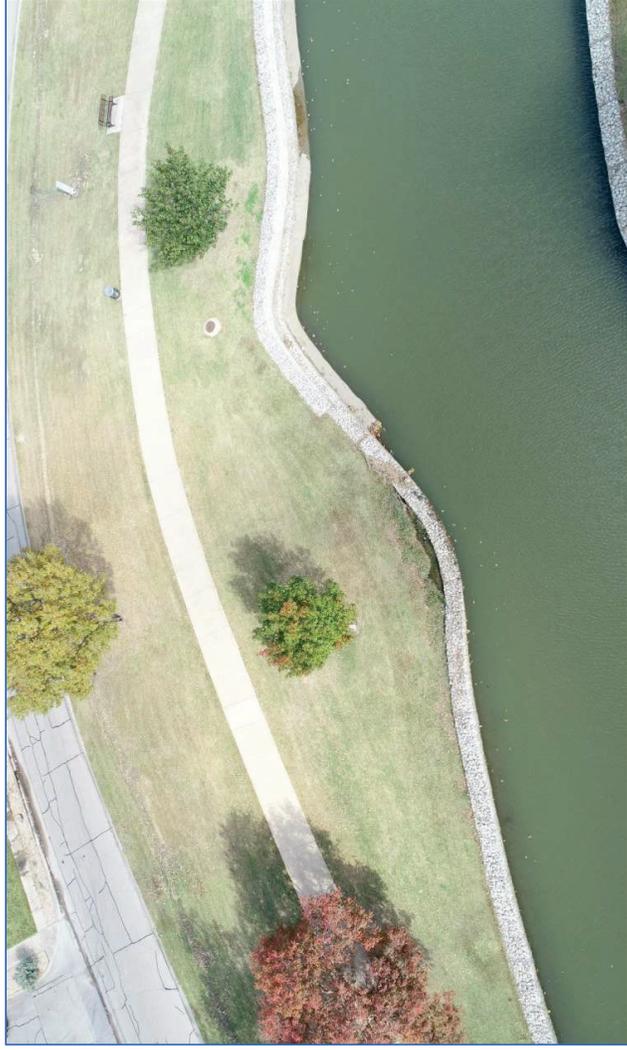
Figure II. Aerial Drone Imagery of Project Area 3. Shot on DJI Phantom 4 Pro Version 2.0 at 100' agl (above ground level).

Reference Address:	13800 Block of Lillard Lane	
Project Area: 3	Priority: Low	Estimated Cost: \$371,000 (Includes Project Areas 3, 4 & 5)
Problem Description:	Damage of gabion wall along the right bank of the channel (Images 12, 13, and 15). Localized erosion at transition from gabion wall to natural ground. Water seepage occurring behind the baskets, likely resulting in the gabion wall leaning inwards towards the creek.	
Proposed Improvement:	Remove 25 LF of gabion baskets. Reconstruct and install 20 CY of new gabion baskets around the channel bend to connect to existing gabion wall. Perform bank grading to establish a gradual and uniform slope at the transition from top of gabion wall to natural ground. Install 110 SY of turf reinforcement matting (TRM) to armor bank from further erosion. Tie TRM to gabion wall to prevent seepage behind wall. A sample TRM detail has been included as part of this Appendix.

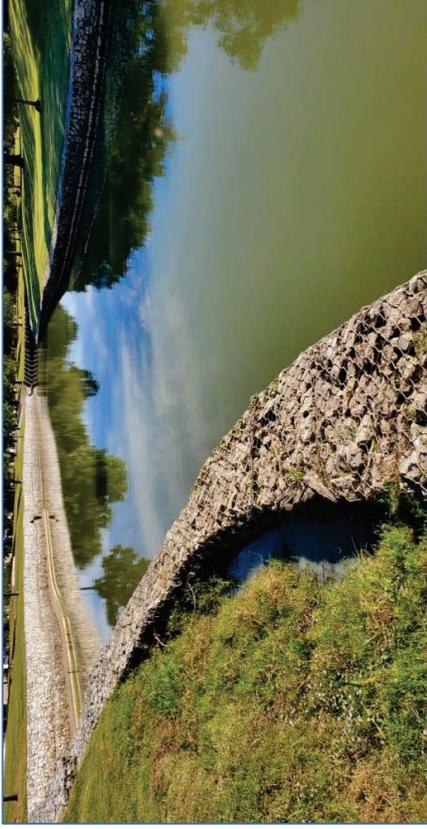
Image 12. Undetermined gabion wall (upstream view).

Solution: Install new gabion baskets within this section.

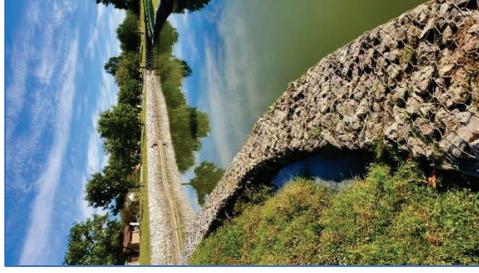
Image 15. Leaning gabion wall (upstream view).

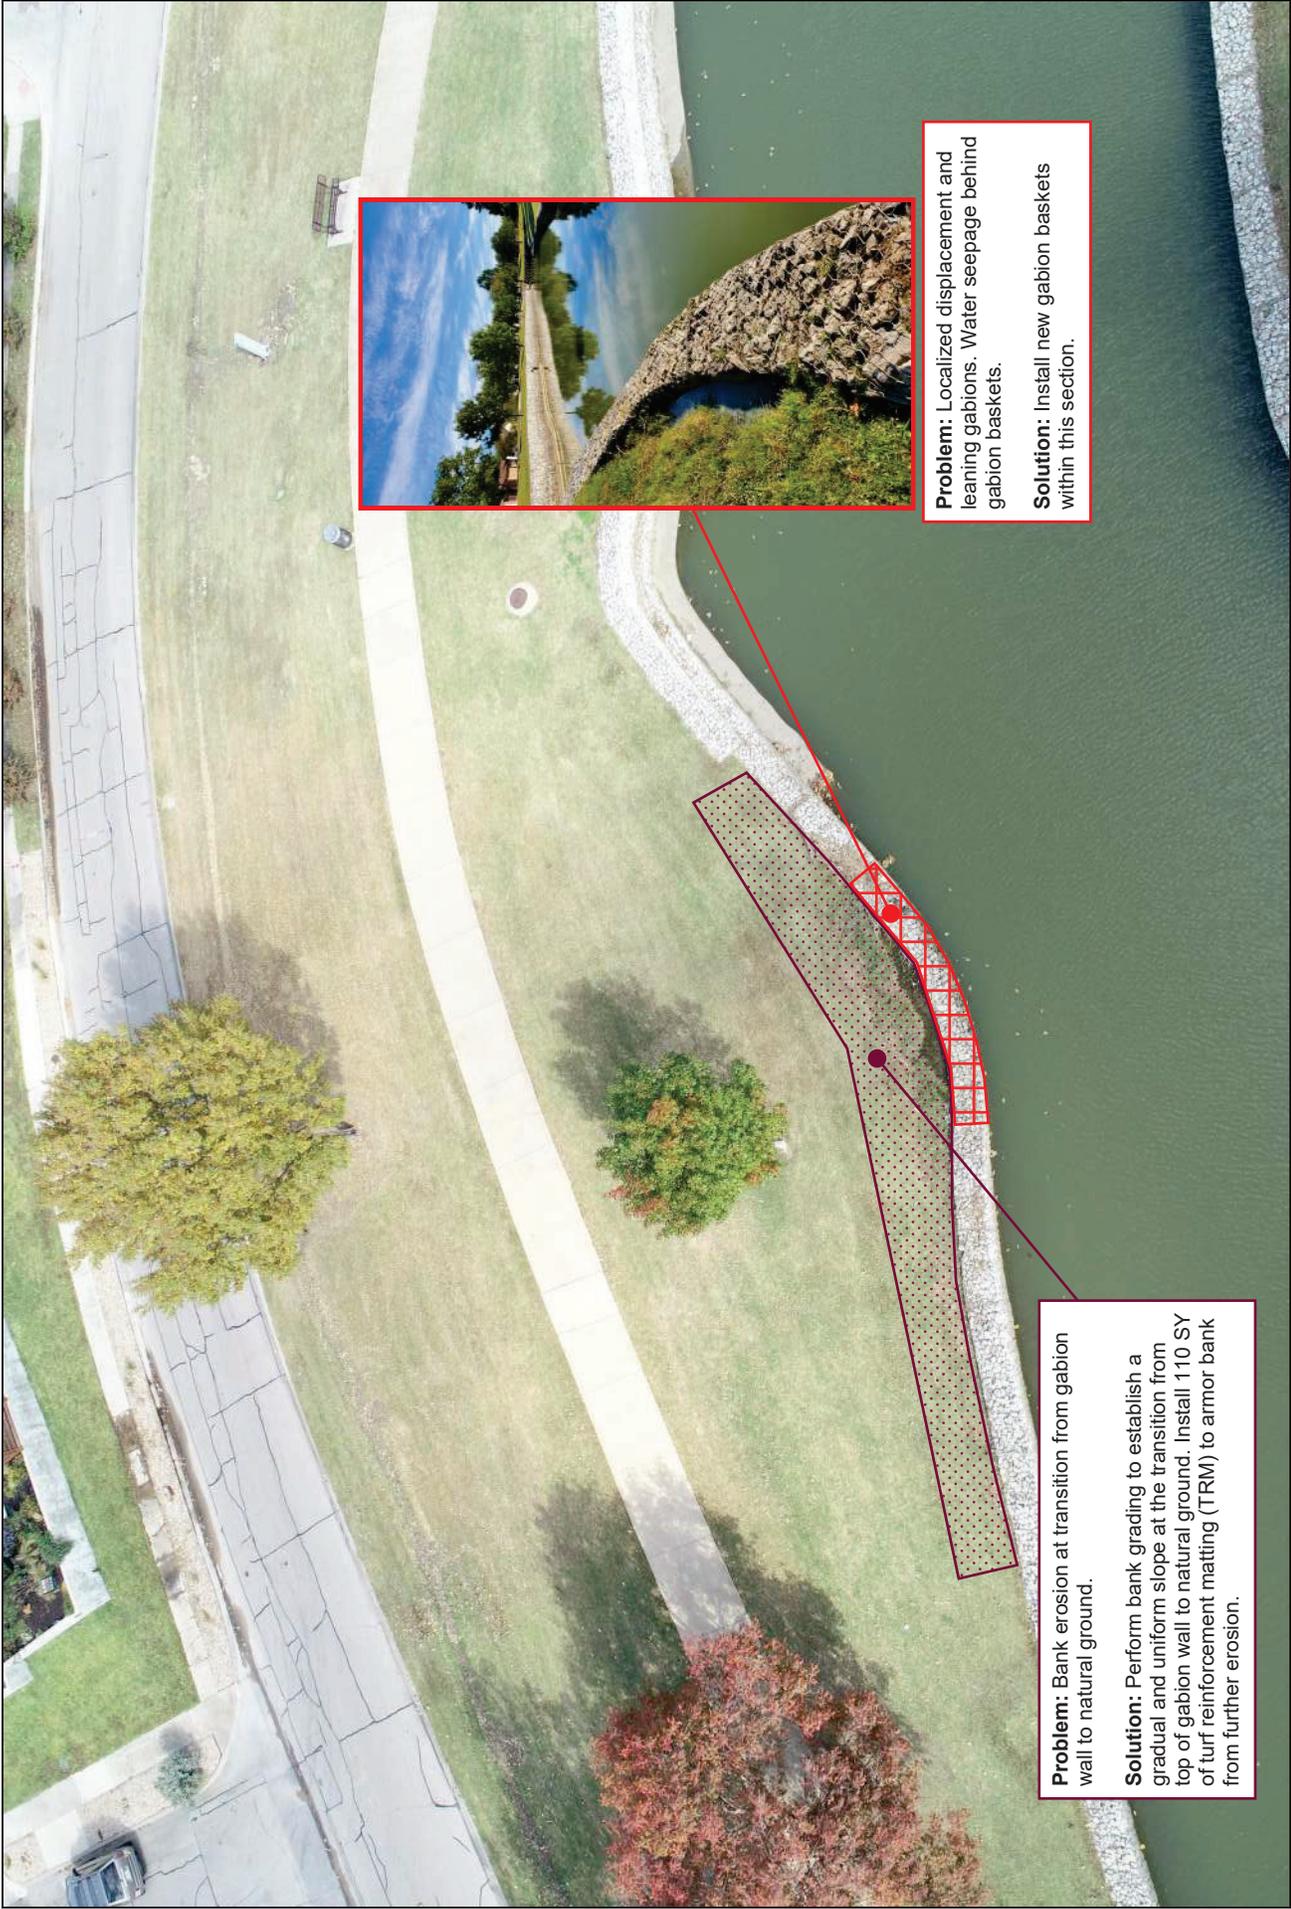
Figure IV. Project Area 3 Proposed Improvement

Problem: Localized displacement and leaning gabions. Water seepage behind gabion baskets.

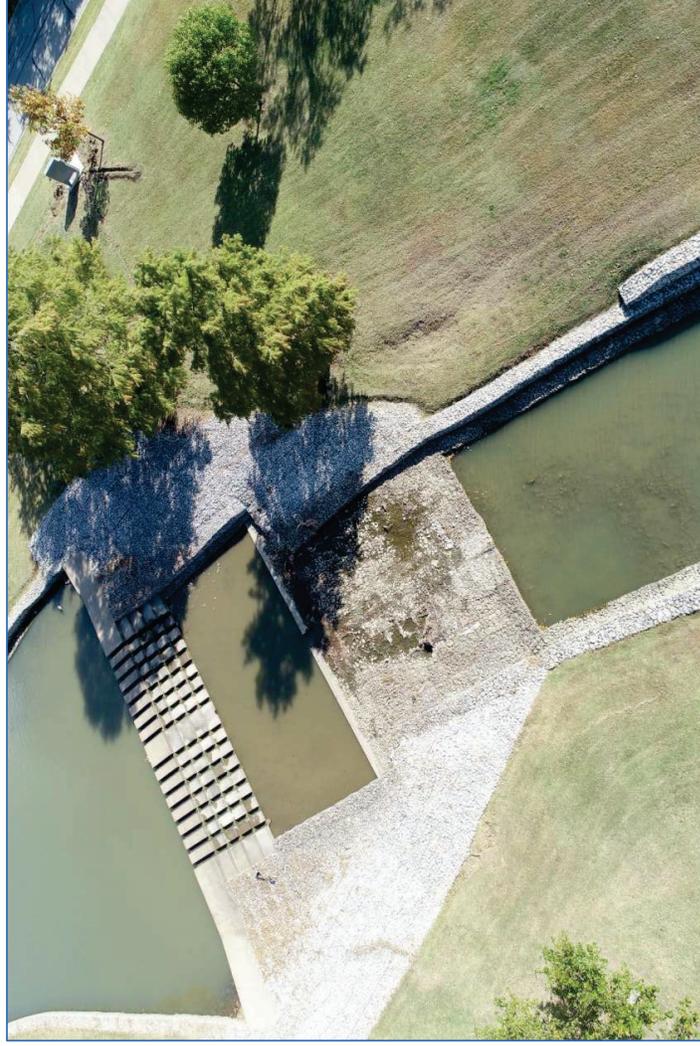
Figure III. Aerial Drone Imagery of Project Area 4.
Shot on DJI Phantom 4 Pro Version 2.0 at 100' agl (above ground level).

Reference Address:	13750 Block of Rawhide Pkwy	
Project Area: 4	Priority: Low	Estimated Cost: \$371,000 (Includes Project Areas 3, 4 & 5)
Problem Description:	Gabion mattress downstream of check-dam damaged due to debris and litter caught within the wiring, which appears to have eventually caused breakage (Images 16 and 17). The adjacent gabion wall along the left bank is leaning in towards the gabion mattress. The upstream check dam does not appear to be undermined by the damaged gabion sections.	
Proposed Improvement:	Repair damaged portions of 12" gabion mattress, including replacing lost rock fill and replacing wire mesh. Remove and replace 20 LF of gabion baskets at connection with existing gabion wall. Remove and dispose of debris.

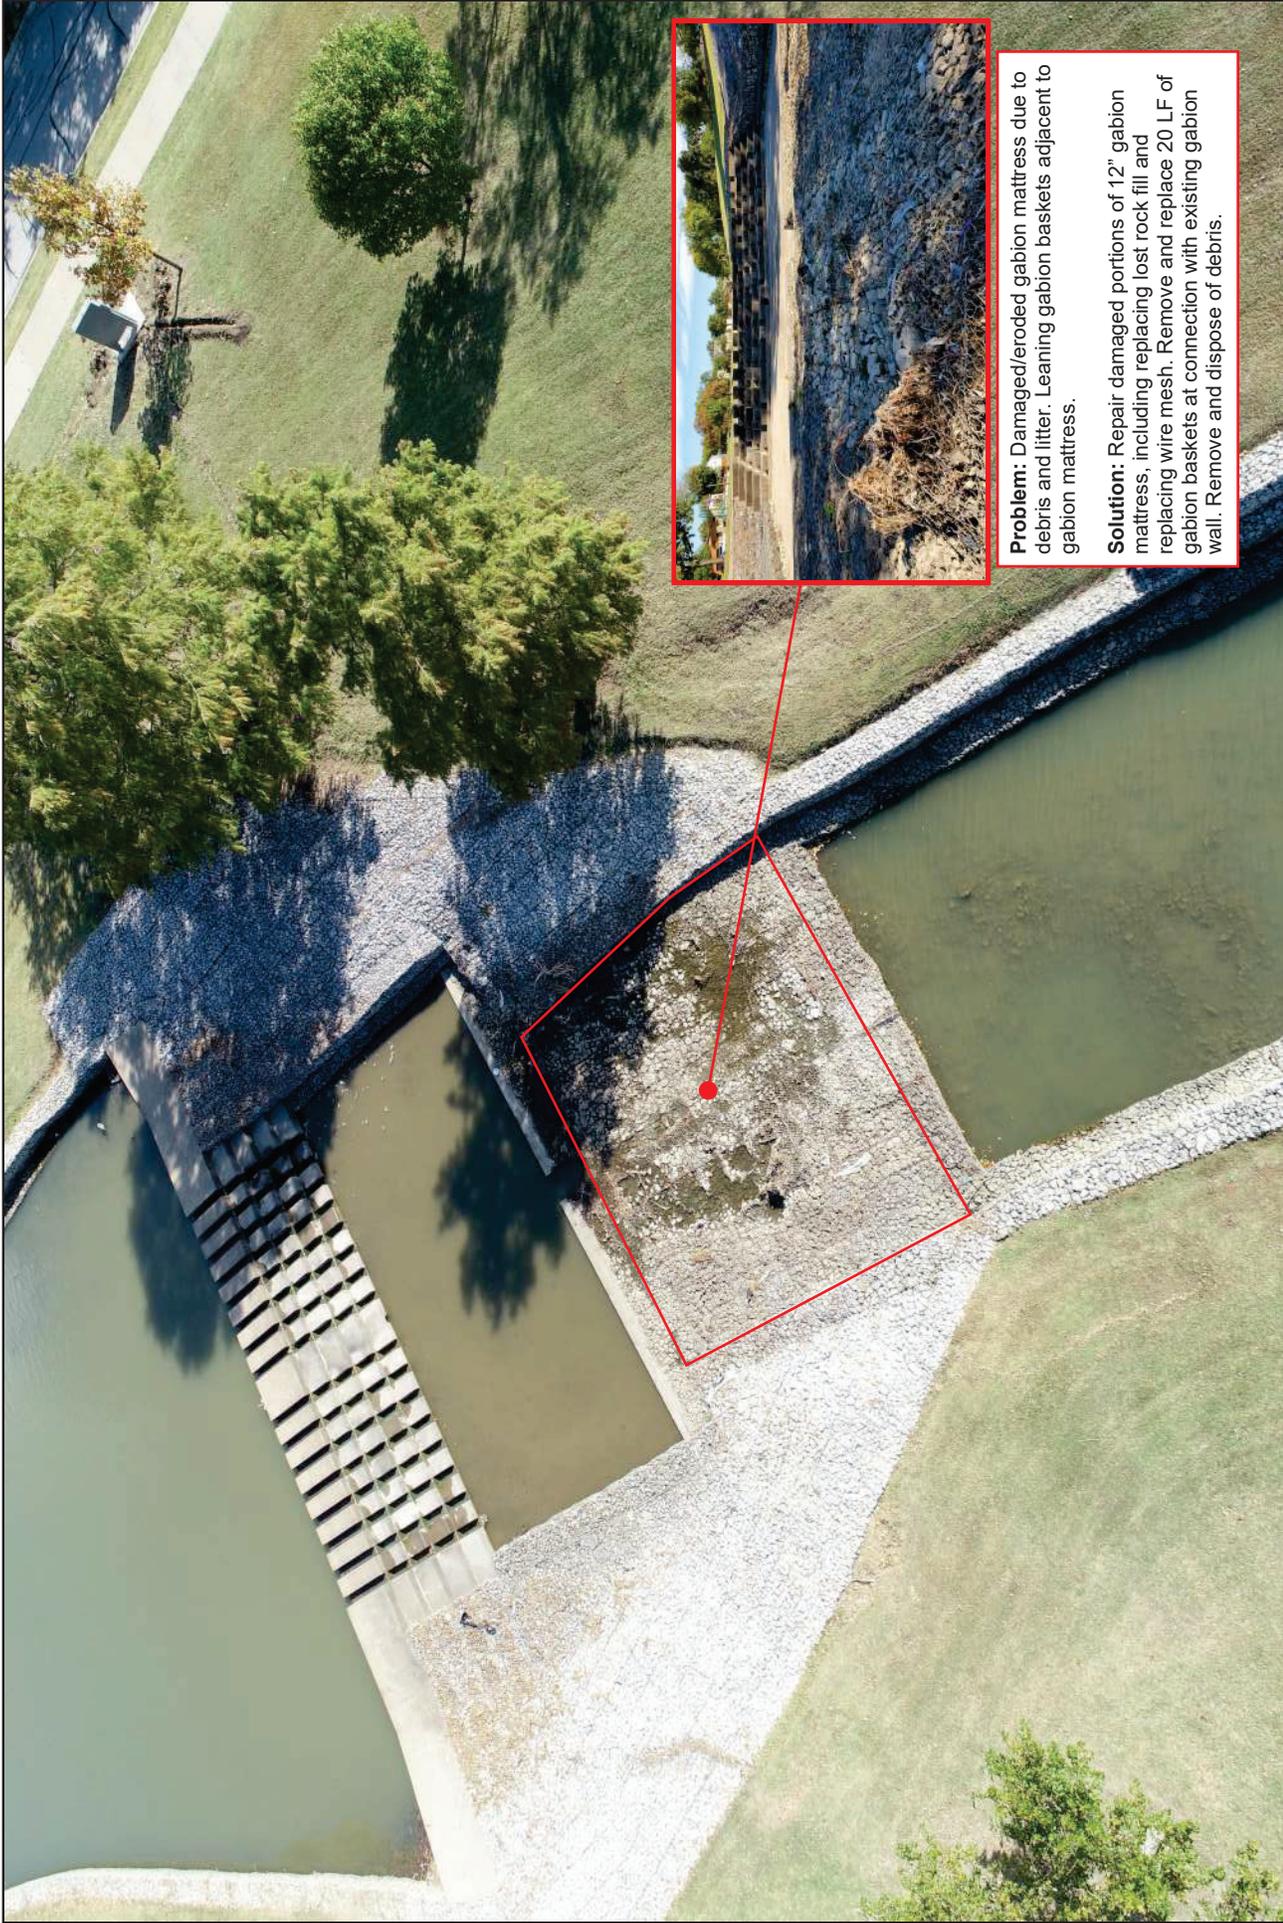
Figure V. Project Area 4

Problem: Damaged/eroded gabion mattress due to debris and litter. Leaning gabion baskets adjacent to gabion mattress.

Solution: Repair damaged portions of 12" gabion mattress, including replacing lost rock fill and replacing wire mesh. Remove and replace 20 LF of gabion baskets at connection with existing gabion wall. Remove and dispose of debris.

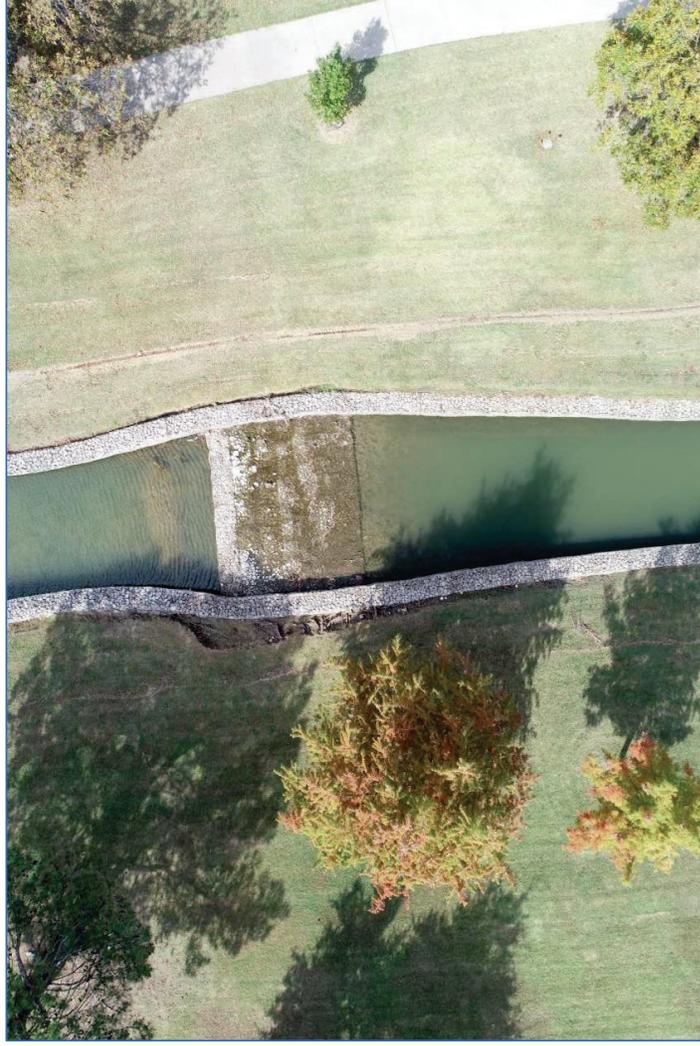
Figure IV. Aerial Drone Imagery of Project Area 5. Shot on DJI Phantom 4 Pro Version 2.0 at 100' agl (above ground level).

Reference Address:	2970 Block of Golfing Green Drive	
Project Area: 5	Priority: Low	Estimated Cost: \$371,000 (Includes Project Areas 3, 4 & 5)
Problem Description:	High erosion along the left bank behind the gabion wall directly downstream of the Tom Field Road intersection (Image 19). Gabion baskets are leaning inwards towards the creek (Image 18). Gabion mattress in creek does not have significant damage.	
Proposed Improvement:	Remove and replace 50 LF of gabion wall. Perform bank grading to establish a gradual and uniform slope at the transition from top of gabion wall to natural ground. Install 890 SY of TRM to armor bank from further erosion. Tie TRM to gabion wall to prevent seepage behind wall.

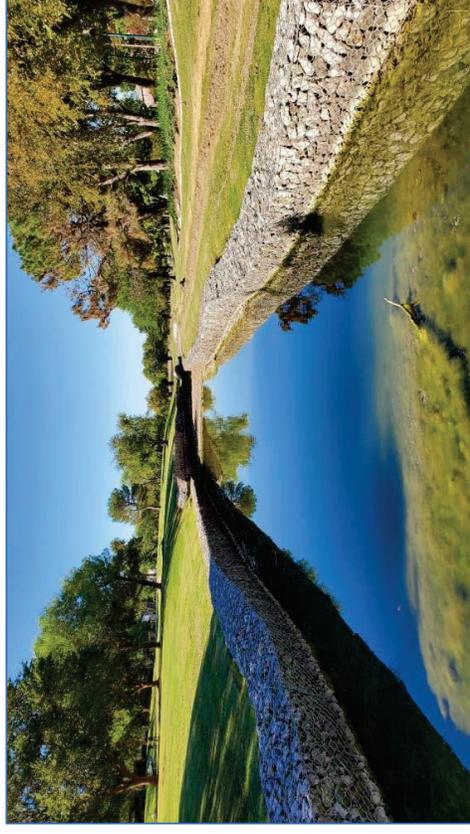
Image 18. Looking downstream at leaning gabion wall due to erosion along the left bank.

Solution: Replace 50 LF of leaning gabion wall by installing new gabion baskets.

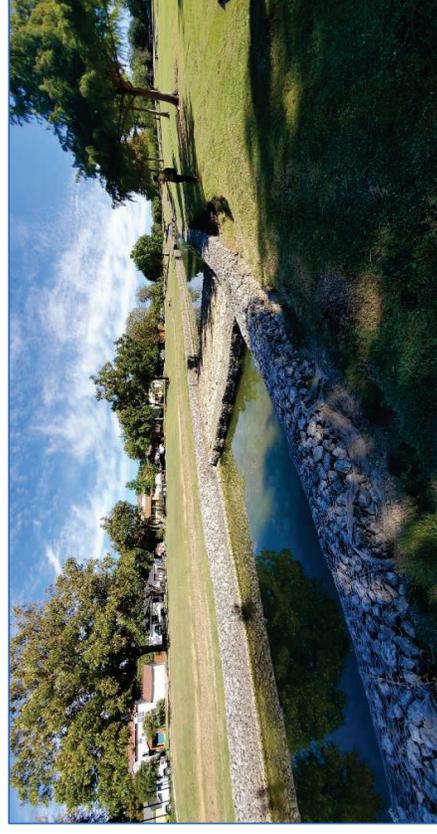
Image 19. Side profile of erosion along bank easement.

Solution: Perform bank grading to establish a gradual and uniform slope at the transition from top of gabion wall to natural ground. Install 890 SY of TRM to armor bank from further erosion.

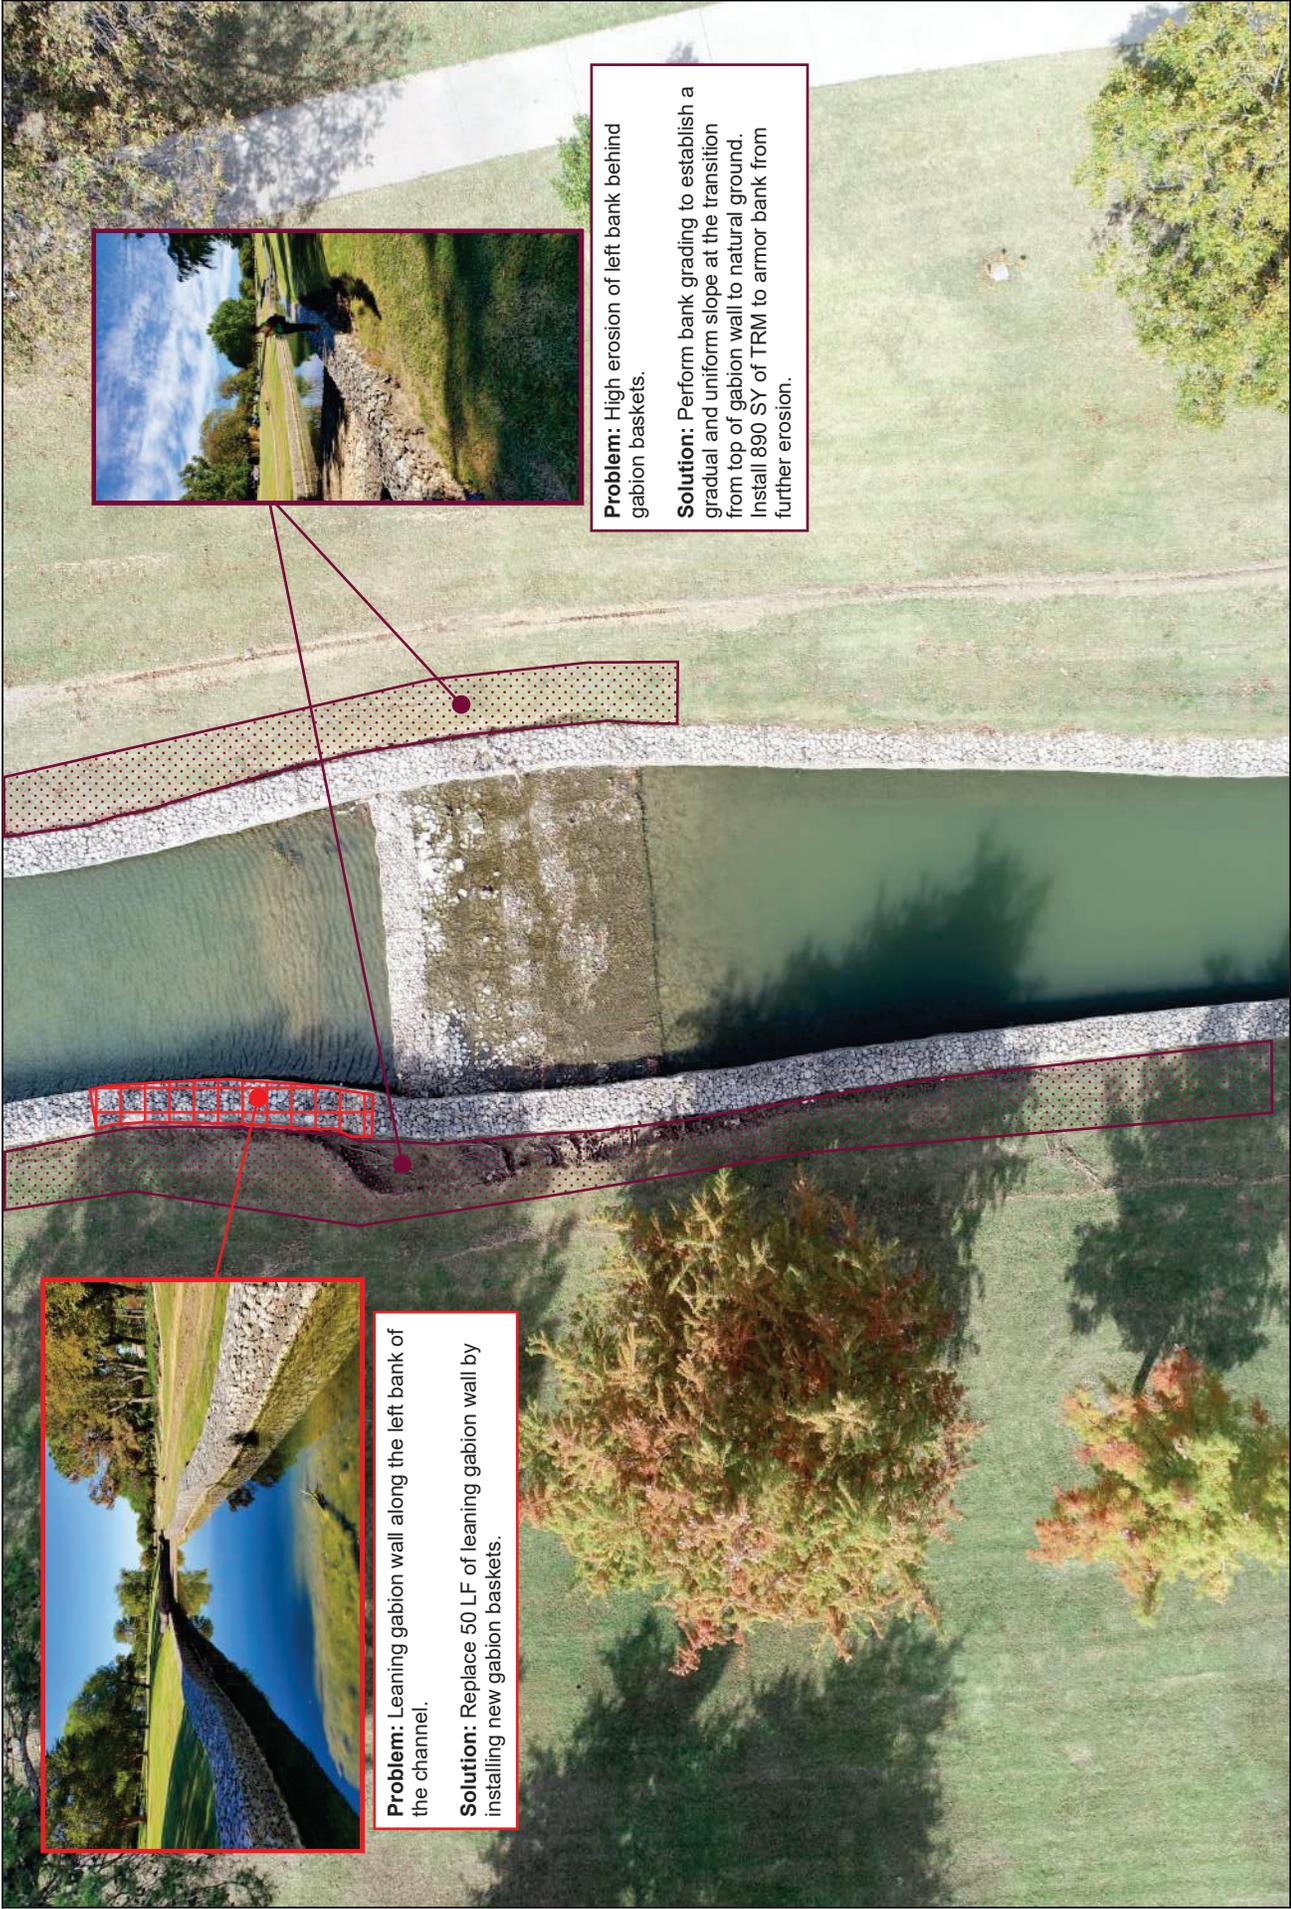
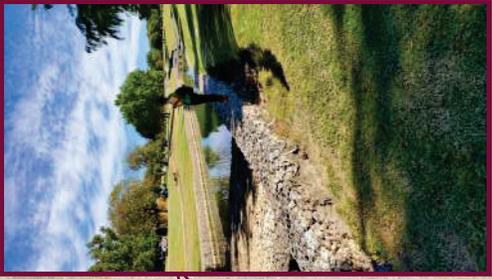
Problem: High erosion of left bank behind gabion baskets.

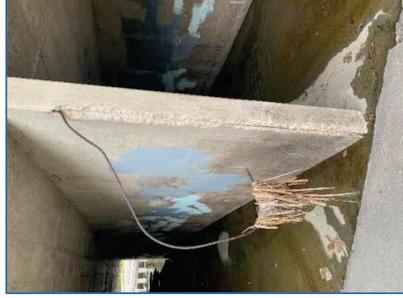
Image 22. Exposed rebar within culvert.

Problem: Exposed reinforcing steel at connection wingwalls to culvert barrel.
Solution: Seal joints at wingwalls and culvert.

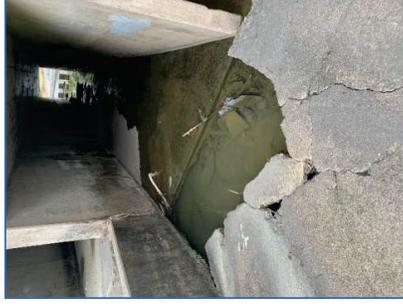
Image 23. Water percolation within concrete riprap.

Problem: Concrete apron/riprap severely damaged.
Solution: Replace concrete apron/riprap.

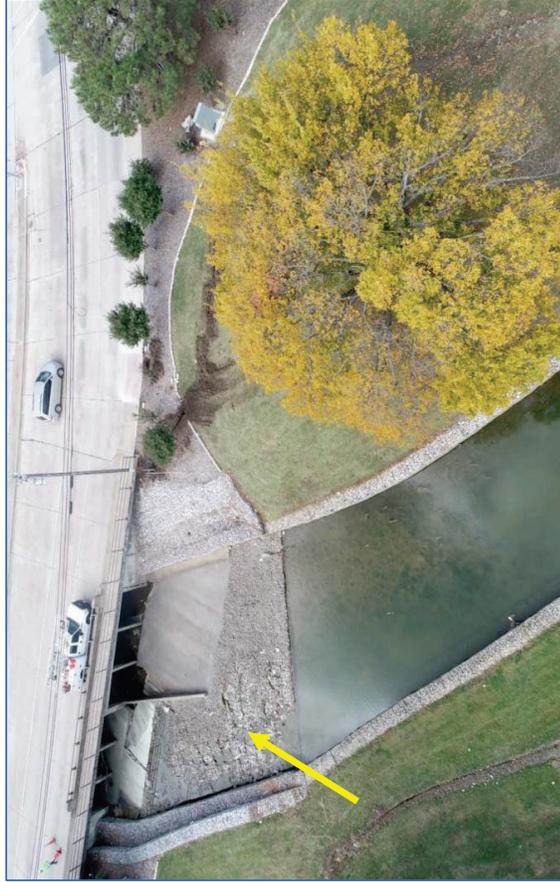
Figure V. Aerial Drone Imagery of Project Area 6. Shot on DJI Phantom 4 Pro Version 2.0 at 100' agl (above ground level).

Reference Address:	13450 Josey Lane	
Project Area:	Priority:	Estimated Cost:
Problem Description:	High	\$394,000
Proposed Improvement:	<p>Upstream apron is damaged (Figure V). Upstream concrete riprap is severely damaged (Image 20). There is water flowing under the concrete riprap from the high side to the entrance of the culvert. Possibility of water flowing under the culvert and forming cavities should be investigated. There is no way to confirm whether there is a cut off wall at the upstream side of culvert without excavation and no record drawings are available.</p> <p>There are concrete spalls and rusted reinforcing at both ends at wingwall and culvert connection (Image 21). A corner reinforcing bar is exposed and bent out at upstream end (Image 22)</p> <p>Clean corroded exposed reinforcing and repair spalls. Seal joints at wingwalls and culvert. Replace damaged concrete riprap and apron. Investigate possible soil loss under the culvert. Fill voids by pumping fill material (flowable fill). Perform a site visit to verify whether the items noted in TXDOT inspection, conducted on 5/22/2019, have expanded.</p>

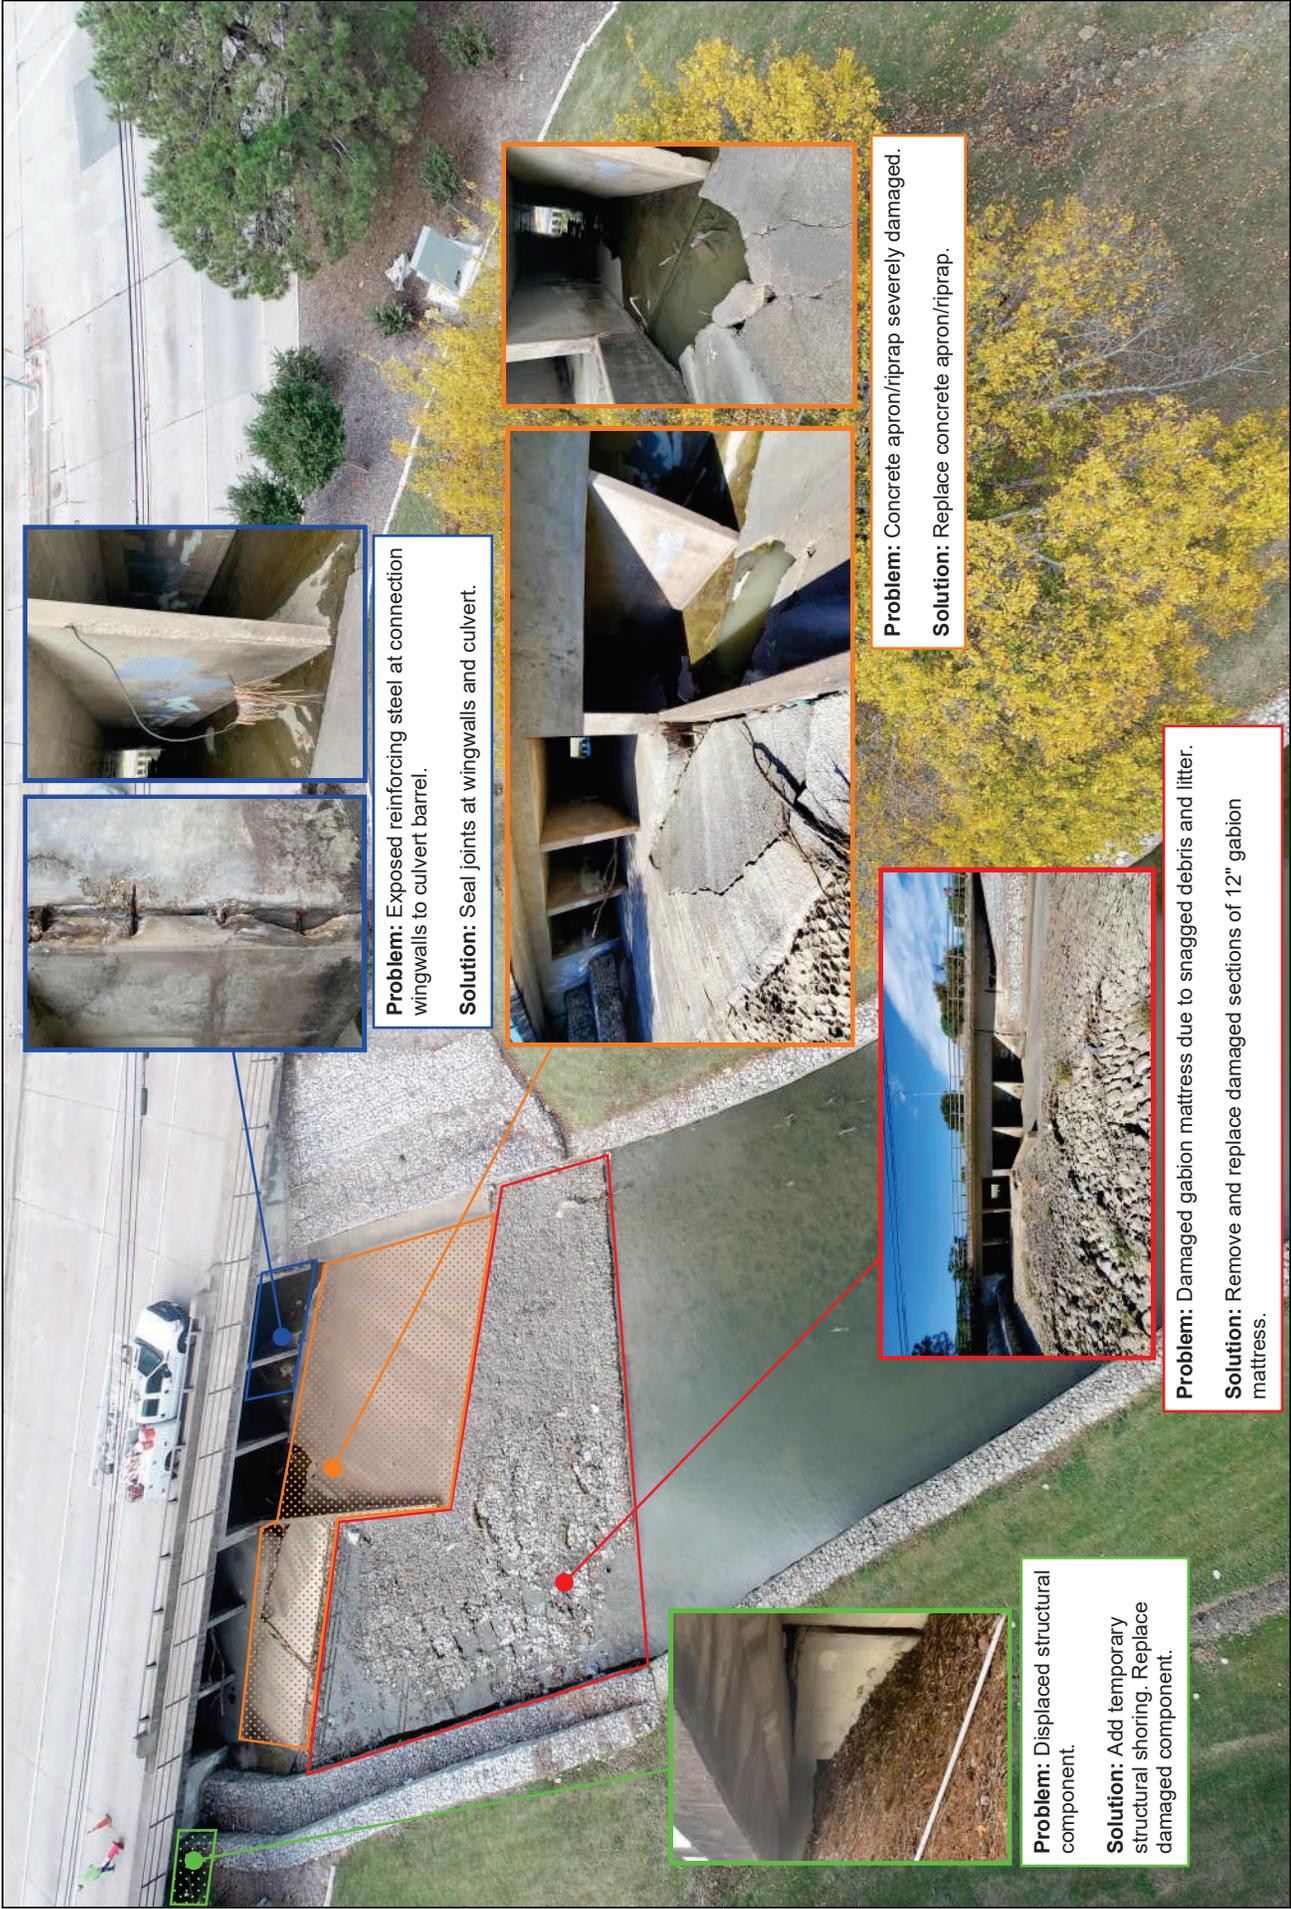
Figure VII. Project Area 6

Problem: Displaced structural component.
Solution: Add temporary structural shoring. Replace damaged component.

Problem: Damaged gabion mattress due to snagged debris and litter.
Solution: Remove and replace damaged sections of 12" gabion mattress.
