Rawhide Creek Infrastructure Assessment

Final Technical Memorandum

December 18, 2020

TO: Marc Bentley, PE
FROM: David Rivera, PhD, PE, CFM
SUBJECT: Rawhide Creek Infrastructure Assessment
DATE: 12/18/2020
PROJECT: FBR20638 – Rawhide Infrastructure Assessment

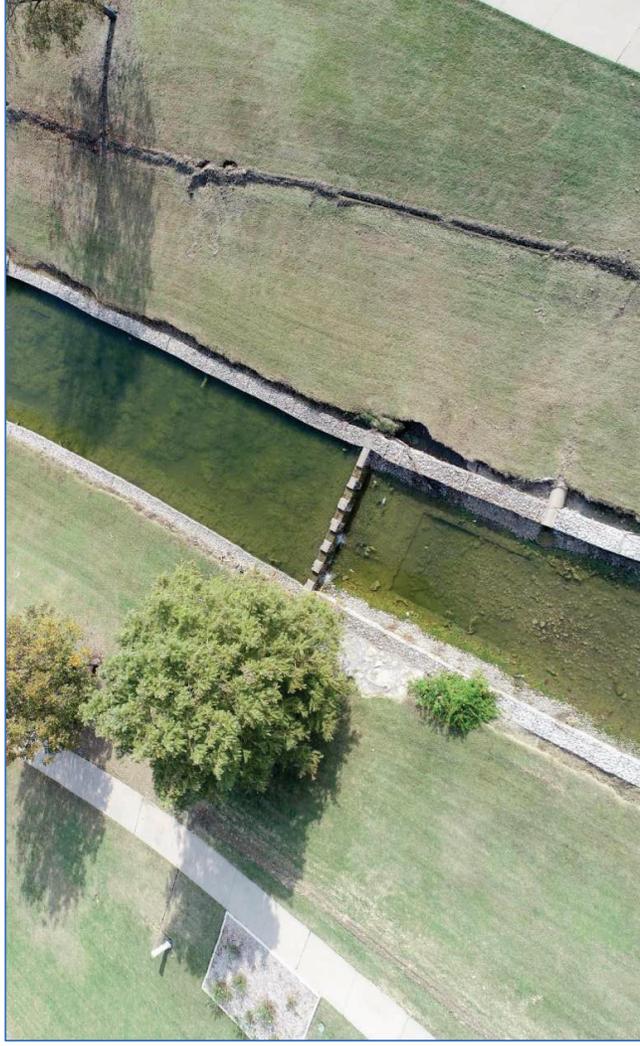
Figure VI. Aerial Drone Imagery of Project Area 7.
Shot on DJI Phantom 4 Pro Version 2.0 at 100' agl (above ground level).

Reference Address:	2850 Golfing Green Drive
Project Area: 7	Priority: Low
Problem Description:	High erosion of left and right banks behind gabion wall. Exposed concrete outfall pipe within the gabion baskets along the left bank (Figure VI and Image 24).
Proposed Improvement:	Backfill and grade behind gabion wall to establish a gradual and uniform slope at the transition from top of gabion wall to natural ground. Install 880 SY of TRM to armor bank from further erosion. Tie TRM to gabion wall to prevent seepage behind wall. Stabilize stormwater outfall during bank repairs.

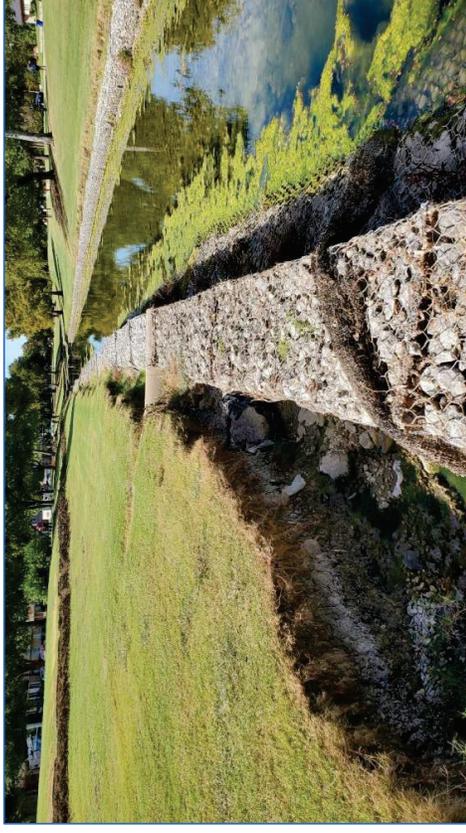
Image 24. Erosion of earthen material adjacent to gabion wall and exposed outfall pipe.

Problem: Exposed concrete outfall pipe within gabion wall.
Solution: Stabilize pipe outfall during bank repairs.

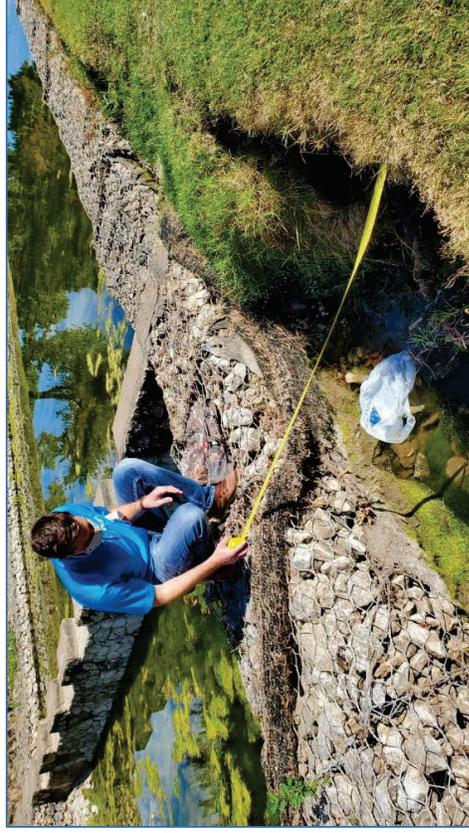
Image 25. Side profile of erosion along bank easement.

Problem: High erosion of left and right banks behind gabion baskets.
Solution: Backfill and grade behind gabion wall to establish a gradual and uniform slope at the transition from top of gabion wall to natural ground. Install 880 SY of TRM to armor bank from further erosion.

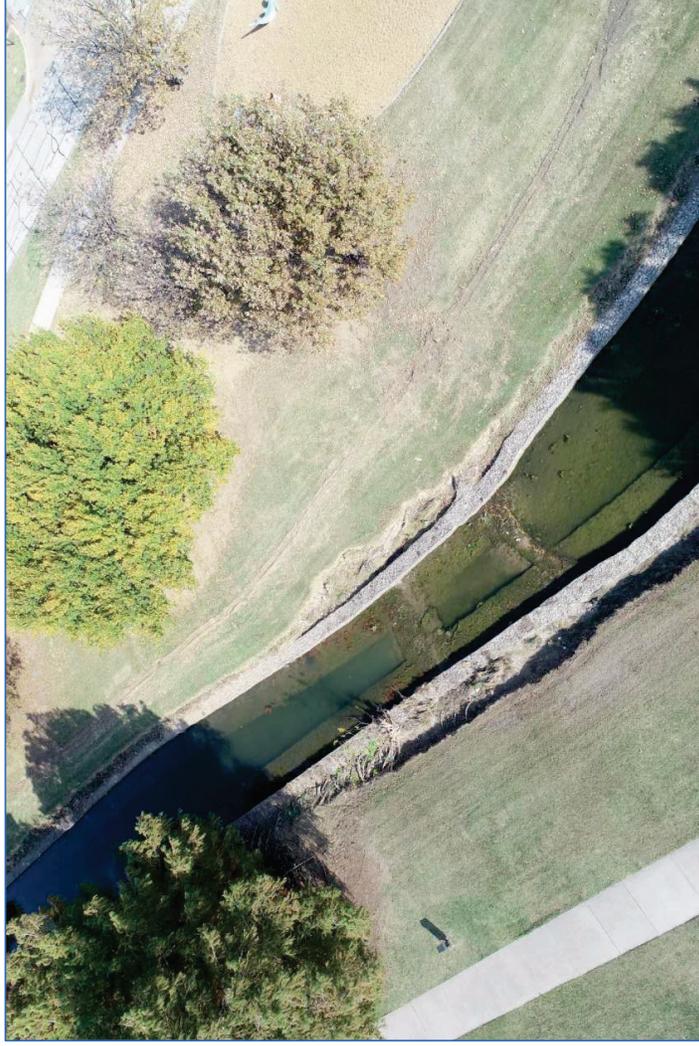
Figure VII. Aerial Drone Imagery of Project Area 8.
Shot on DJI Phantom 4 Pro Version 2.0 at 100' agl (above ground level).

Reference Address:	2800 Golfing Green Drive
Project Area: 8	Priority: Low
Problem Description:	Estimated Cost: \$834,000 (Includes Project Areas 7, 8, & 9) Erosion behind gabion walls along both the left and right banks of the channel. Steep drops in the terrain elevations adjacent to the gabion channel lining.
Proposed Improvement:	Backfill and grade behind gabion wall to establish a gradual and uniform slope at the transition from top of gabion wall to natural ground. Install 720 SY of TRM to armor bank from further erosion. The TRM to gabion wall to prevent seepage behind wall. Remove and replace damaged gabion baskets. Install an additional row of gabion baskets, approximately 775 LF, to help meet grade in areas with drastic changes of elevation between natural ground and top of wall.

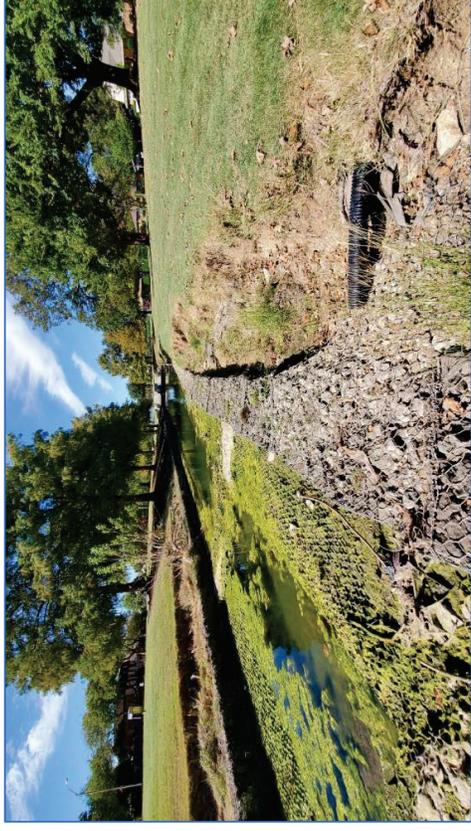
Image 26. Upstream view of Golfing Green Drive erosion along the right bank.

Solution: Backfill and grade behind gabion wall to establish a gradual and uniform slope at the transition from top of gabion wall to natural ground. Install 720 SY of TRM to armor bank from further erosion.

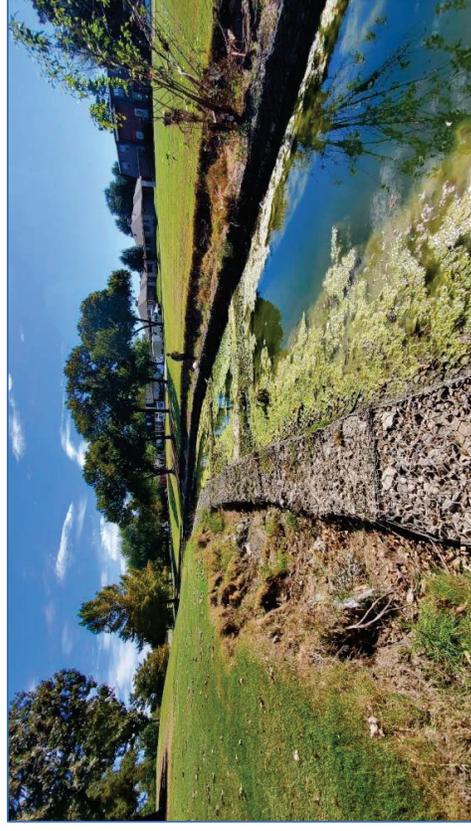
Image 27. Downstream view of Golfing Green Drive erosion along the right bank.

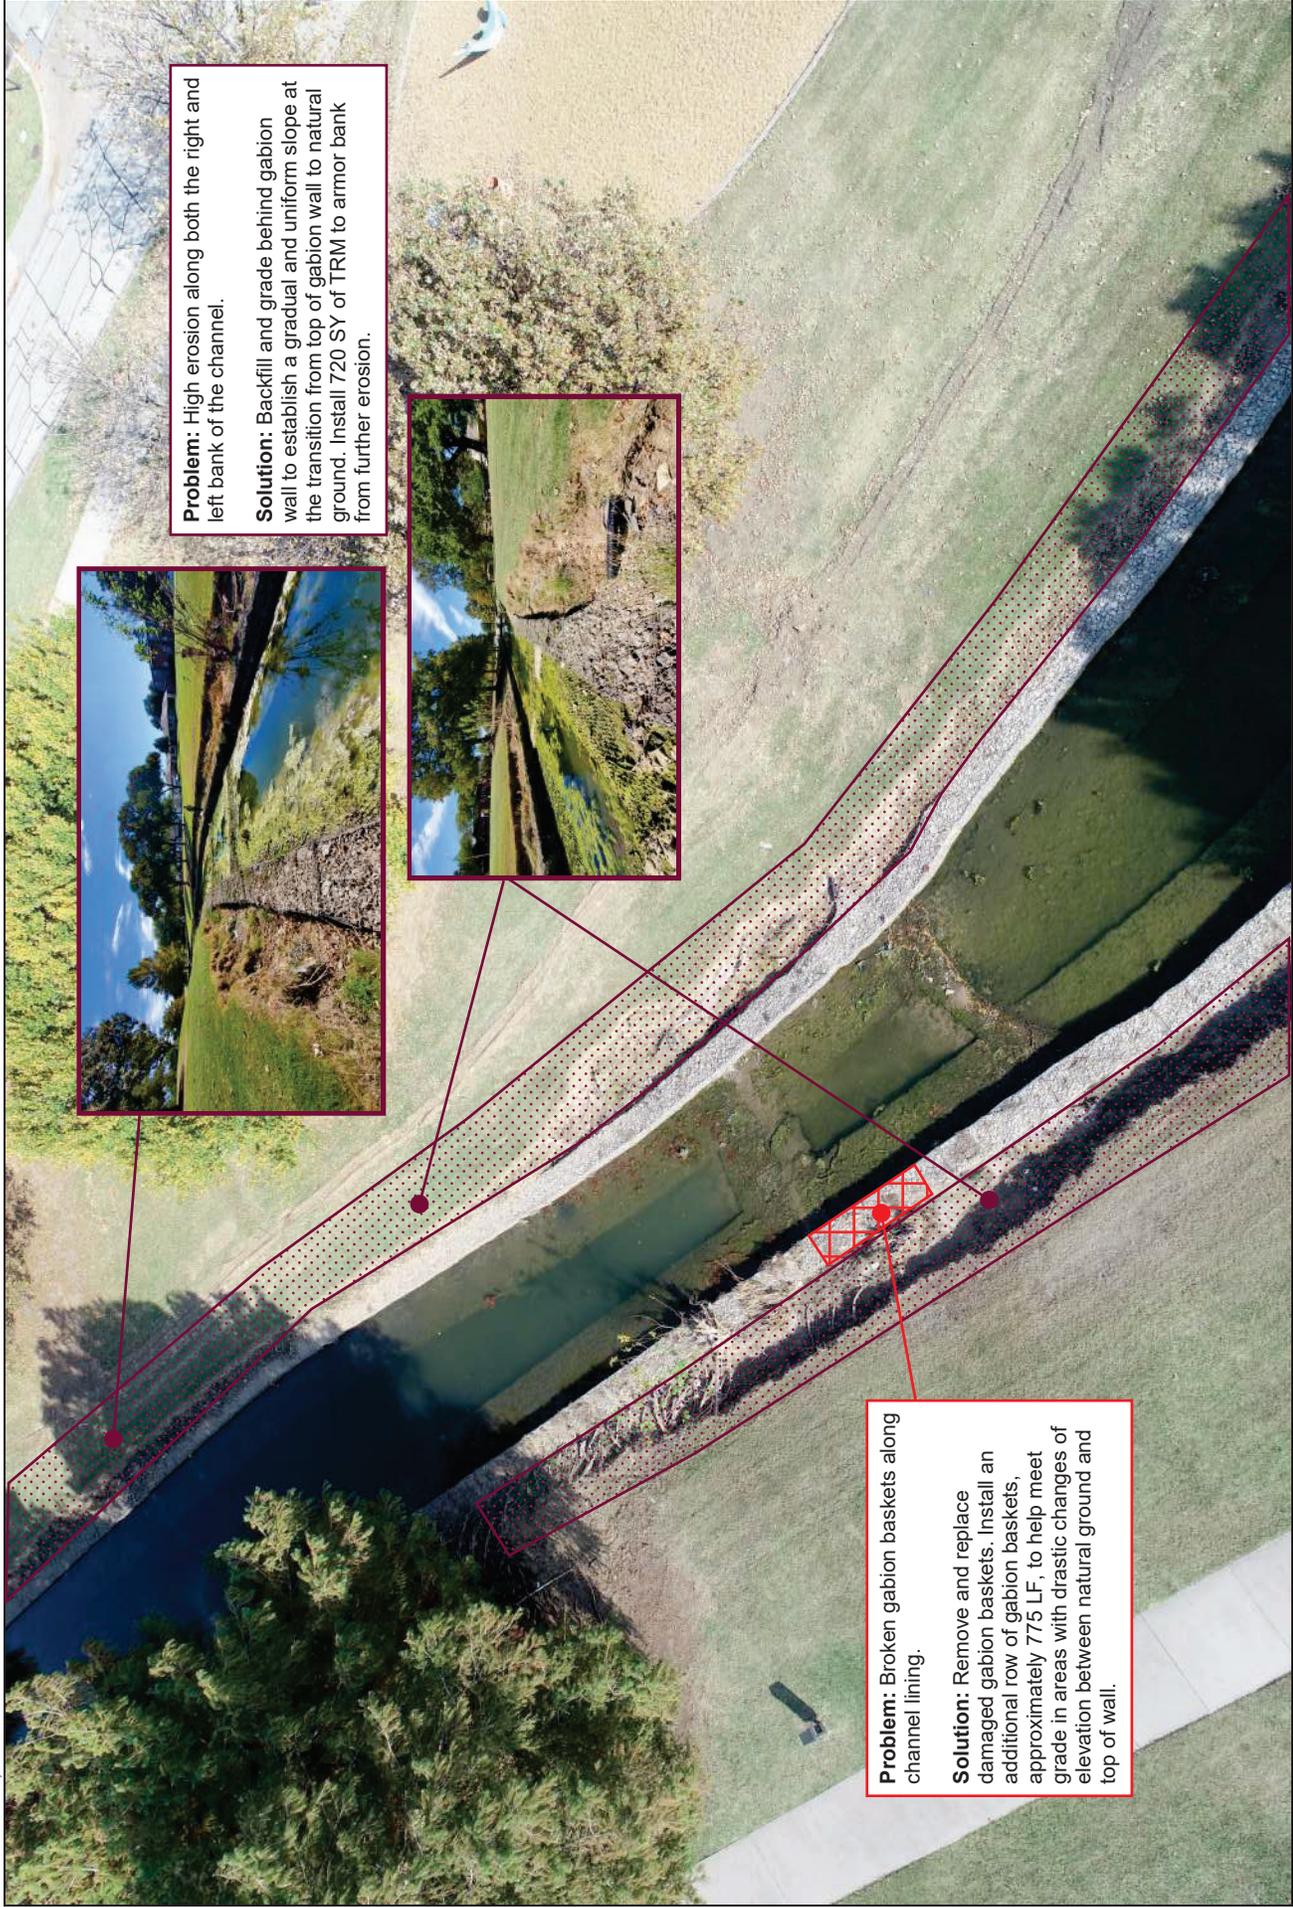
Problem: High erosion along both the right and left bank of the channel.

Problem: Broken gabion baskets along channel lining.

Solution: Remove and replace damaged gabion baskets. Install an additional row of gabion baskets, approximately 775 LF, to help meet grade in areas with drastic changes of elevation between natural ground and top of wall.

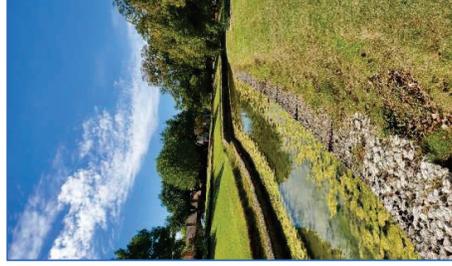
Image 29. Elevation changes along right bank (upstream view).

Problem: Drastic changes in slope behind gabion wall.
Solution: Extend additional gabion basket row along the right bank.

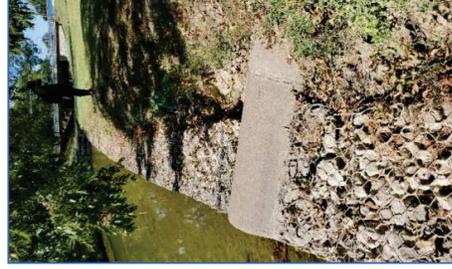
Image 30. Exposed storm sewer line.

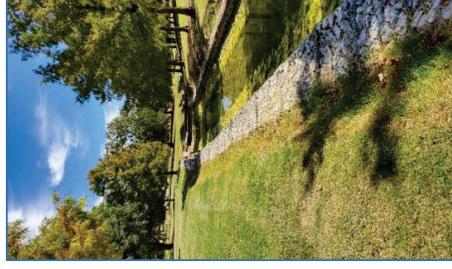
Image 31. Elevation changes along right bank (downstream view).

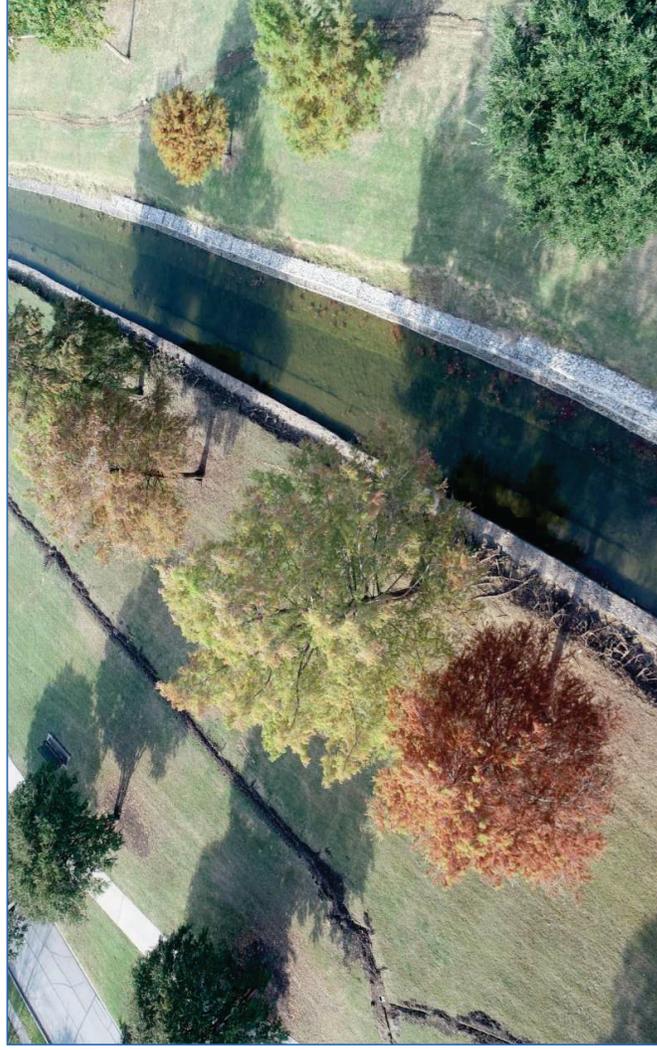
Figure VIII. Aerial Drone Imagery of Project Area 9. Shot on DJI Phantom 4 Pro Version 2.0 at 100' agl (above ground level).

Reference Address:	13500 Heartside Place
Project Area: 9	Priority: Low
Problem Description:	Estimated Cost: \$834,000 (Includes Project Areas 7, 8, & 9) Sharp drops in terrain elevations – potential pedestrian safety hazard, specifically along the right side of the channel adjacent to the jogging trail (Image 28). Erosion behind gabion wall/baskets (Image 29). Exposed concrete outfall pipe within the gabion baskets along the right bank (Image 29).
Proposed Improvement:	Backfill and grade behind gabion wall to establish a gradual and uniform slope at the transition from top of gabion wall to natural ground. Install 610 SY of TRM to armor bank from further erosion. Tie TRM to gabion wall to prevent seepage behind wall. Remove and replace damaged gabion baskets. Install an additional layer of gabion wall, 275 LF, to help meet grade in areas with drastic changes of elevation between natural ground and top of wall. Stabilize stormwater outfall during bank repairs.

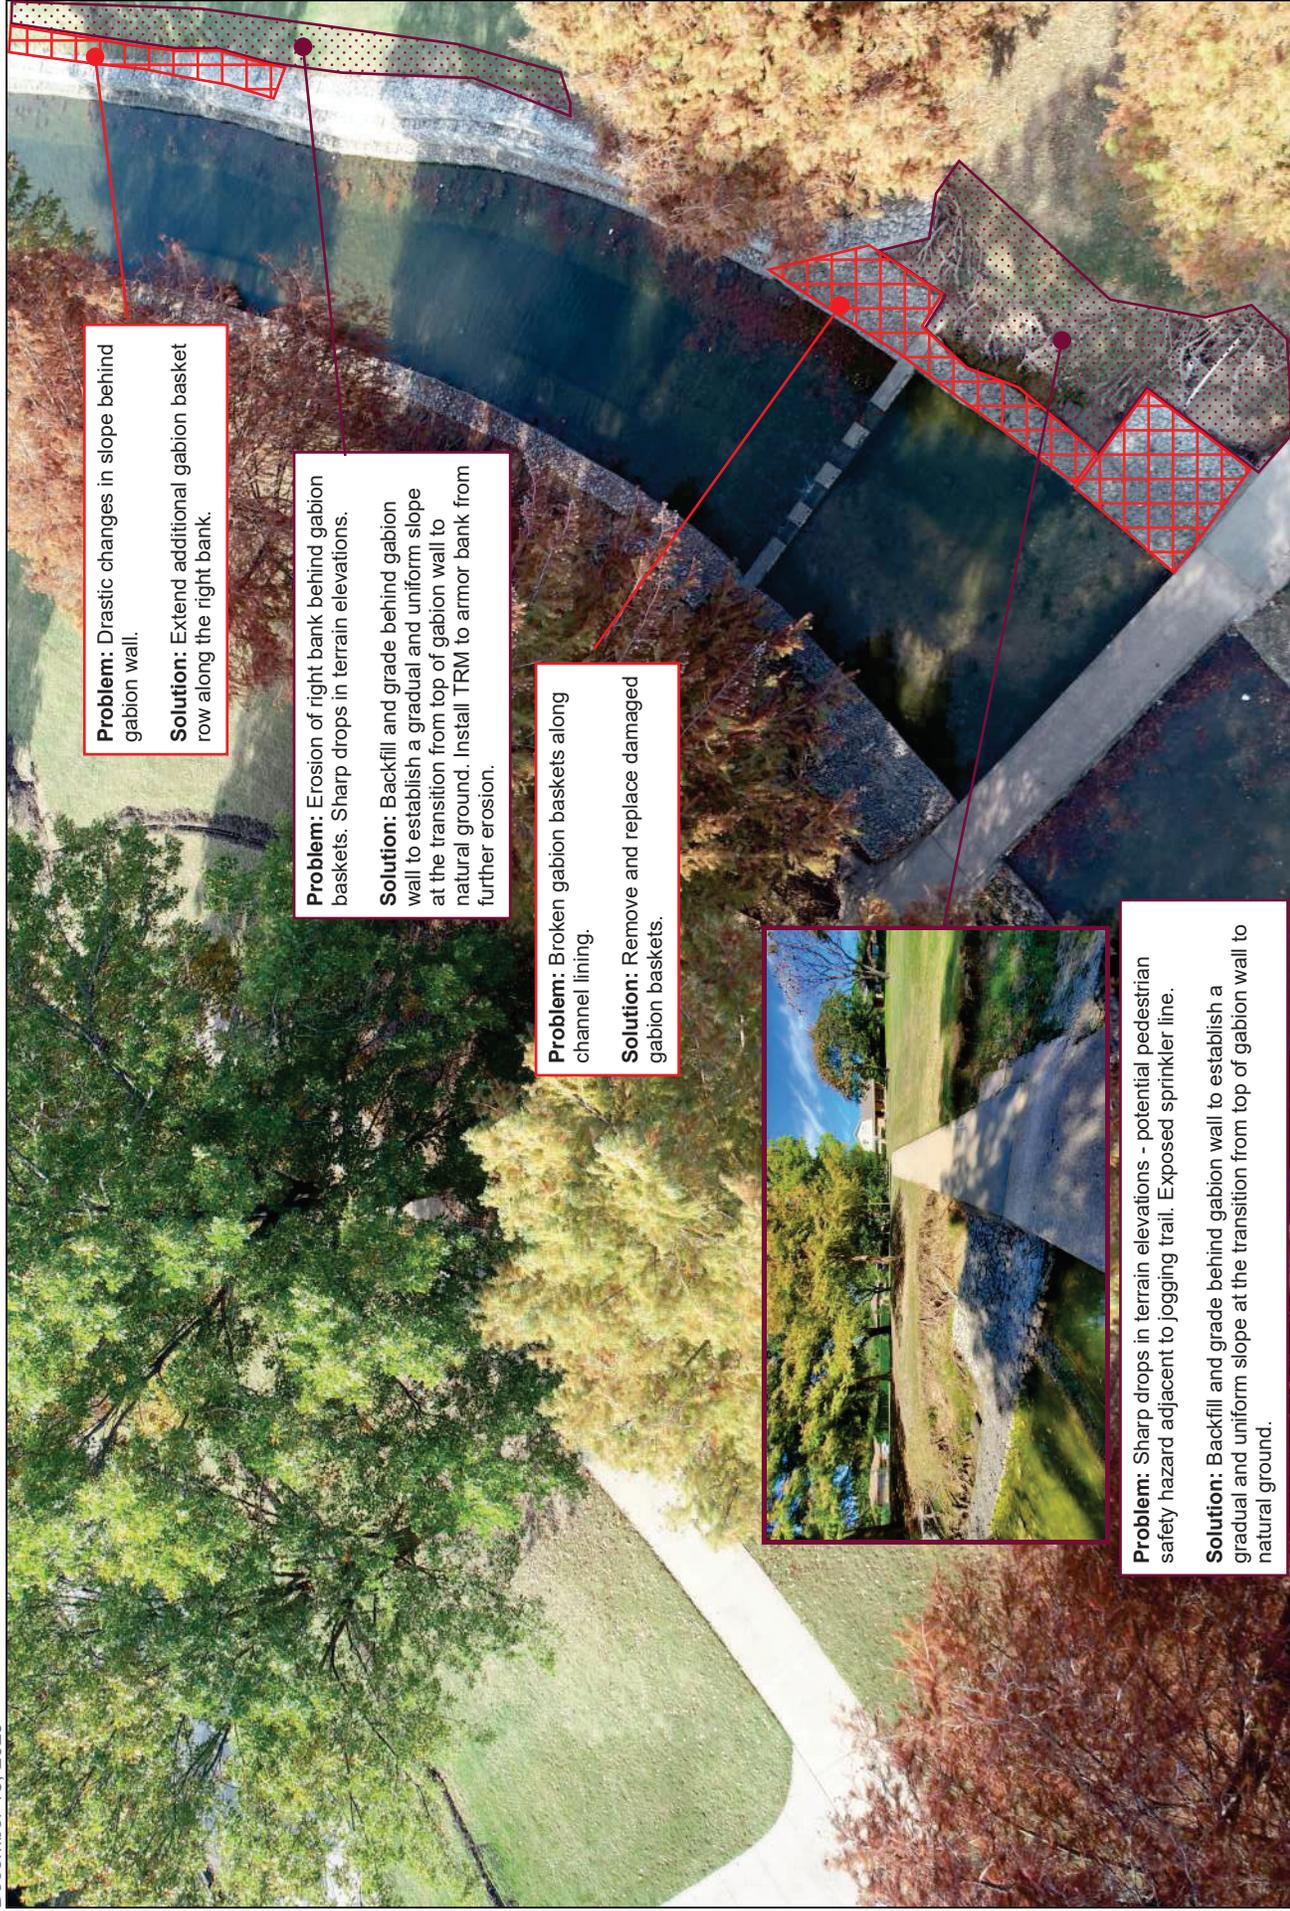
Problem: Erosion of right bank behind gabion baskets. Sharp drops in terrain elevations.
Solution: Backfill and grade behind gabion wall to establish a gradual and uniform slope at the transition from top of gabion wall to natural ground. Install TRM to armor bank from further erosion.

Problem: Broken gabion baskets along channel lining.
Solution: Remove and replace damaged gabion baskets.

Problem: Sharp drops in terrain elevations - potential pedestrian safety hazard adjacent to jogging trail. Exposed sprinkler line.
Solution: Backfill and grade behind gabion wall to establish a gradual and uniform slope at the transition from top of gabion wall to natural ground.

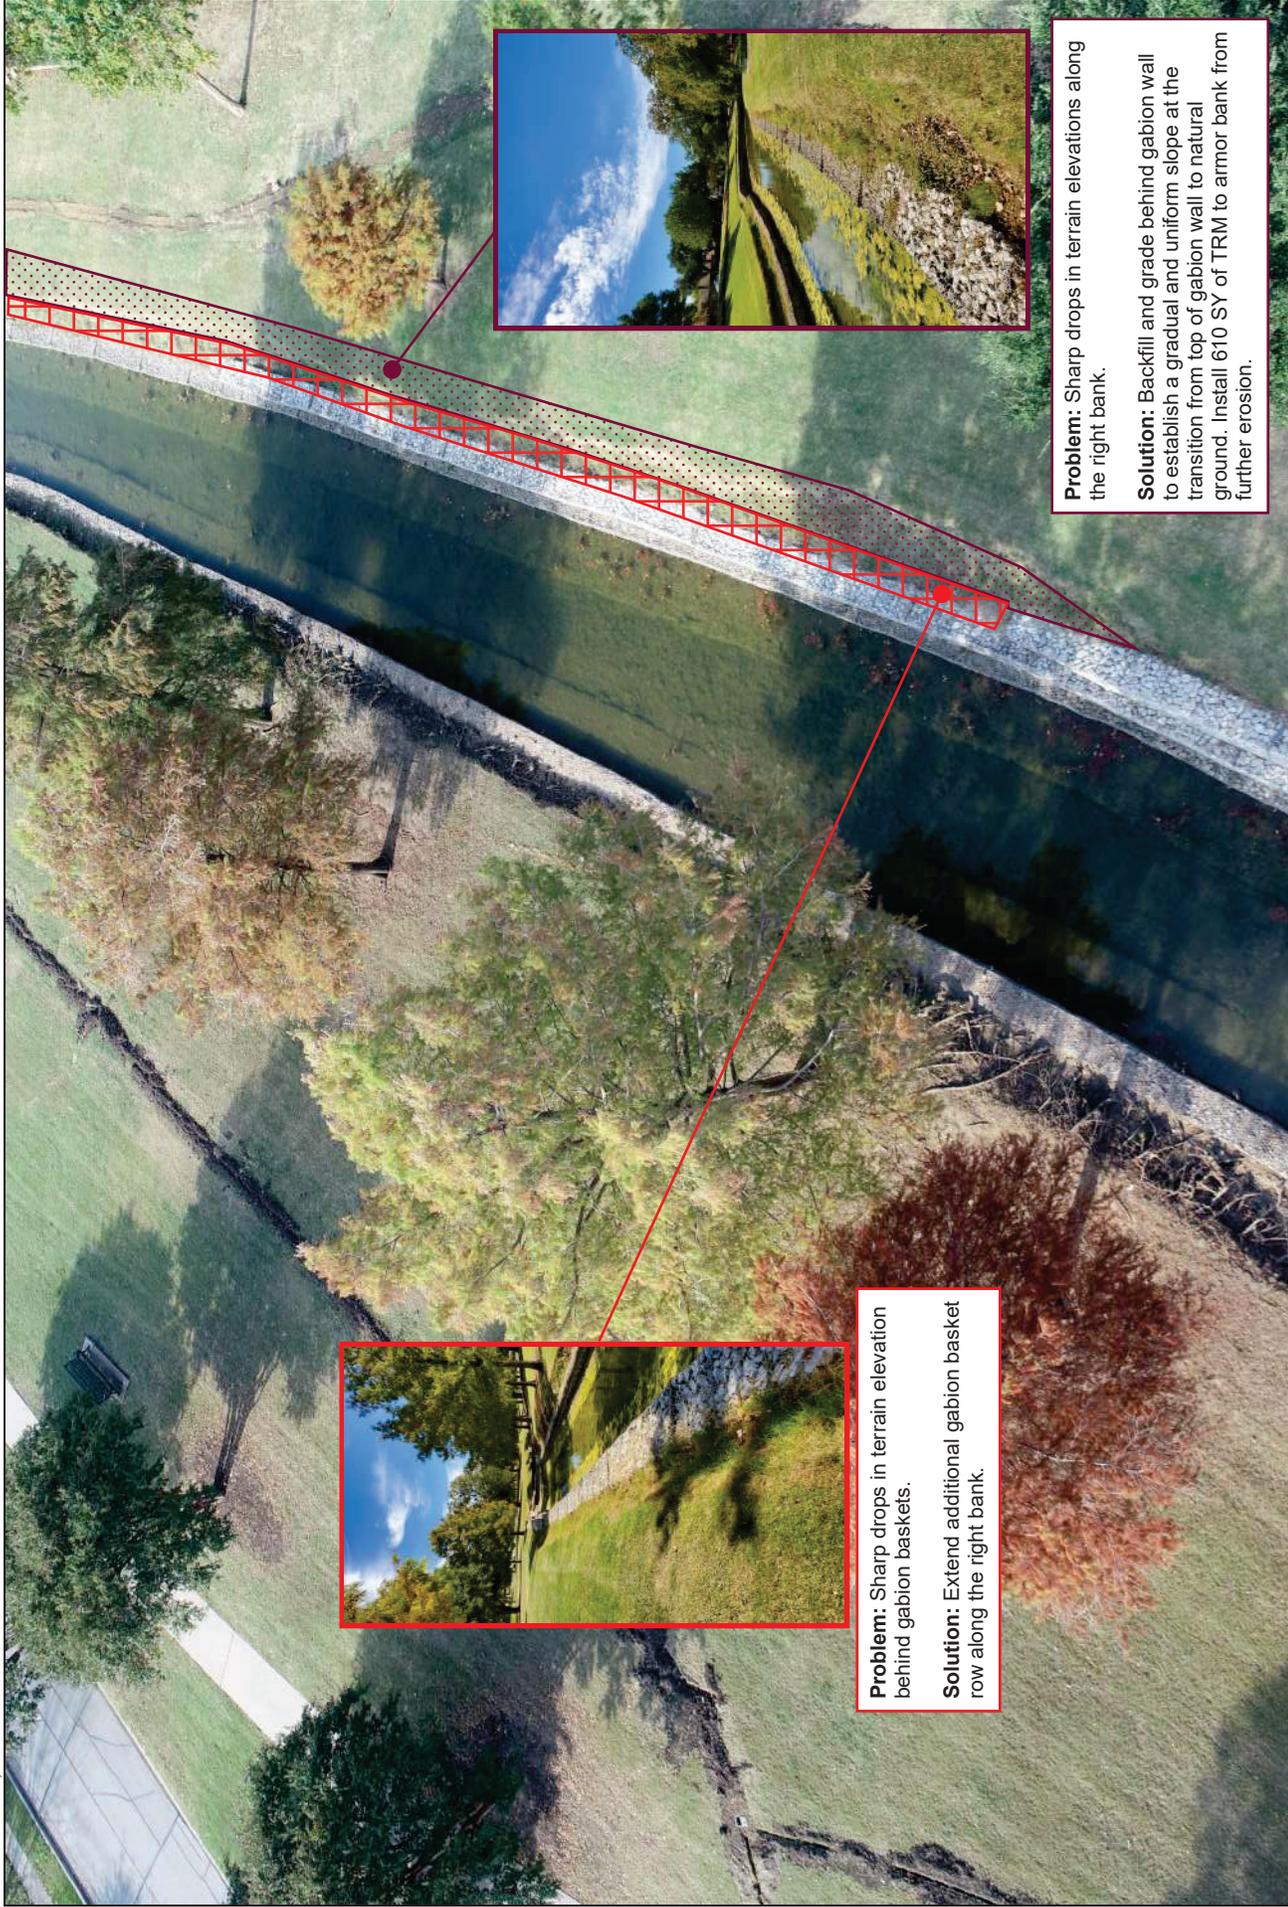
Figure X. Project Area 9 (US)

Problem: Sharp drops in terrain elevation behind gabion baskets.
Solution: Extend additional gabion basket row along the right bank.

Problem: Sharp drops in terrain elevations along the right bank.
Solution: Backfill and grade behind gabion wall to establish a gradual and uniform slope at the transition from top of gabion wall to natural ground. Install 610 SY of TRM to armor bank from further erosion.

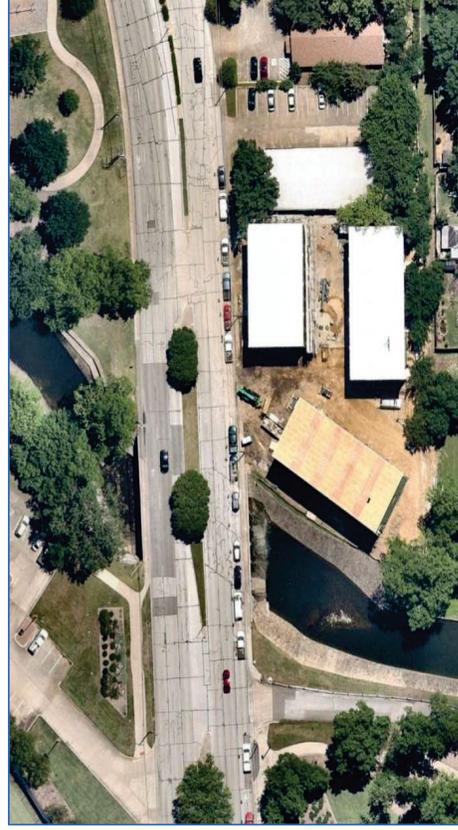
Reference Address:	2800 Rawhide Drive (Valley View Lane)
Project Area: 10	Priority: High Estimated Cost: \$650,000
Problem Description:	Gabion mattress downstream of check-dam damaged due to debris and litter caught within the wiring, which caused breakage (Image 32). Gabion mattress under the concrete apron is undermined (Image 33). Cracks within siding rock (localized) at grout seams. There are efflorescence and lime residue build-ups on the inside surfaces of the culvert concrete, indication of moisture seepage through the concrete hairline cracks (Image 33). Headwall concrete has spalled off at majority of the sidewalk handrail.
Proposed Improvement:	Remove failing concrete apron and gabion toe on downstream side. Replace concrete apron and fill voids beneath apron with select backfill and flowable fill as needed. Install concrete toe wall at edge of apron for protection. Remove and replace damaged gabion mattress upstream. Connect to existing gabion wall. Repair spalled concrete and handrail support concrete at top of the culvert at bottom of posts. Repair concrete spalls on wall 4 from east and soffit of barrel 2 at east end and east end of barrel 5. Monitor interior hair cracks. Perform a site visit to verify whether items identified in TXDOT inspection report of 05/14/2019 have expanded.

Image 32. Close-up of wire damage within gabion mattress at Valley View (upstream).

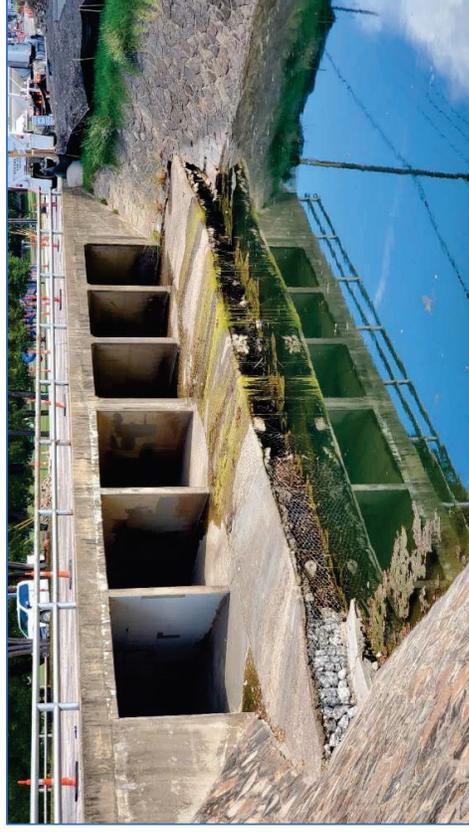
Image 33. Undermined concrete apron at Valley View (downstream).

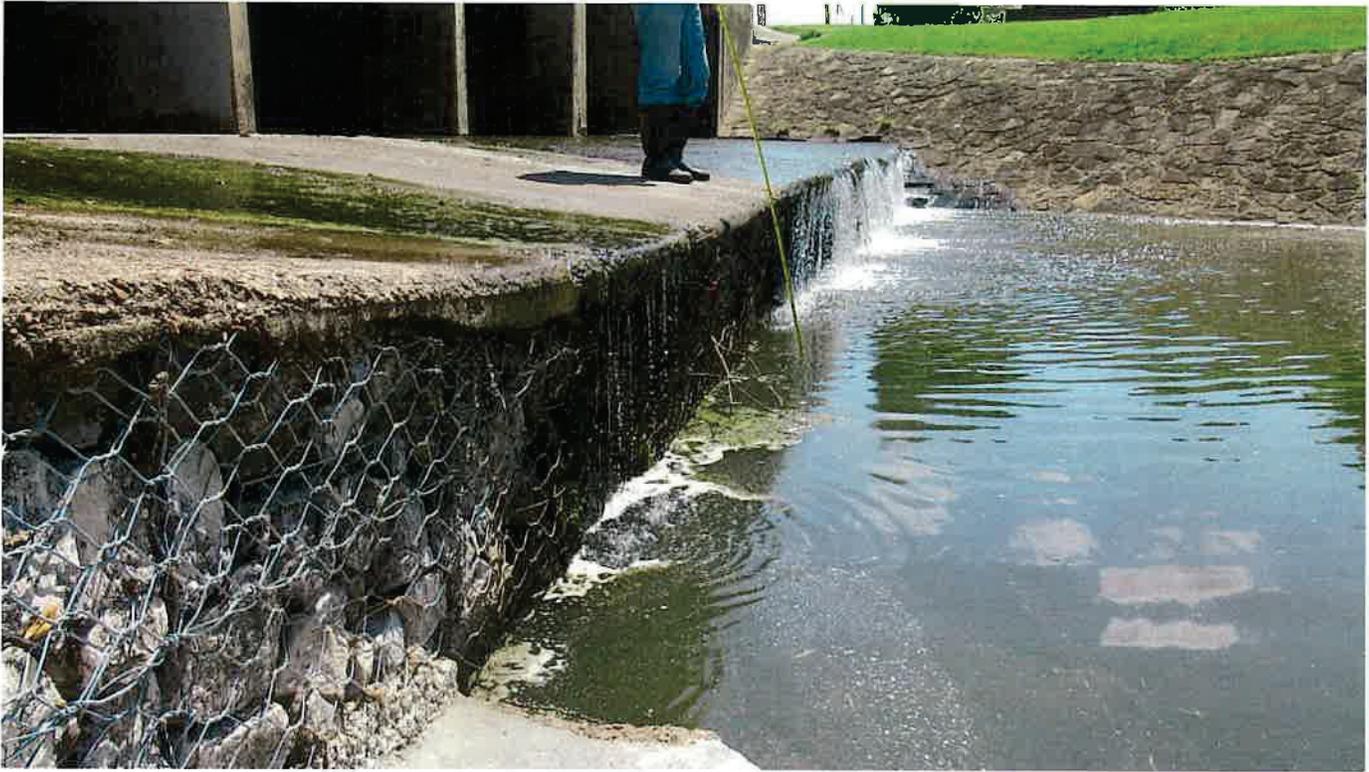
VIEW 8128

DOWNSTREAM APRON TOEWALL - LOOKING EAST

NOTE: DOWNSTREAM APRON TOEWALL IS EXPOSED 7' DEEP.

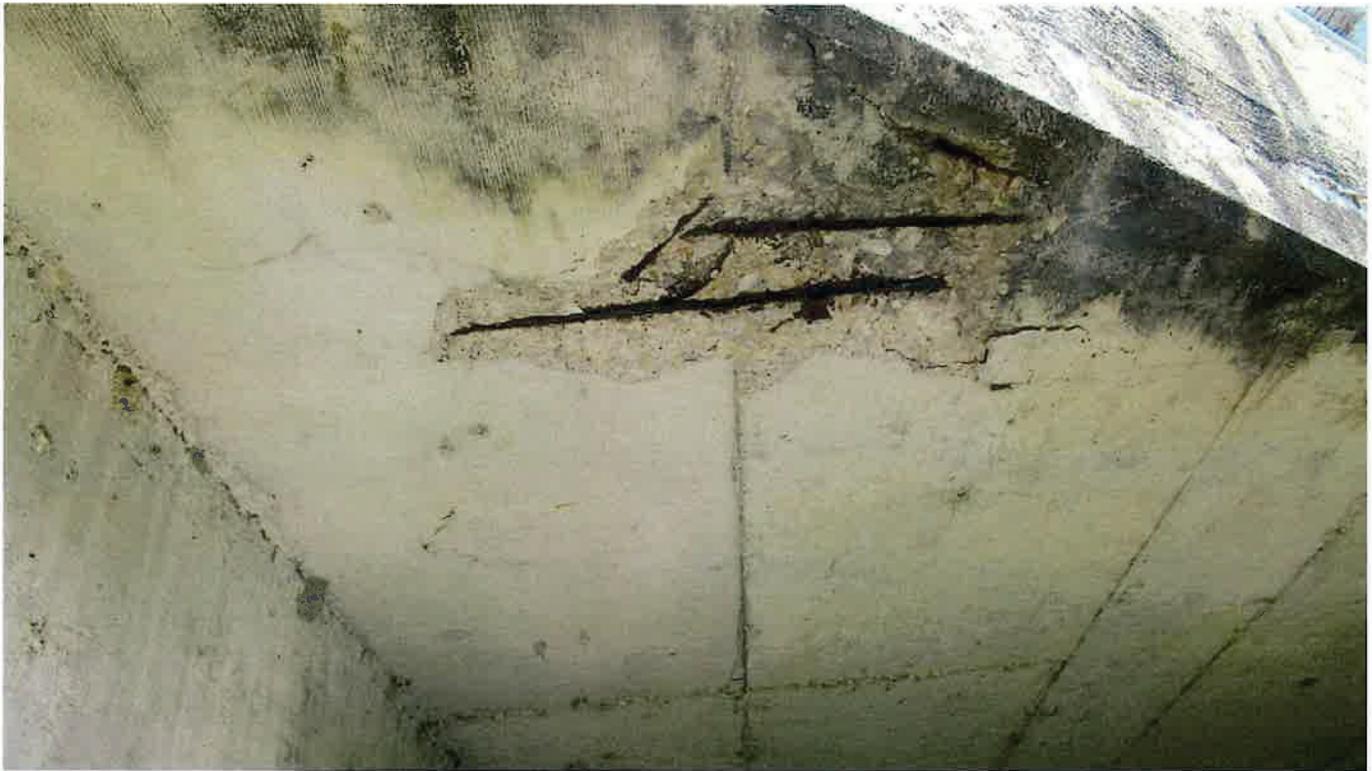
VIEW 8129

BARREL 5 FROM EAST - LOOKING NORTHEAST

NOTE: MODERATE SPALL WITH EXPOSED REBAR IN SOFFIT OF BARREL 5 FROM EAST AT SOUTH END.
