Reference: **Asbestos Survey of Target Areas at the Site Related to Proposed Renovation Activities**
Equipment Services
13333 Senlac Dr. Farmers Branch, TX 75234
Ridgeline Project No. 240520.64

REPORT OF ASBESTOS INVESTIGATION

EQUIPMENT SERVICES

13333 SENLAC DR.

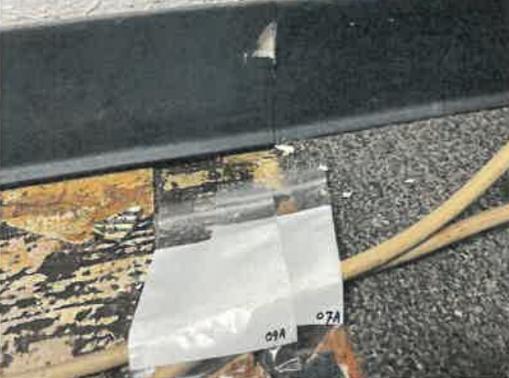
<p>PHOTOGRAPH 3:</p> <p>SAMPLE NUMBERS – 07A,09A</p> <p>MATERIAL: Cove Base (Black), 12”x12” VCT White/ Black Mastic</p> <p>ASBESTOS CONTENT:</p> <p>2% Chrysotile Asbestos Detected</p>

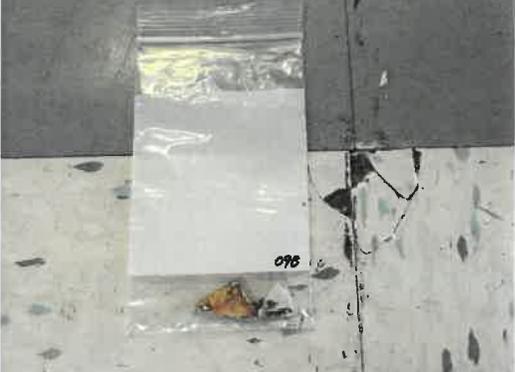
<p>PHOTOGRAPH 38:</p> <p>SAMPLE NUMBERS – 09B</p> <p>MATERIAL: 12”x12” VCT White/ Black Mastic</p> <p>ASBESTOS CONTENT:</p> <p>2% Chrysotile Asbestos Detected</p>
